AIRCRAFT ACCIDENT REPORT

PICOMSS/07/05/2012/F

**Report on the Serious Incident involving
Presidential Implementation Committee on
Maritime Safety and Security (PICOMSS) with
Registration 5N-BKS at Benin Airport Edo
State Nigeria on 5th July, 2012**

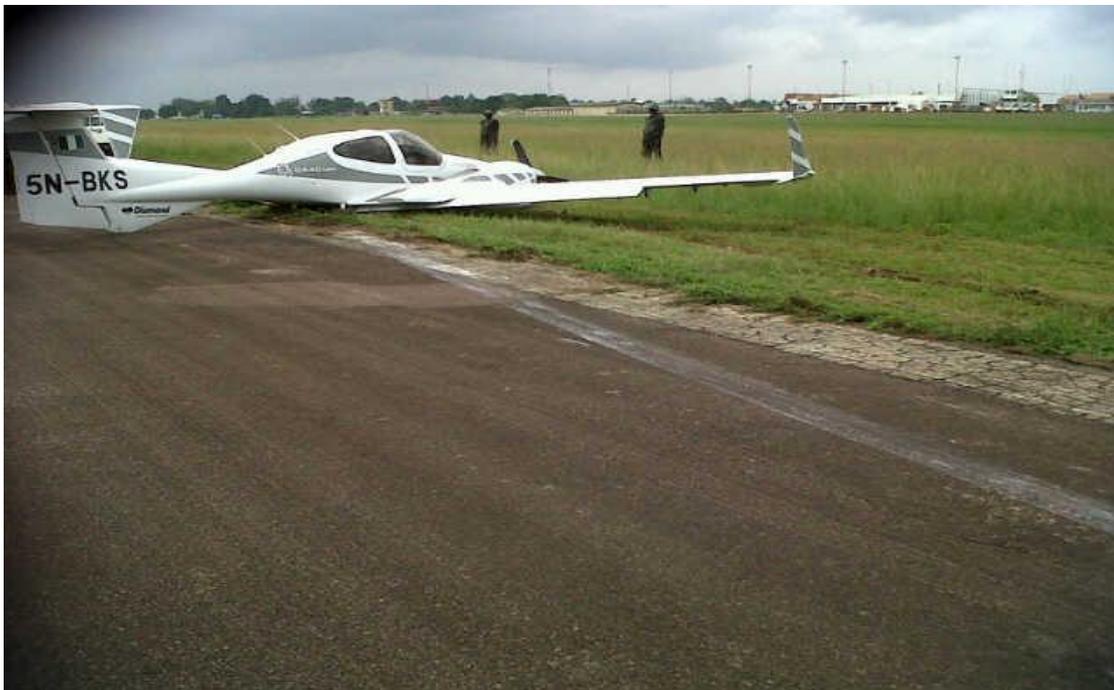
Figure 1.3a Aircraft Final Place of Rest

The aircraft was substantially damaged. See Figures 1.3a and 1.3b.

The aircraft wreckage was in one place since the damage was limited to the propeller and the collapsed undercarriage.
