# AIRCRAFT ACCIDENT REPORT

NCAT/2008/10/06/F

**Report on the serious incident involving a Tampico  
TB 9 Aircraft belonging to NCAT, registration 5N-CBC  
which occurred at Zaria Aerodrome, Kaduna State  
on the 6<sup>th</sup> of October, 2008**

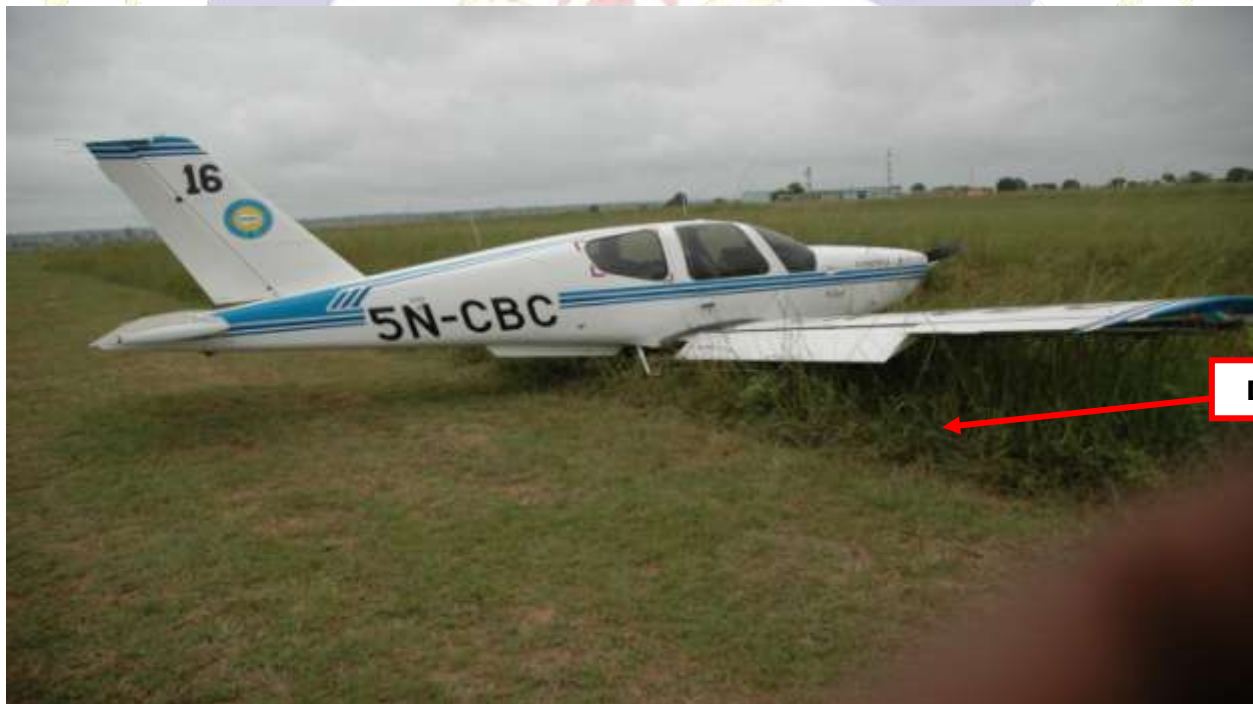
The aircraft travelled a further 200m from touchdown point before coming to a final stop by a ditch at approximately 31.6m from the edge of the runway. The student pilot disembarked without any injury but the aircraft was substantially damaged.

**Figure 1:** Picture showing the position of the aircraft at final stop (Ditch)

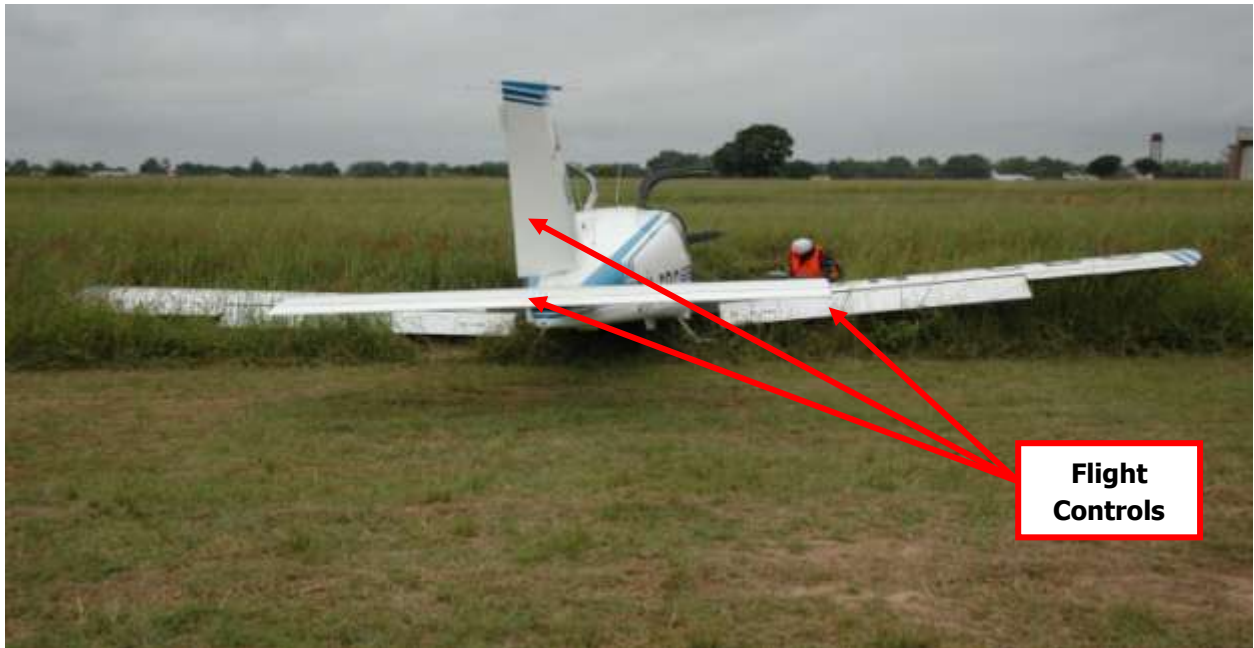
**Figure 2:** Rear view of the aircraft showing the position of the flight controls

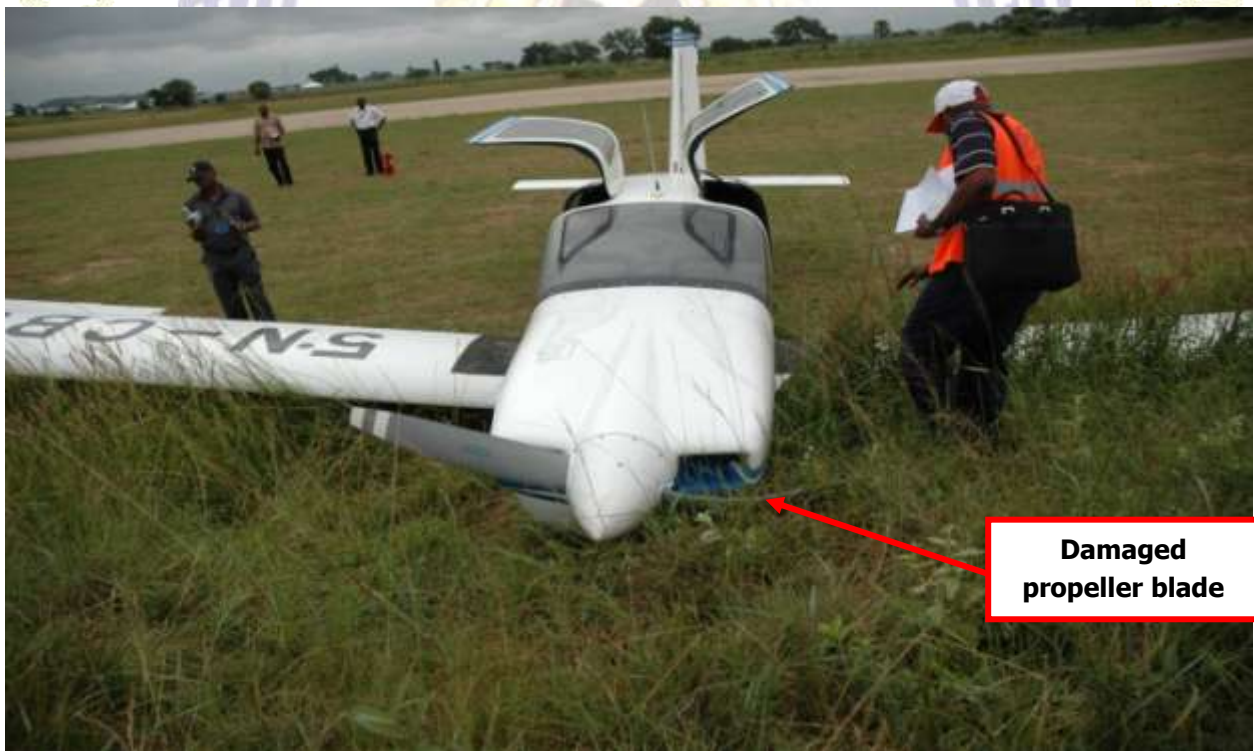
**Figure 3:** Nose dome area of the aircraft showing damage to propeller blade

The aircraft touched down around the first intersection, and veered off the runway centre line and stopped by the ditch. The aircraft sustained substantial structural damage to its propeller, starboard wing and the nose landing gear.

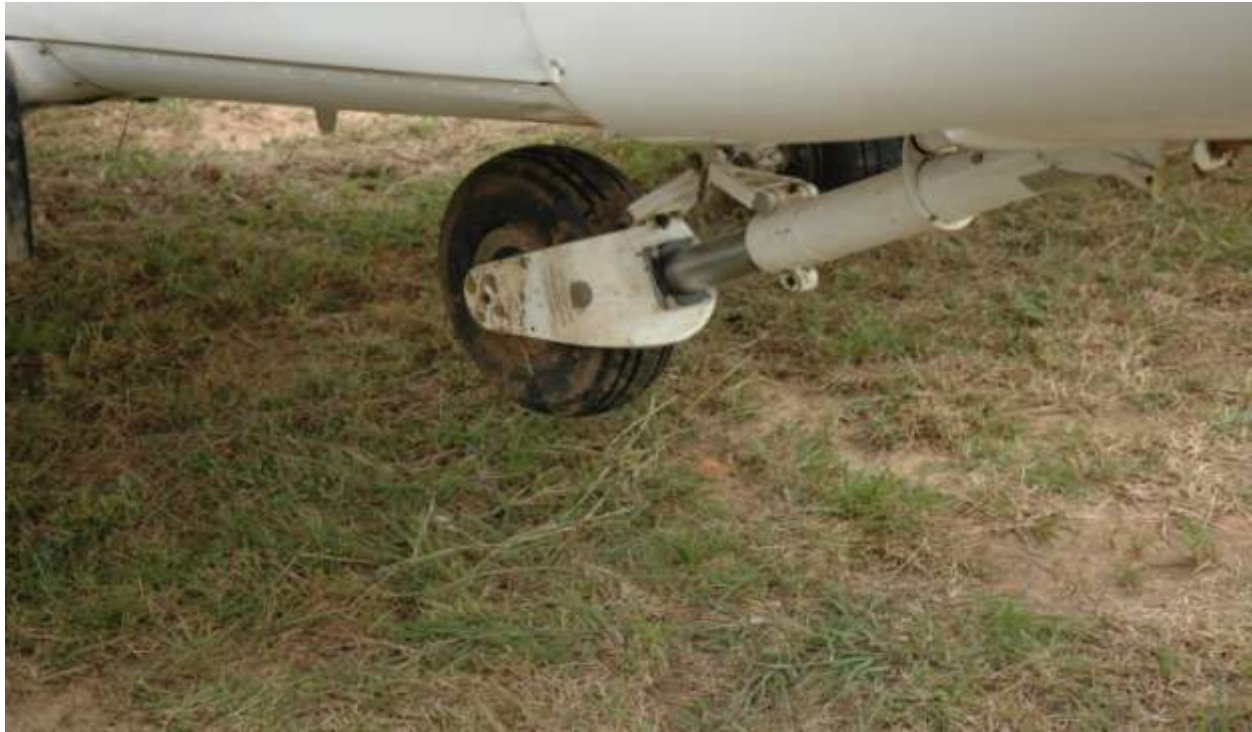
**Figure 4:** Picture showing damaged nose wheel landing gear
