AIRCRAFT ACCIDENT REPORT

NCAT/2012/05/23/F

Accident Investigation Bureau

**Report on the Serious Incident involving
Tampico TB-9 Aircraft belonging to the Nigerian
College of Aviation Technology (NCAT) with
Registration Number 5N-CBI which occurred at
the Zaria Aerodrome in Kaduna State on 23rd
May, 2012.**

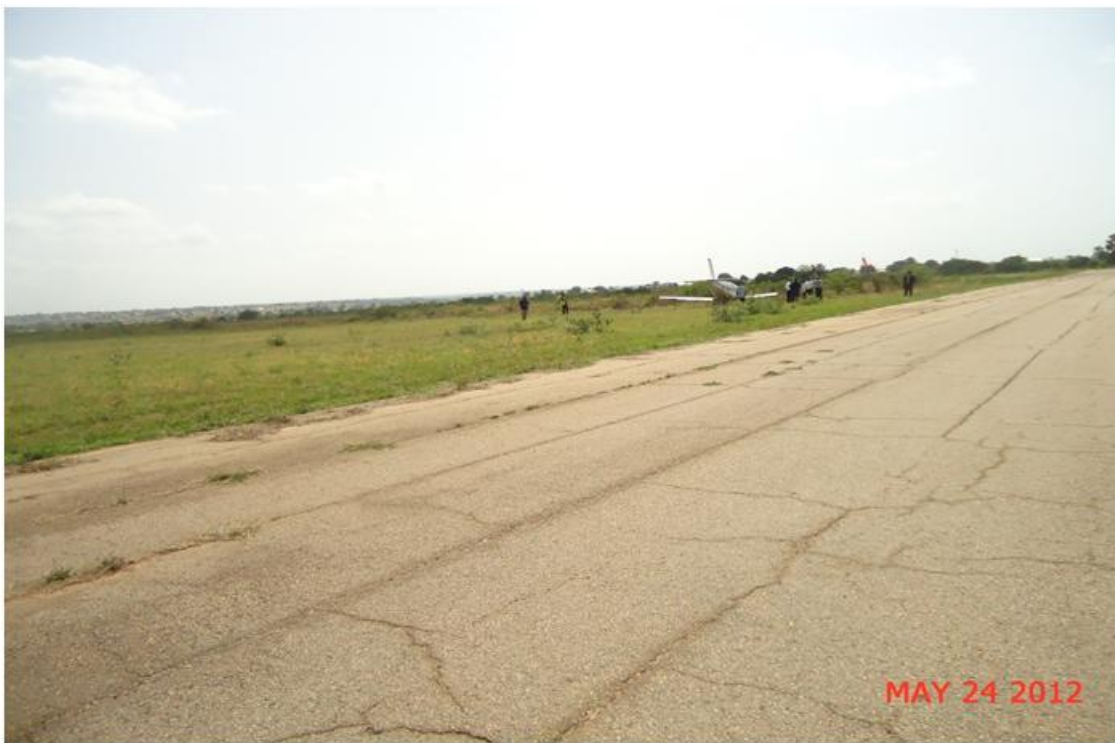
At the time of this occurrence the runway and exit markings were not clear.

Figure 1: The Unclear Runway Markings

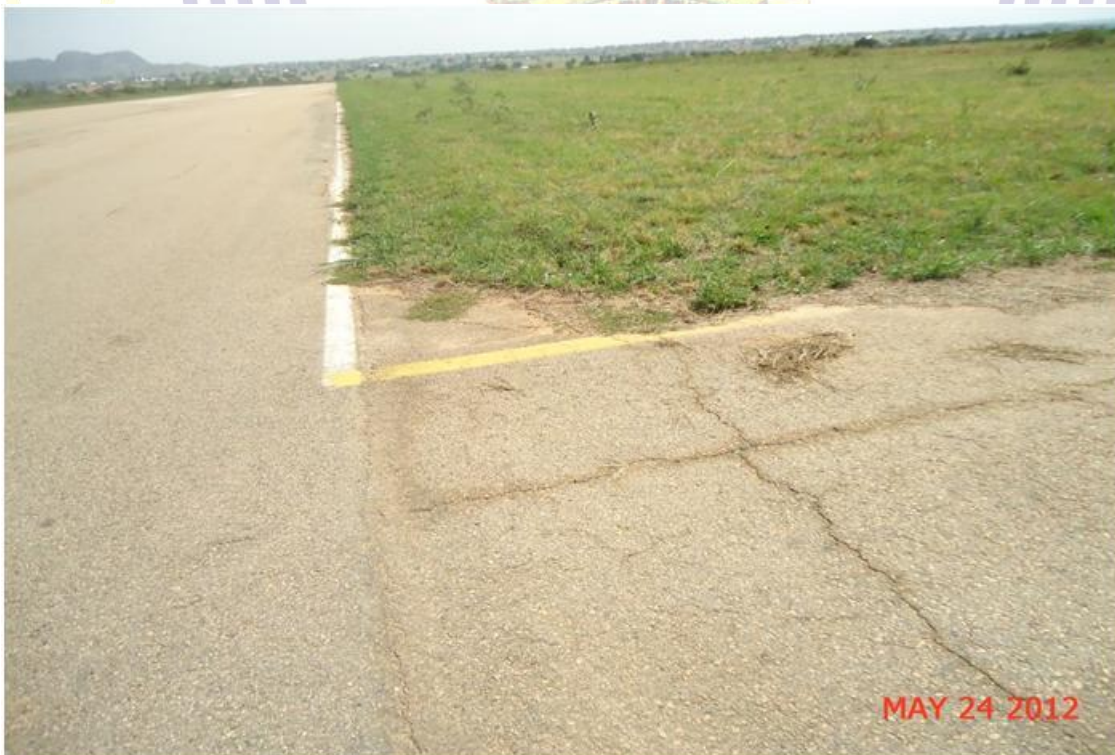
Figure 2: The Unclear exit 3 Markings

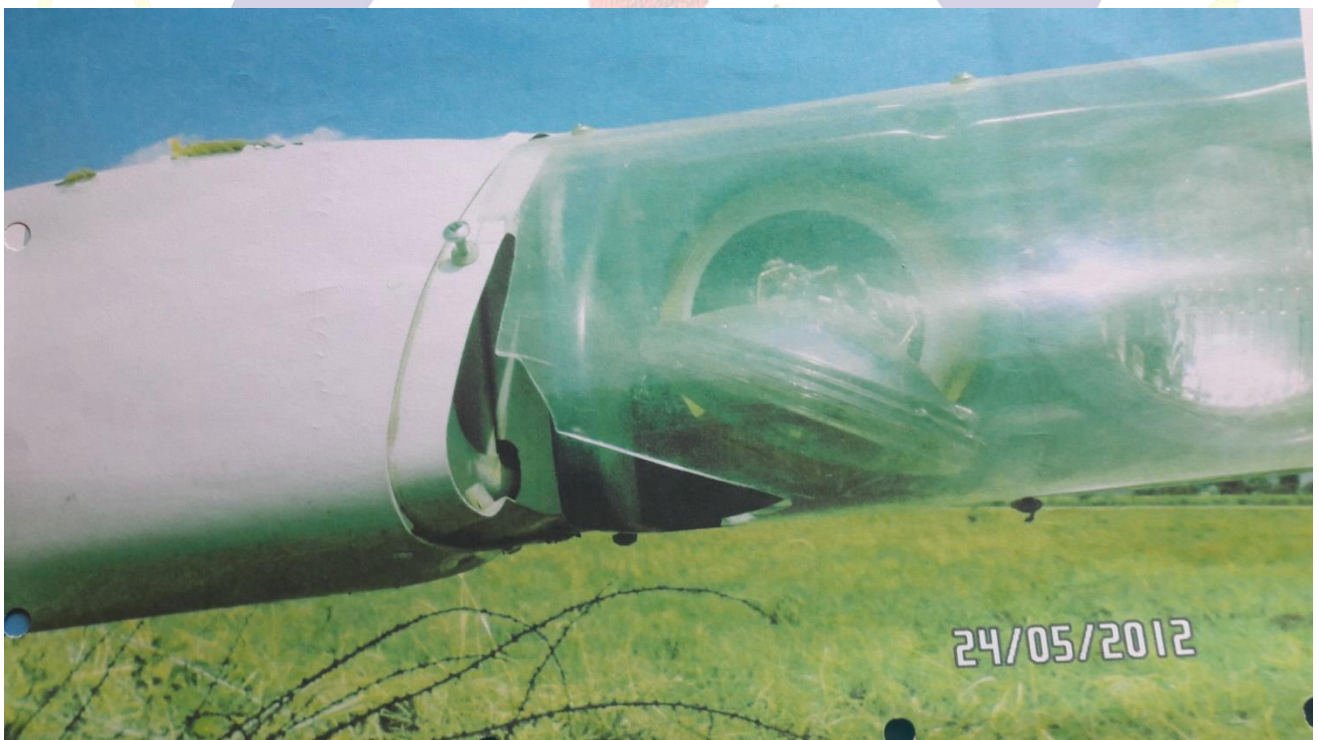
During the landing roll the aircraft veered off the runway, skidded and impacted a ditch parallel to the runway. The aircraft came to rest on a heading of 2850 magnetic. This resulted in damage to the propeller blade, denting the outboard of the left wing leading edge. The taxi and landing light cover was broken.

Figure 3: The broken Landing and Taxi Light cover

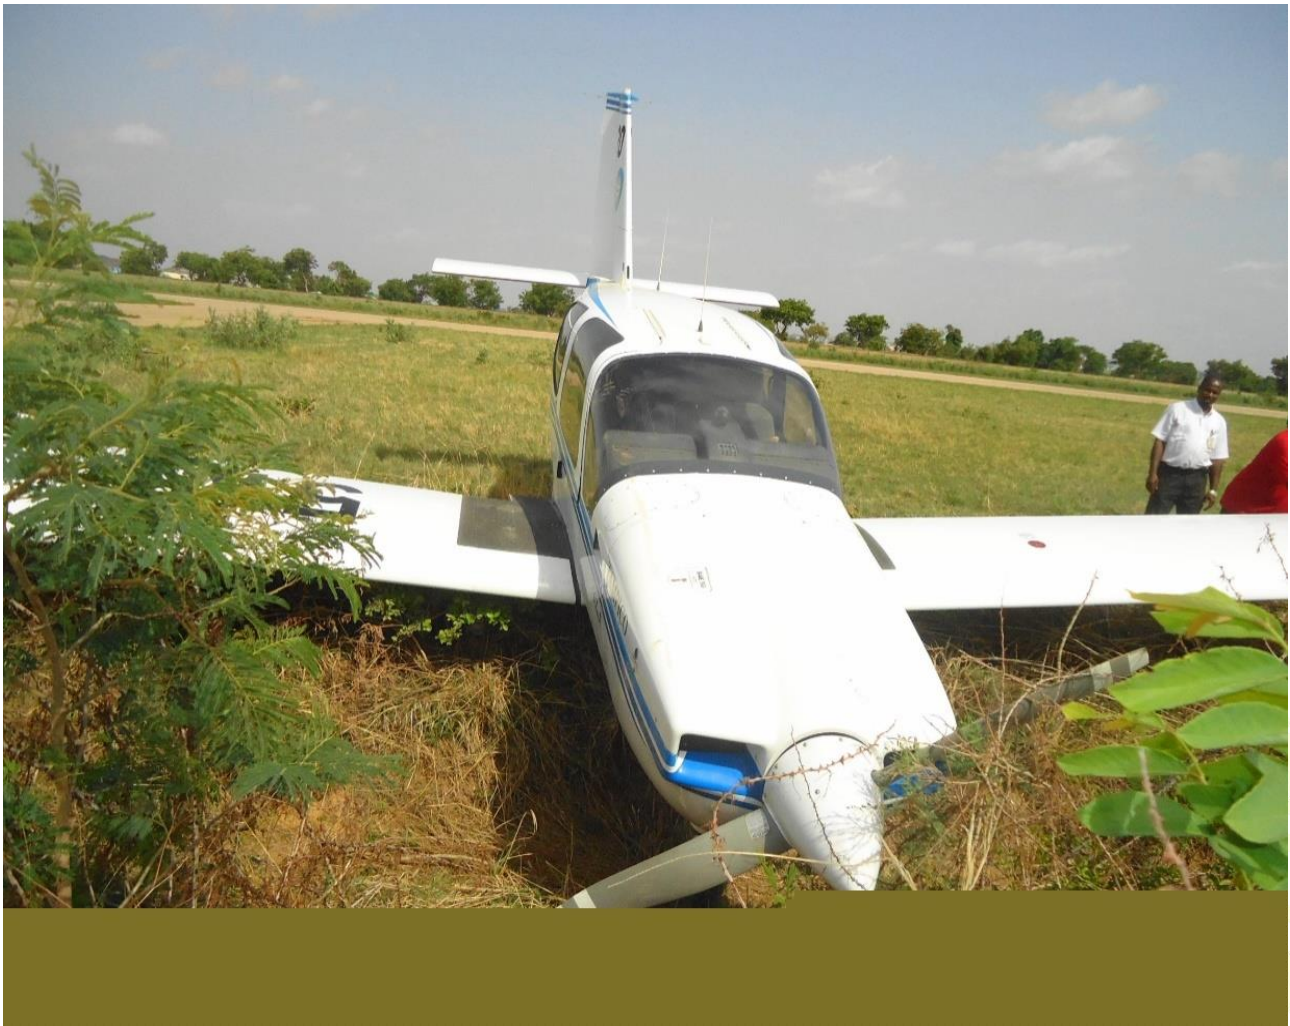
Figure 4: The damaged Propeller

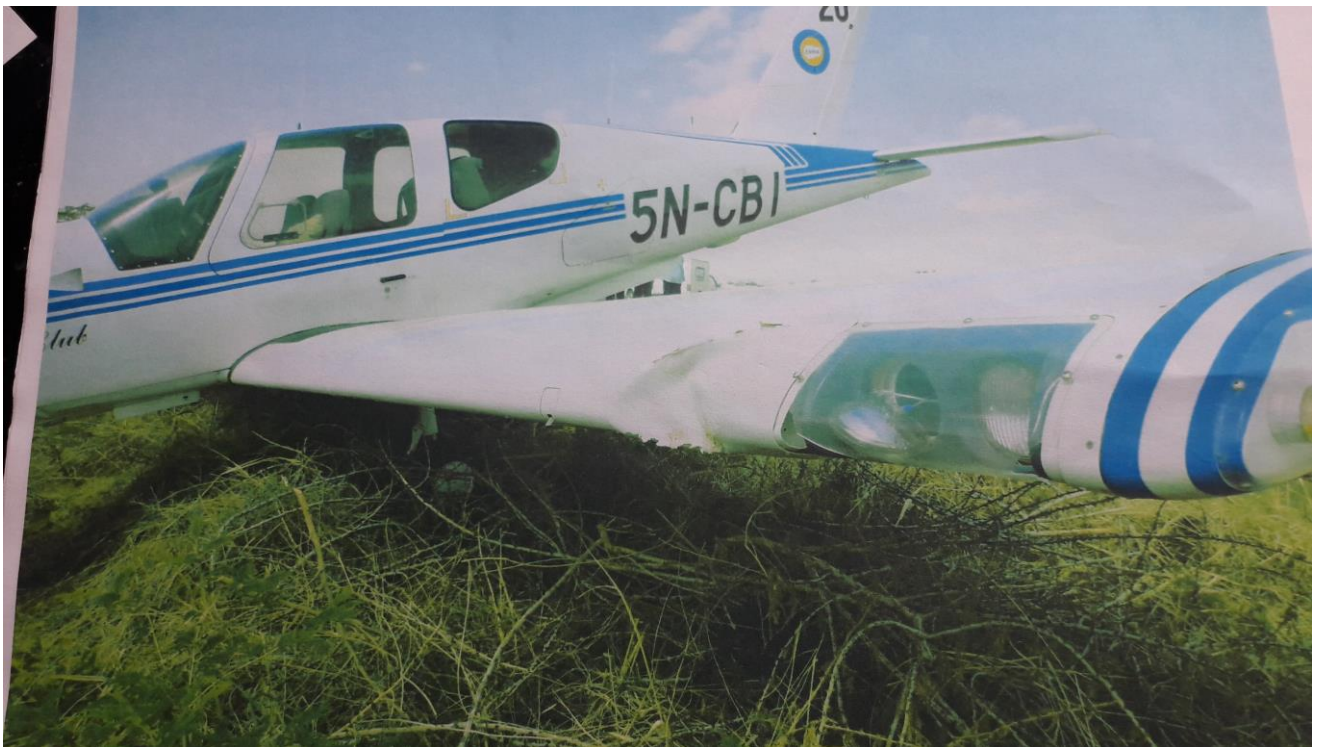
Figure 5: The Damaged left wing leading edge
