**PRELIMINARY REPORT ON SERIOUS INCIDENT INVOLVING DIAMOND DA42 AIRCRAFT OPERATED BY INTERNATIONAL AVIATION COLLEGE (IAC), ILORIN WITH NATIONALITY AND REGISTRATION MARKS 5N-BNH WHICH OCCURRED AT ILORIN INTERNATIONAL AIRPORT, ILORIN, KWARA STATE ON 1ST MAY, 2019**

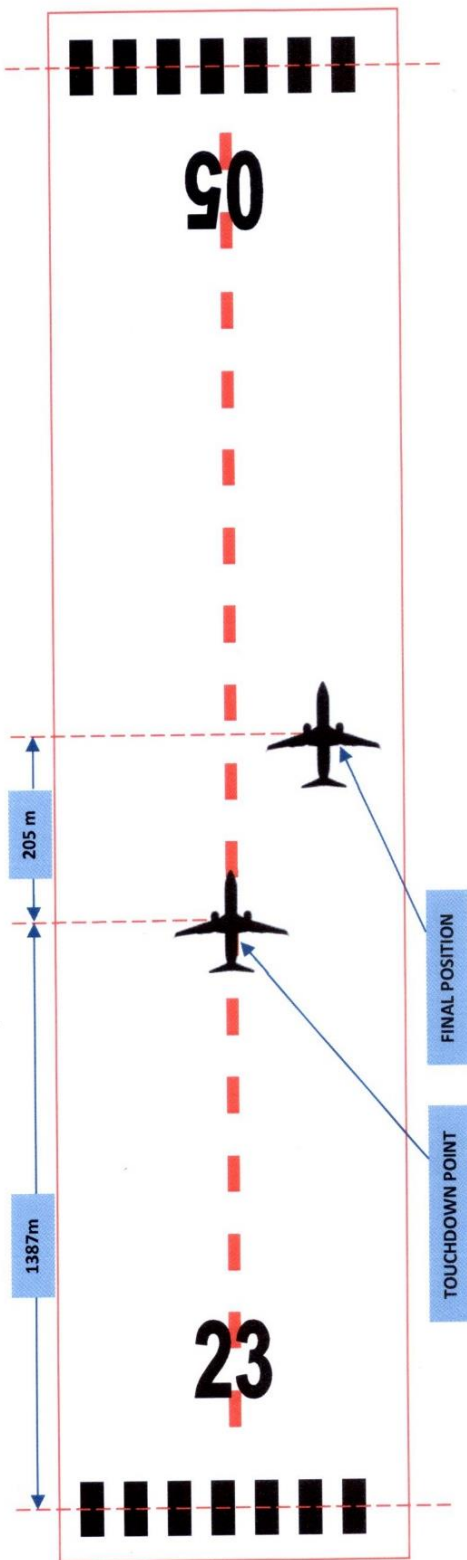
**Figure 1:** The schematic diagram of the position of aircraft after belly landing

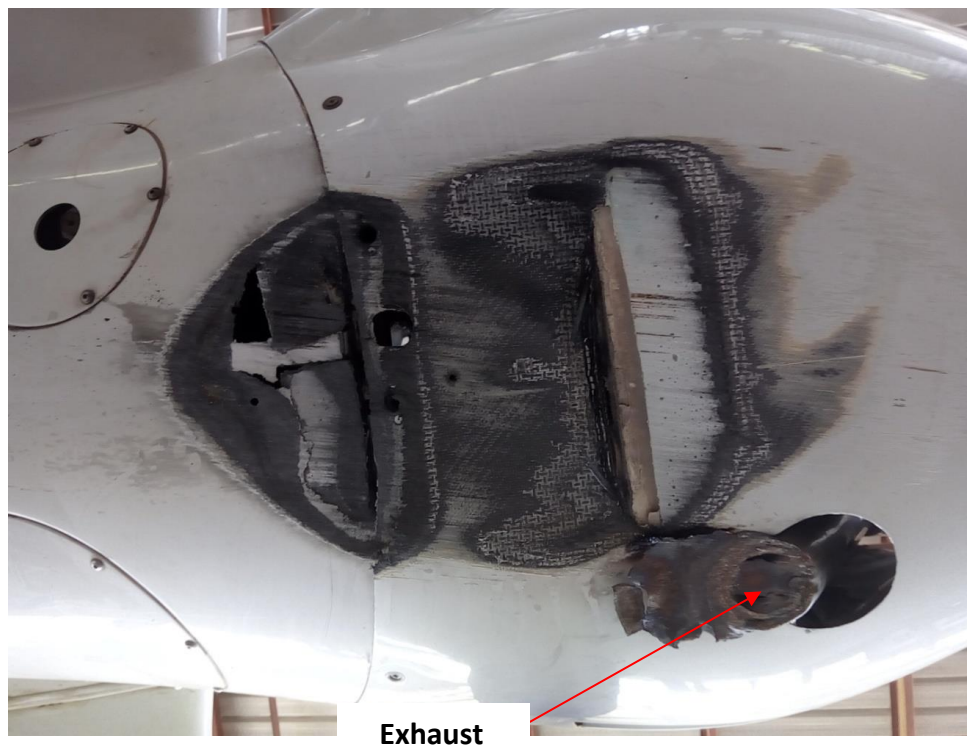
5N-BNH touched down on its engine cowlings (landing gears up) at a distance of 1,387 m from the threshold runway 23 with the nose in the direction of runway heading and made a final stop at distance of about 205 m from the touchdown point. Although the aircraft was relatively in one piece, the left and right stairs were found chopped off, the base of the engine cowling and exhaust as well as the tail skid were abraded, and all the propeller blades were broken.

**Figure 2:** Photo showing the base of engine cowling and exhaust after the incident

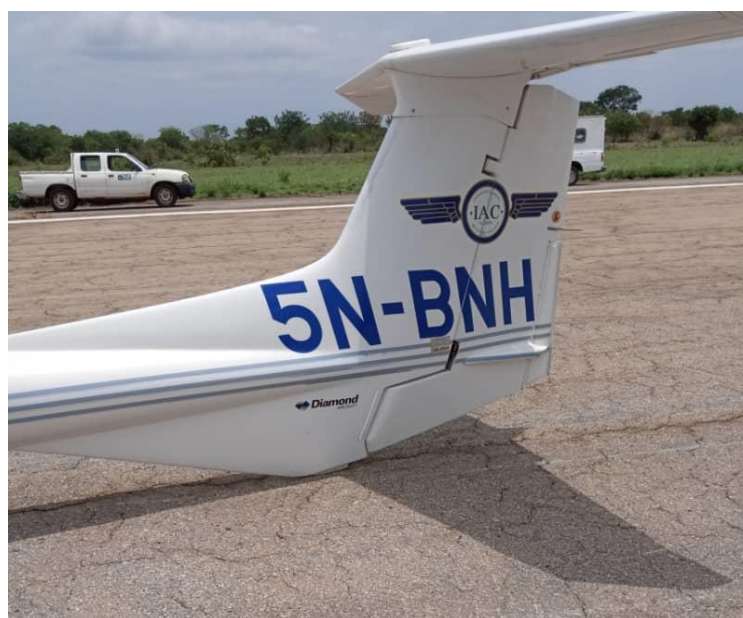
**Figure 3:** The tail skid of aircraft touching the runway

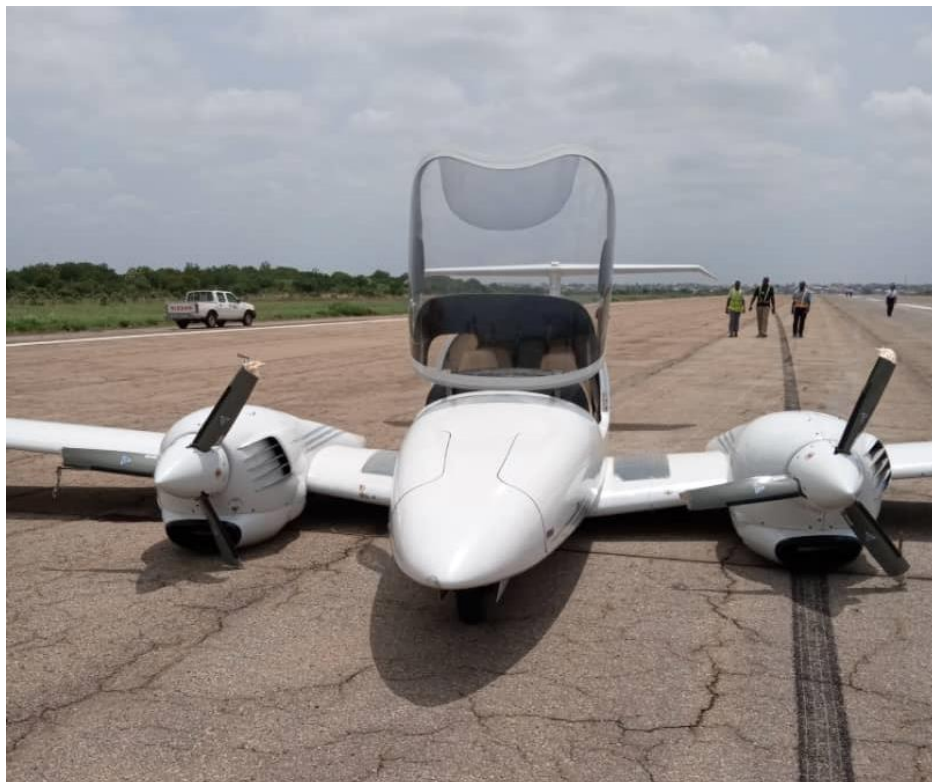
**Figure 4:** Final position of 5N-BNH on runway 23

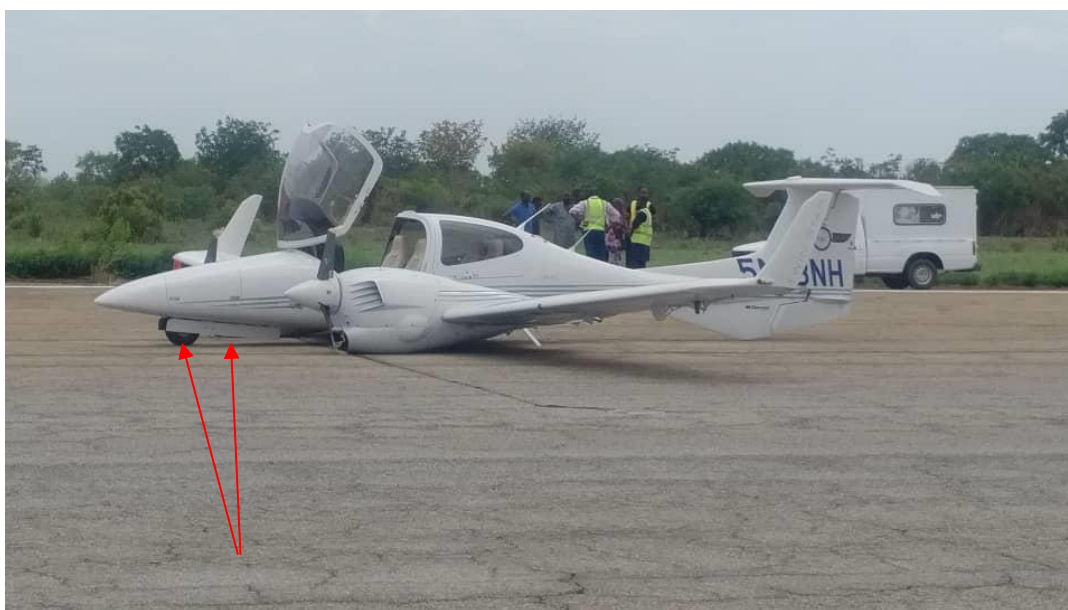
**Figure 5:** The nose-wheel door opened and tyre protruding

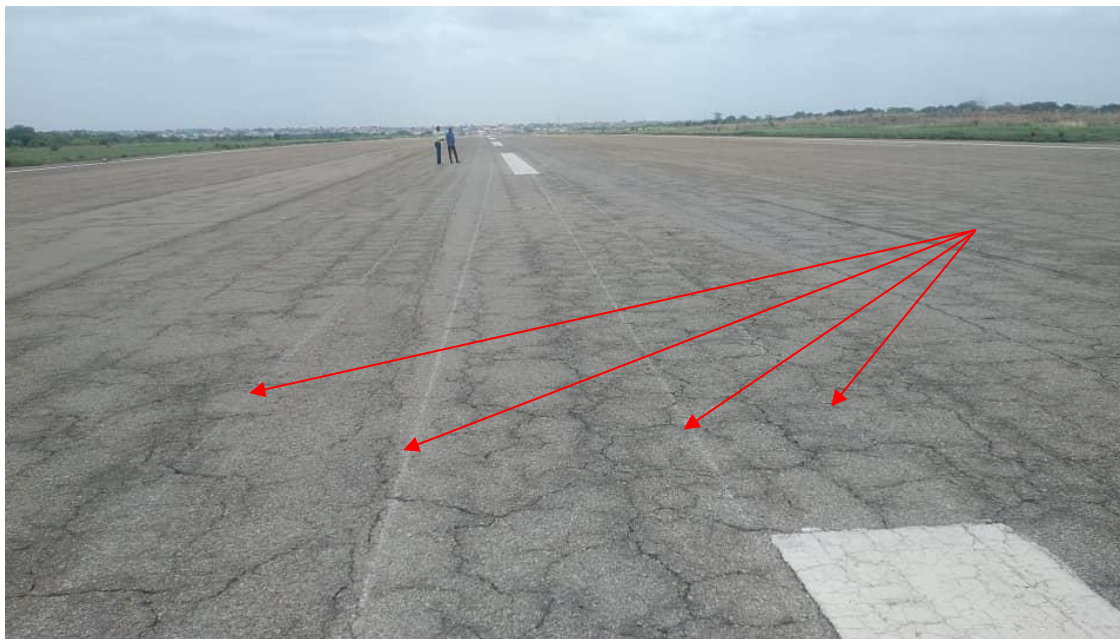
**Figure 6:** Skid marks made by 5N-BNH on runway 23

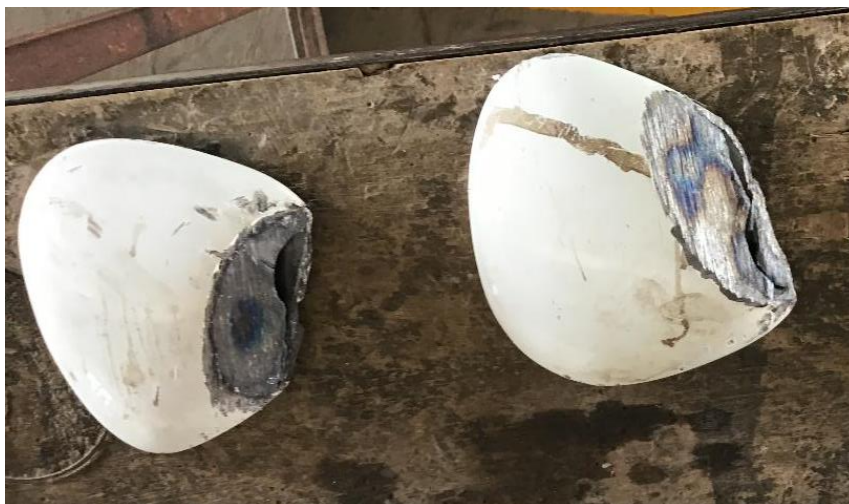
**Figure 7:** Broken Left and Right stairs

11. The propeller blades were broken, the left and right stairs were broken and the base of the engine cowling abraded.

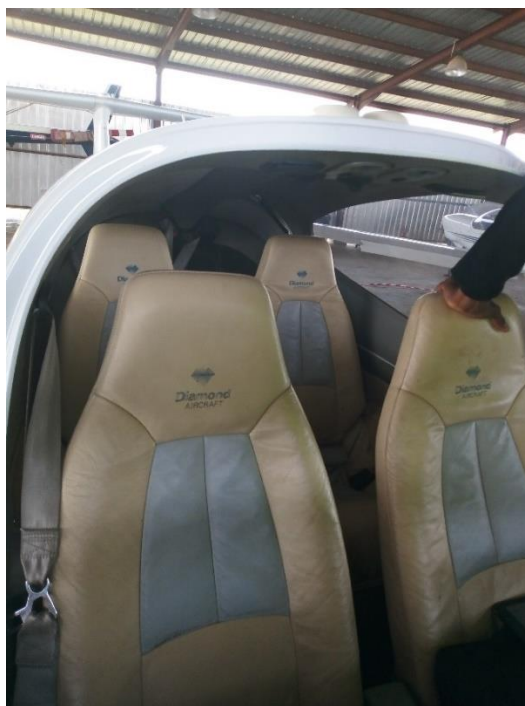
**Figure 7:** The cabin after the incident
