AIRCRAFT ACCIDENT REPORT

BHNL/2016/02/03/F

Accident Investigation Bureau

**Report on the Accident involving a Bristow Helicopters
(Nigeria) Limited Sikorsky S76C++ Helicopter with
nationality and registration marks
5N-BQJ which occurred at 77 NM offshore from
Murtala Muhammed Airport on Radial 139°
on 3rd February 2016**

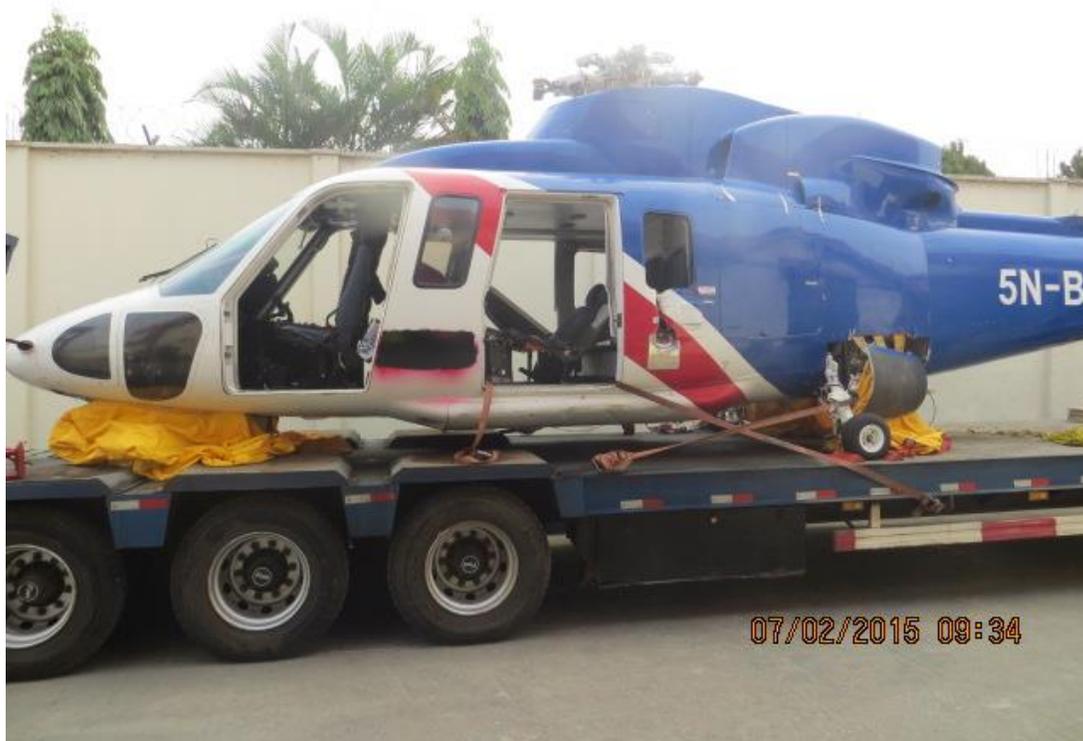
The aircraft was fairly intact although damaged as a result of being submerged in salt water. The life rafts were deployed, and the doors were detached from the aircraft.

Figure 2: The aircraft being transported after recovery from the ocean

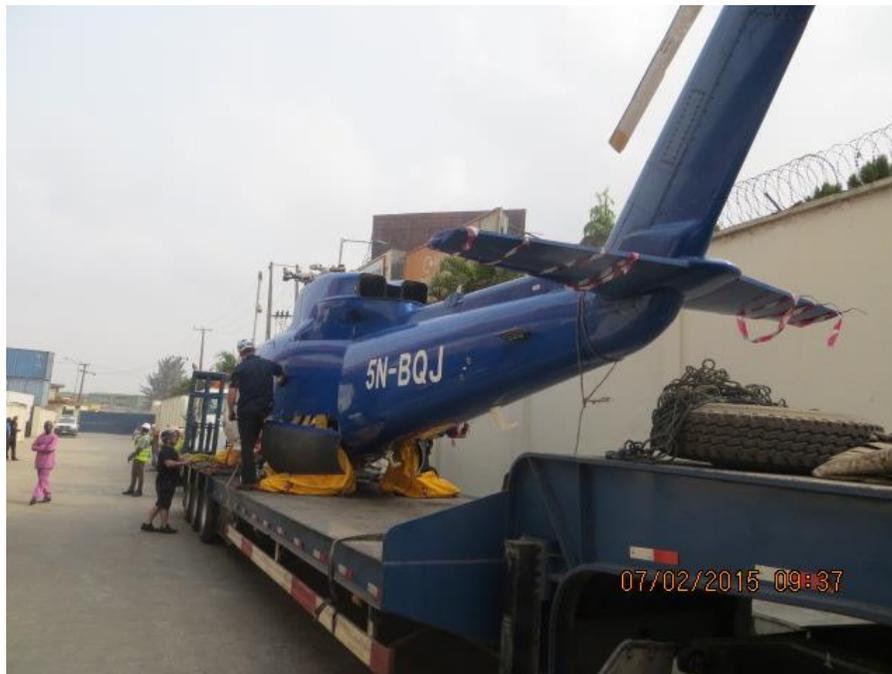
Figure 3: The aircraft being transported after recovery

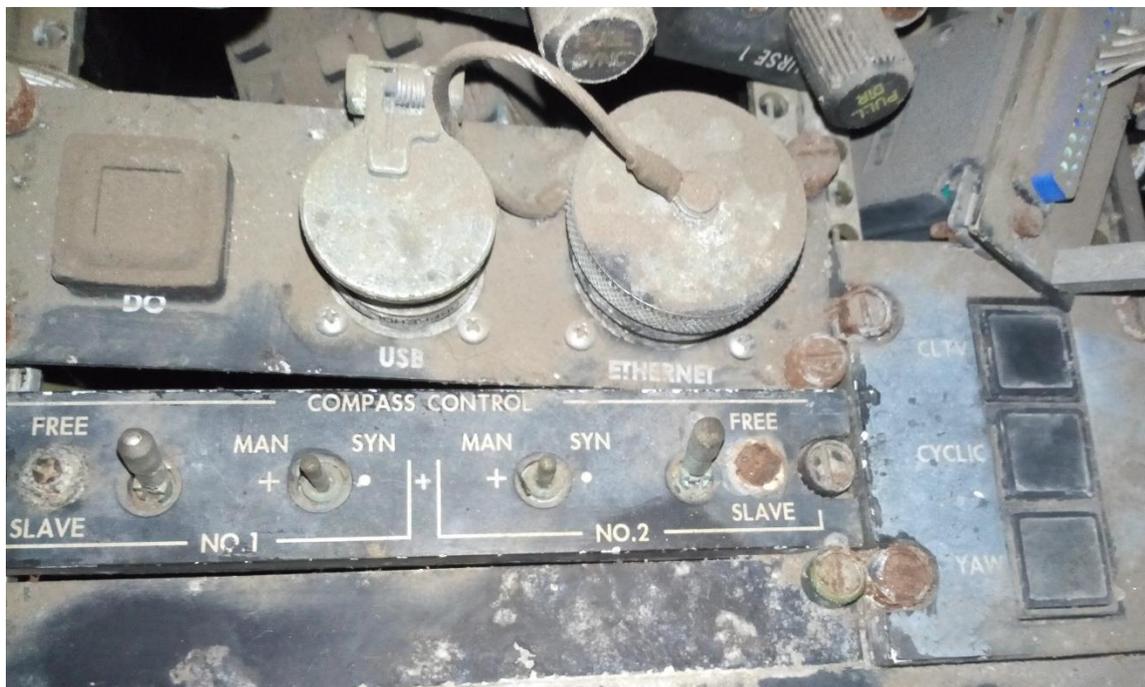
The company Operations Manual (Part B) checklist requires that the compasses be selected to SLAVE mode after take-off. Evidence available to the Bureau indicated that the No. 1 & 2 COMPASSES were in FREE DG mode. (See Figure 4).

Figure 4: Compass control panel

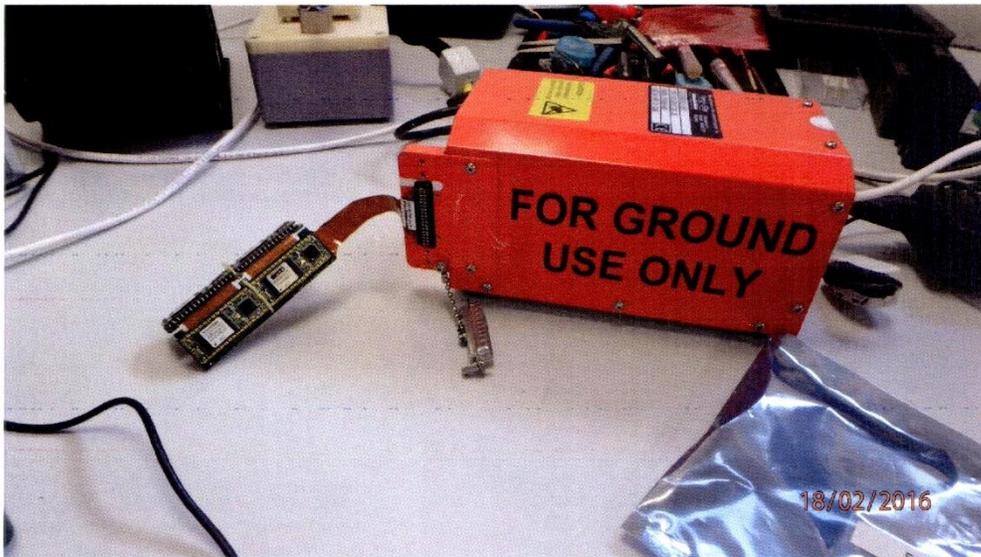
7. Water had entered the inner cylinder. The memory board was cleaned, inspected and placed in a humidity controlled drying cabinet for 48 hours at 50°C. No defects were identified during inspection of the board.

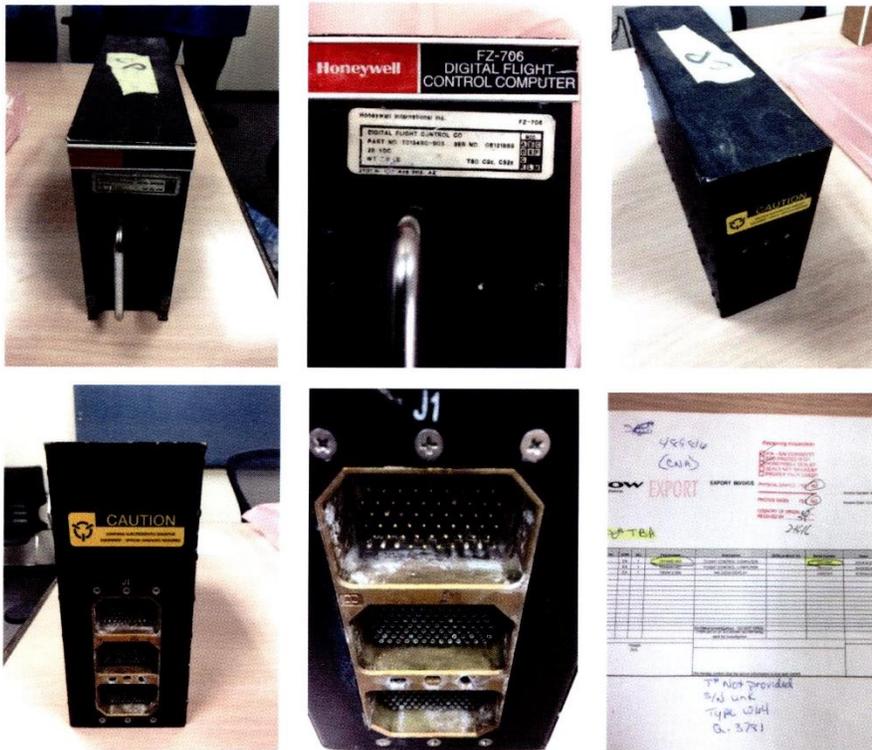
Unit 1 (Marked with "CP" on top)
7015480-903, SN 06121889

The units appear to have spent some time submerged in water and signs of salt and corrosion can be seen on the connectors.

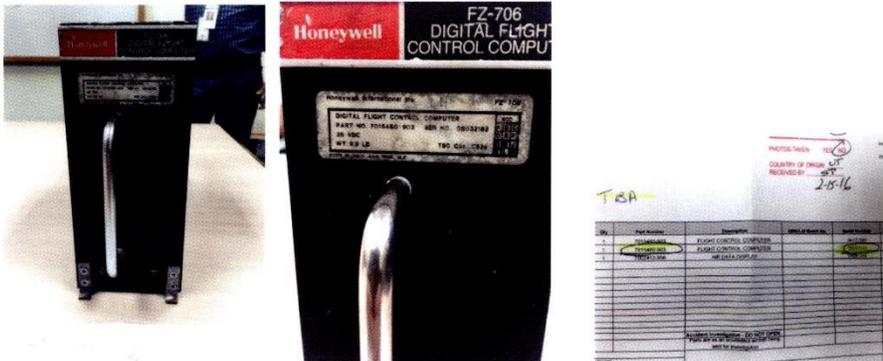
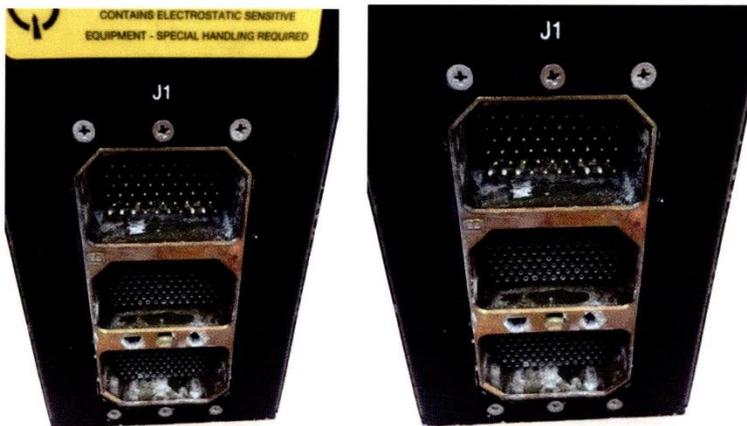
Unit 2 (marked with "P" on top)
7015480-903, SN 08032162

Again, unit 2 showed signs of salt and corrosion on the connectors.
