# AIRCRAFT ACCIDENT REPORT

PAAN/2004/07/26/F

**Report on the Accident to a Pan African Airlines  
Nigeria Ltd Bell 412 EP Helicopter with registration  
5N-BDZ which occurred near SEDCO Energy Rig  
Platform, Off Nigeria's Southern Coastline  
on 26th July, 2004**

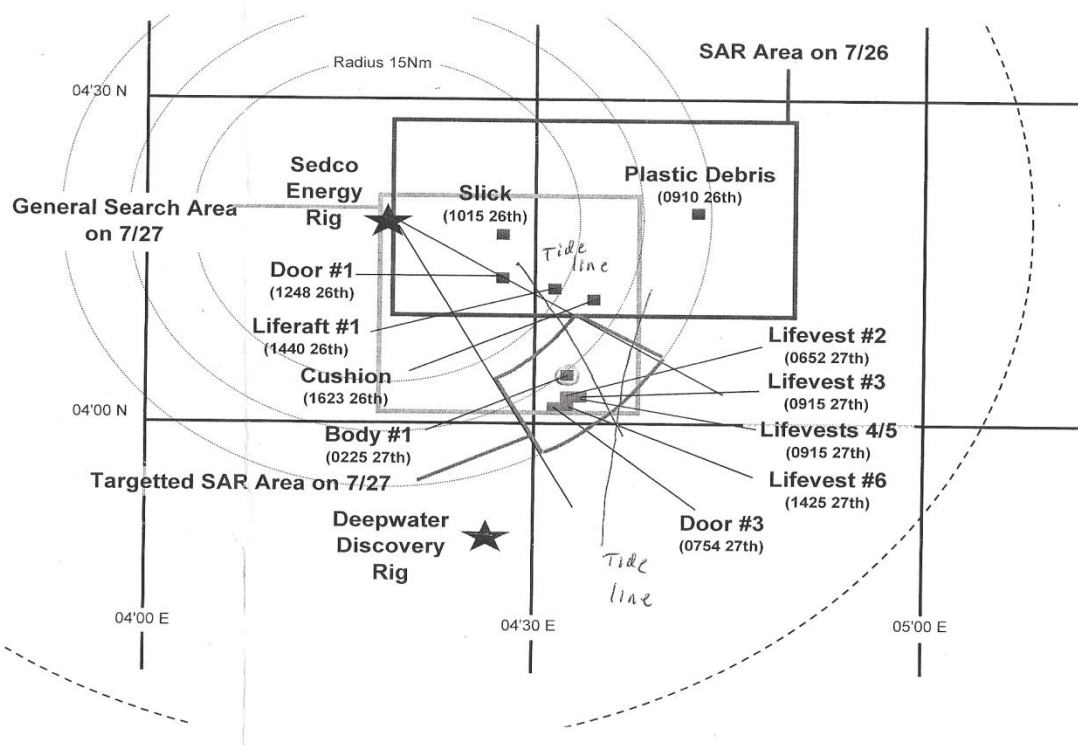
The larger part of the helicopter wreckage was not recovered. However, some items were recovered including doors, life raft, an un-inflated life jacket, seat cushion and part of the tail rotor with blue paint on the leading edge. Some of the items recovered were sent to NTSB, USA for analysis.

**Figure 1:** Wreckage distribution during the Search and Recovery Operation

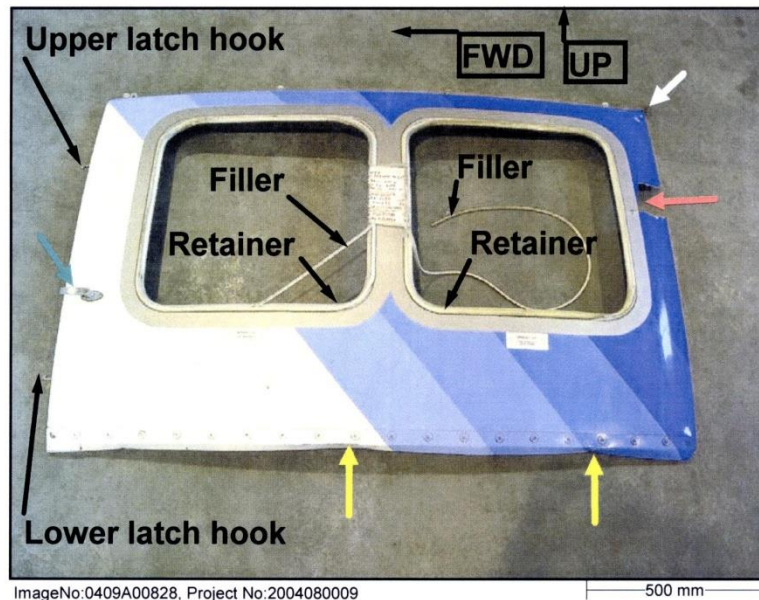
Examination of the left passenger door (see figures 3 and 4) revealed that it was mostly intact. The two windows were missing but the elastomeric retainers and fillers for both windows were present. No fragments of glazing material were observed in the retainers of both windows. A portion of the structure at the rear edge was also missing, as

Figure 3. An exterior view of the left passenger door.

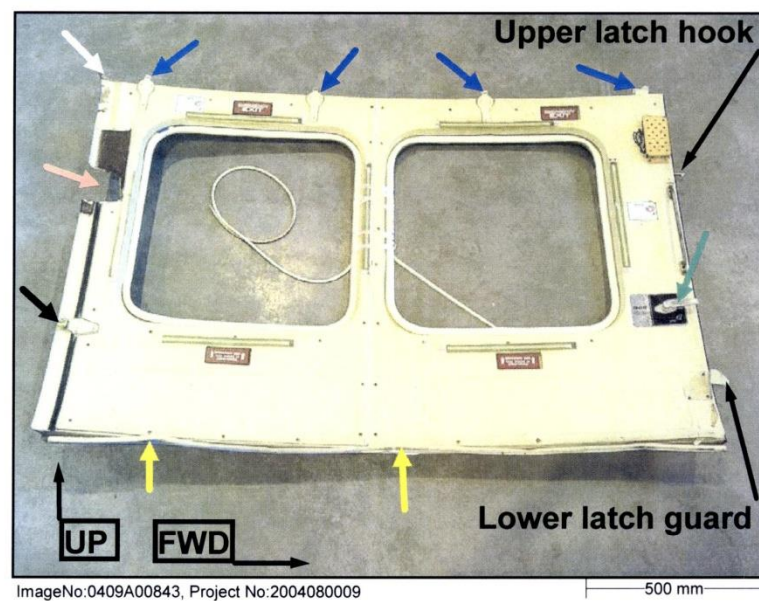
In figure 4, the blue arrows indicate the upper guide roller assemblies, which were attached to the door, rolled freely, and appeared to be undamaged. In contrast, the rear upper guide, also a roller assembly, was missing along with a portion of the door structure at the position indicated by the red arrow.

In figure 4, the lower latch hook, which was present and appeared undamaged, is hidden from view by the lower latch guard. The upper latch hook was also present, and appeared undamaged, but the guard for this hook was missing. Attempts were made to rotate the exterior and interior door handles from their "closed" position but the mechanism was found to be too stiff to operate manually. Examination showed that the latches, the adjacent mechanism visible inside the door, and the area around the latches appeared to be undamaged although the guard plate at the upper latch was missing. The door handles displayed significant surface corrosion. The lower guide assembly, at the location indicated by the black arrow in figure 4, is illustrated in the left view of figure 5 with the interior surface identified. A blue arrow indicates where the lower square groove on the plastic slide had been torn in an inwards direction, and the black arrows indicate the inward bending that had been applied to the normally flat slide retainer, features consistent with the door being forced outwards. The stop bracket assembly, at the location indicated by the white arrow in figure 4, is illustrated in the right view of figure 5. The normally vertical portion of the stop bracket, with the seal attached, had been partially straightened out, and the aft part of the horizontal portion of the bracket had been deformed outwards and upwards, as if the bottom of the door had moved outward while the vertical portion of the stop was retained.

Figure 4. An interior view of the left passenger door.

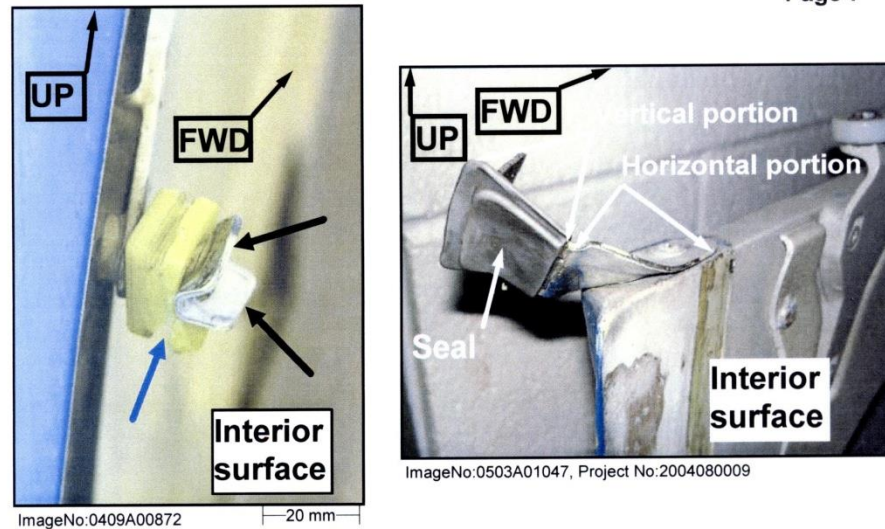
Figure 5. Left photograph shows the left passenger door's lower guide (indicated by the blue arrow in figure 4). Right photograph shows the vertical and horizontal portions of the left door's stop bracket (indicated by the white arrow in figure 4).

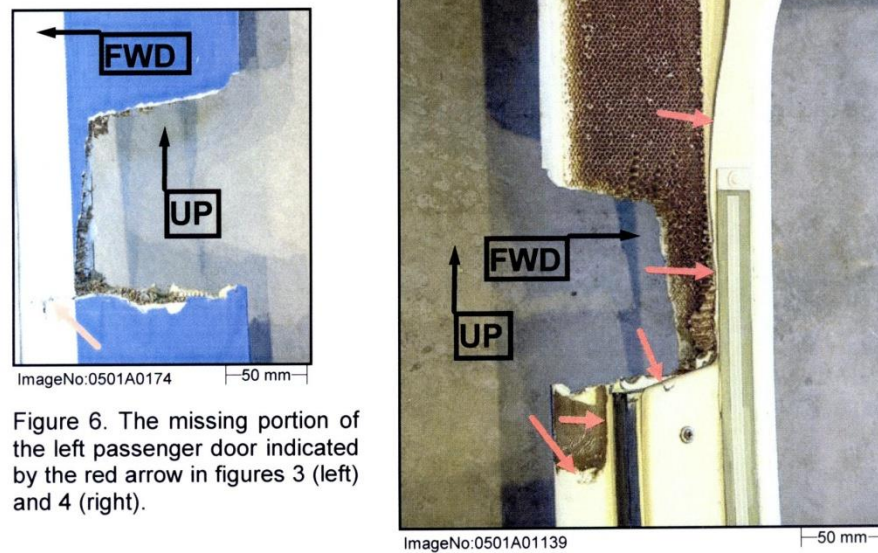
The missing portion of the left passenger door is illustrated in the two views of figure 6. The left view illustrates the exterior surface at the location indicated by the red arrow in figure 3. The missing portion was a rectangular shape with three fractured edges that were mostly straight and well defined. The edge of the lower fracture had propagated further forward as indicated by the red arrow. The right view illustrates the interior surface at the location indicated by the red arrow in figure 4, with the rectangular shape, illustrated in the left view, in the background. The missing rectangular shape would correspond with the location of the rear upper guide, which probably remained in its guide channel on the fuselage. A significant amount of the interior surface material above the rectangular shape was missing. Smaller amounts of interior surface material were missing from below and forward of the rectangular shape. The red arrows indicate the fractured edges of the material missing from the interior structure.

Figure 6. The missing portion of the left passenger door indicated by the red arrow in figures 3 (left) and 4 (right).

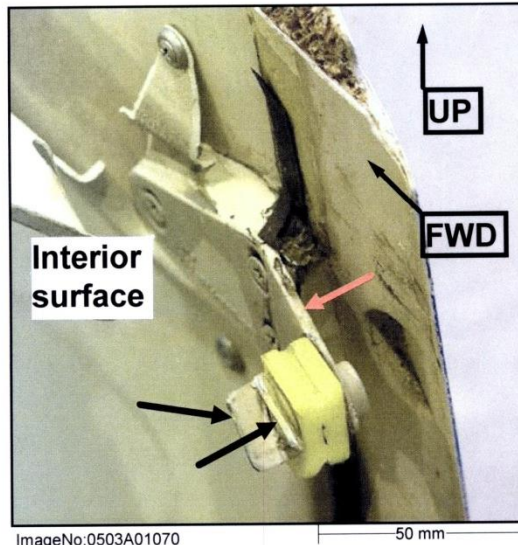
The black arrow in figure 8 indicates the lower guide assembly (the upper guide assembly was missing as it was also located on the missing portion of structure indicated by the red arrows). A closer view of the lower guide is illustrated in figure 9. The red arrow indicates the inward bending that had been imparted to the normally flat guide support plate. The black arrows indicate the inward bending that had been applied to the normally flat slide retainer, similar to that on the left door and also consistent with the door being forced outwards.

Figure 9. A view, from the rear, of the right passenger door's lower guide indicated by the black arrow in figure 8.

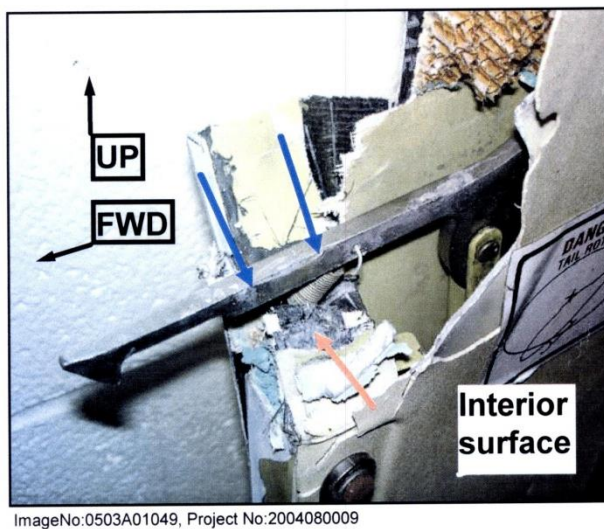
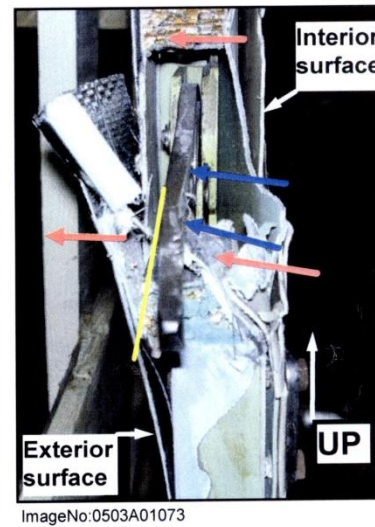
Figure 10. The right passenger door's upper latch, viewed from the inner rear (left) and from the rear (right).
