# AIRCRAFT ACCIDENT REPORT

DANA/2018/02/20/F

**Report on the Accident involving a Boeing MD-83  
aircraft operated by Dana Airlines Ltd with Nationality  
and Registration Marks 5N-SRI which occurred at Port  
Harcourt International Airport  
On 20th February, 2018**

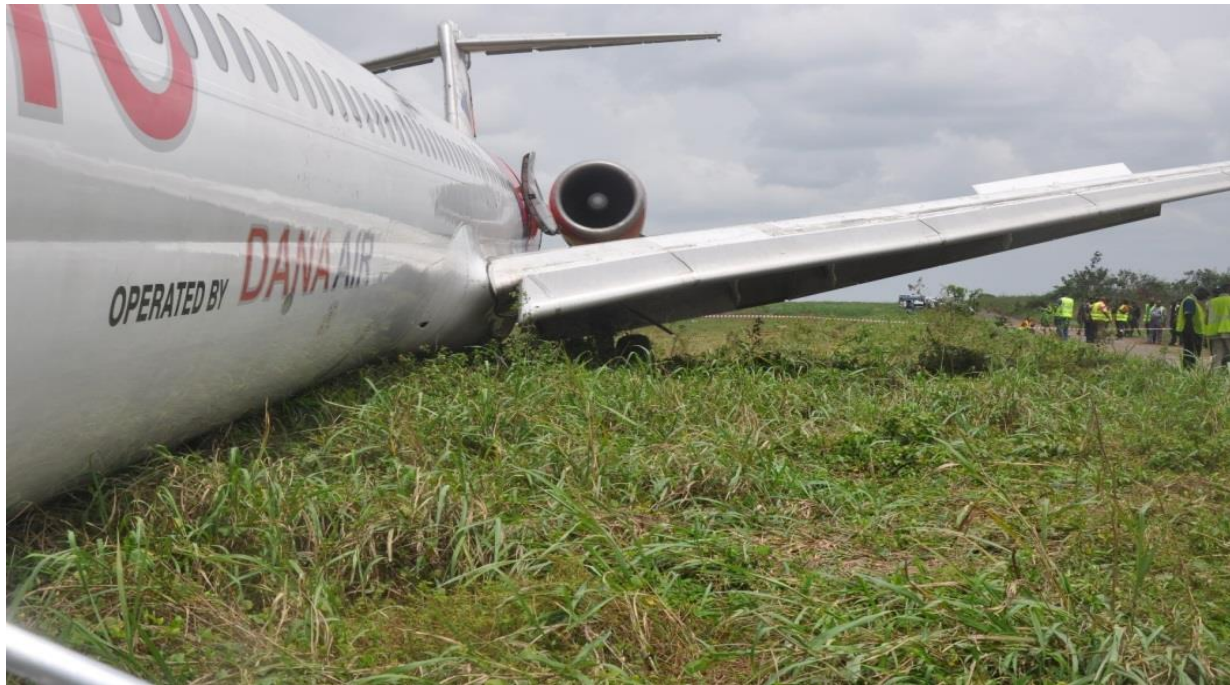
The aircraft was on the centreline until it veered off left approximately 200 feet to the end of the runway, exited the paved surface, into the grass area and came to a stop 978 feet from the end of runway 21, approximately 33 feet left of the extended centreline. Some runway Approach Lights were broken, and the following NavAids were damaged: ILS Antenna and ILS light stand.

**Figure 1:** Final resting point of the aircraft after the accident

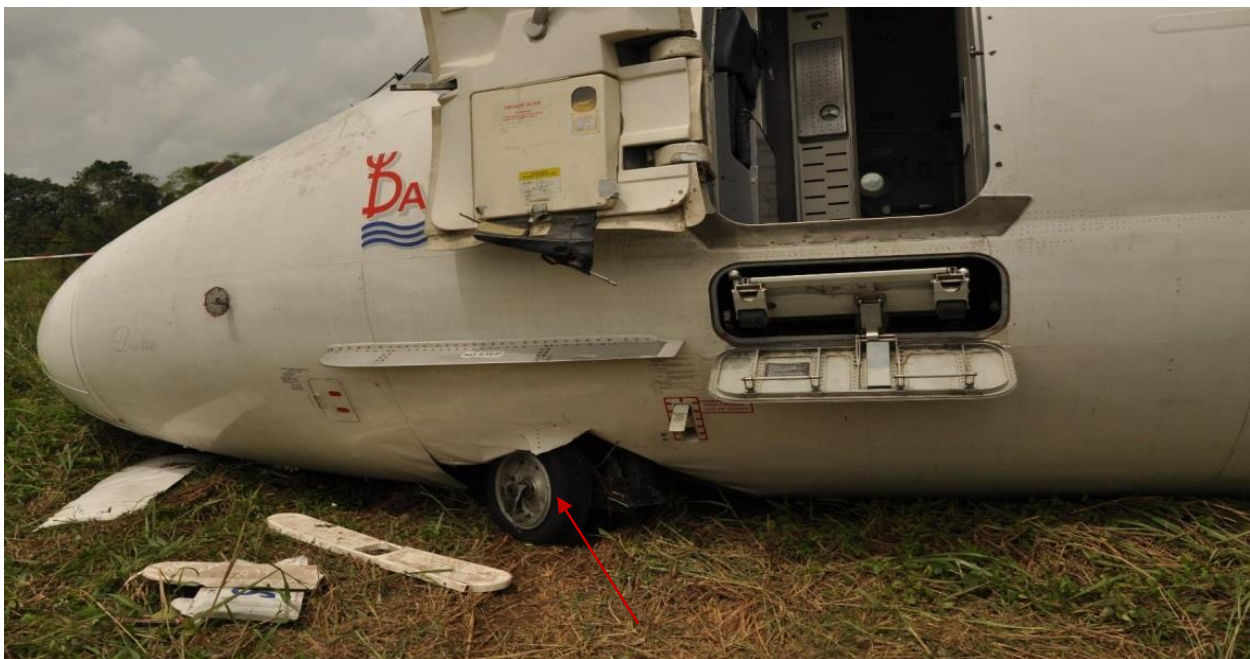
The aircraft was substantially damaged; the nose wheel collapsed into the fuselage, the right wing trailing edge flap was damaged, and the right main wheel tyres burst.

**Figure 2:** Collapsed nose wheel of the aircraft

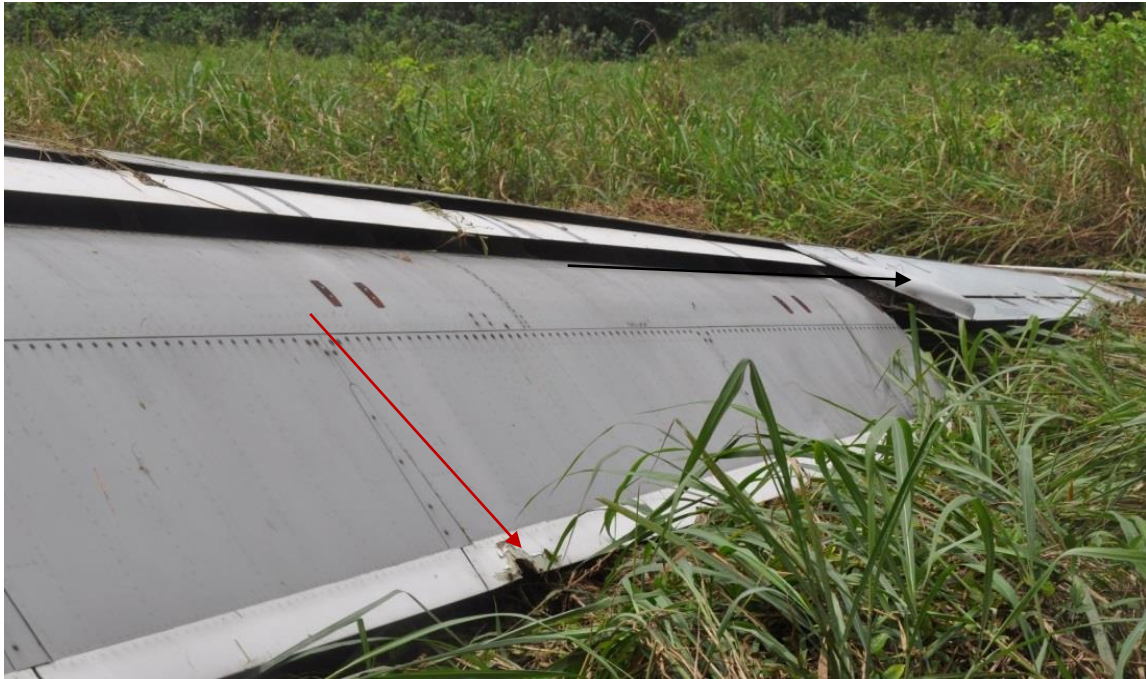
**Figure 3:** Damage on the right-wing trailing edge flap

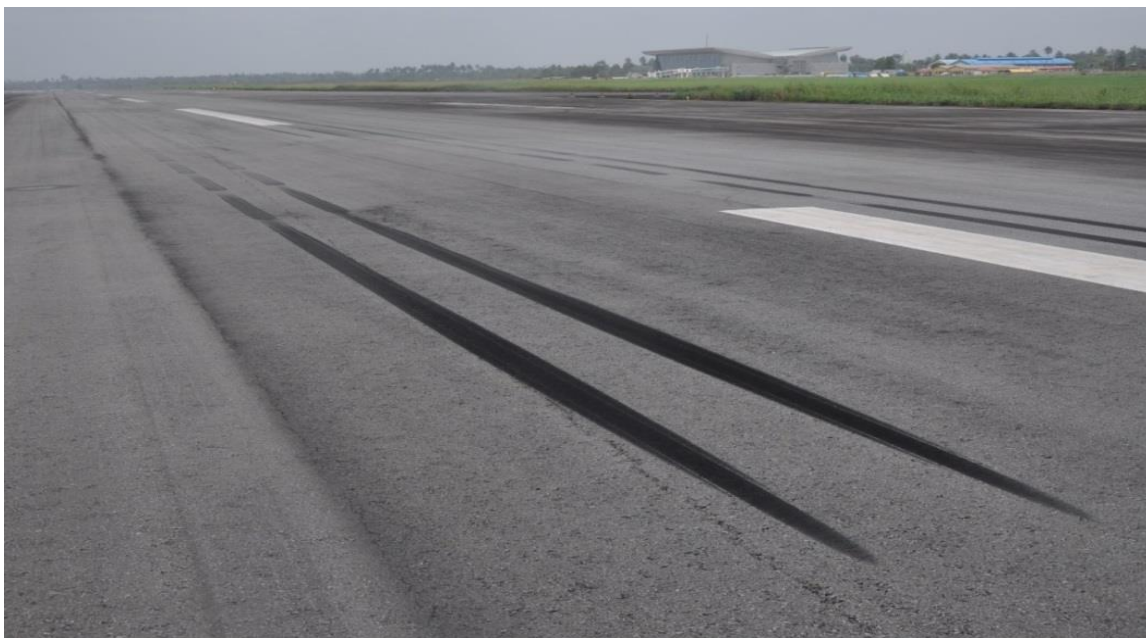
**Figure 4:** Tyre marks from the right main landing gear of the aircraft

the airplane initially veered to the left. Traverse scuff marks found on some of the tyres also indicated that they had been subjected to a skid. The offset between the tyre marks and the nose gear and main gears indicated that the airplane was in a near low-degree yaw as it veered to the left.

The Investigation believes that the tyre marks noted on the runway were not caused by hydroplaning but were erasure marks on the wet runway. There were a large number of similar marks on the runway surface from other landing aircraft that were not hydroplaning.

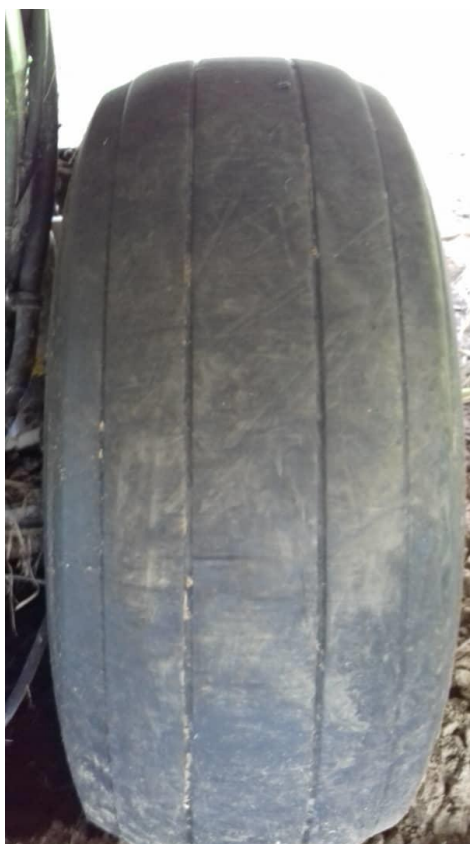
The conditions of the main wheel tyres were taken during the post-impact inspection; MW No. 1 tyre remained inflated after the post-crash impact but had multiple cuts. MW No. 2 tyre was worn to third ply in several spots, had cuts but remained inflated after the post-crash impact. MW No. 3 tyre had a deep cut and deflated after the post-crash impact. MW No. 4 tyre was worn to second ply, had a deep cut and deflated after the post-crash impact. **See Figures 5, 6, 7, and 8 below.**

**Figure 5:** Photo of Main wheel No. 1 tyre

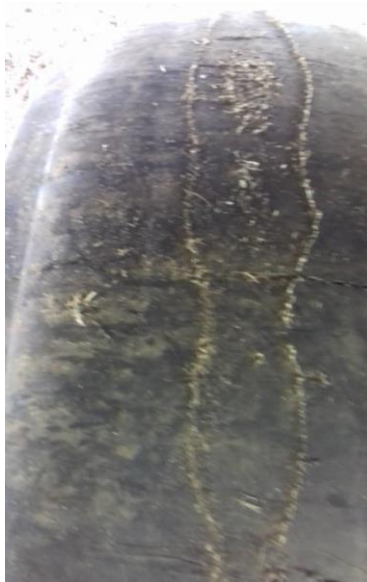
**Figure 6:** Photo of Main wheel No. 2 tyre

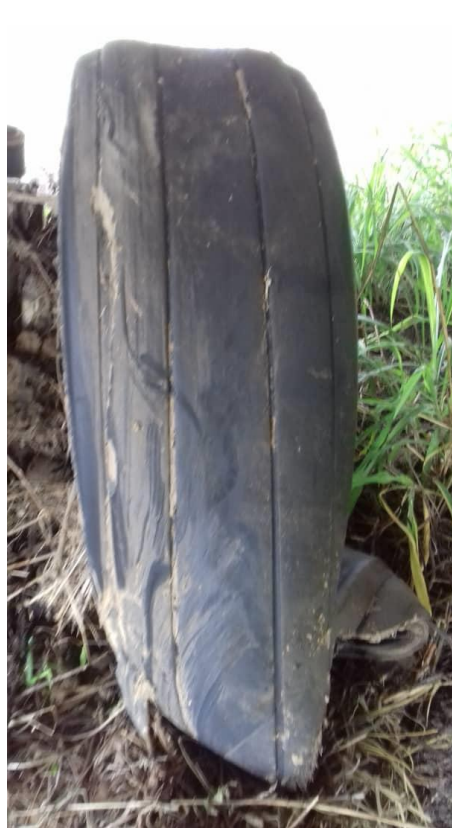
**Figure 7:** Photo of Main wheel No. 3 tyre

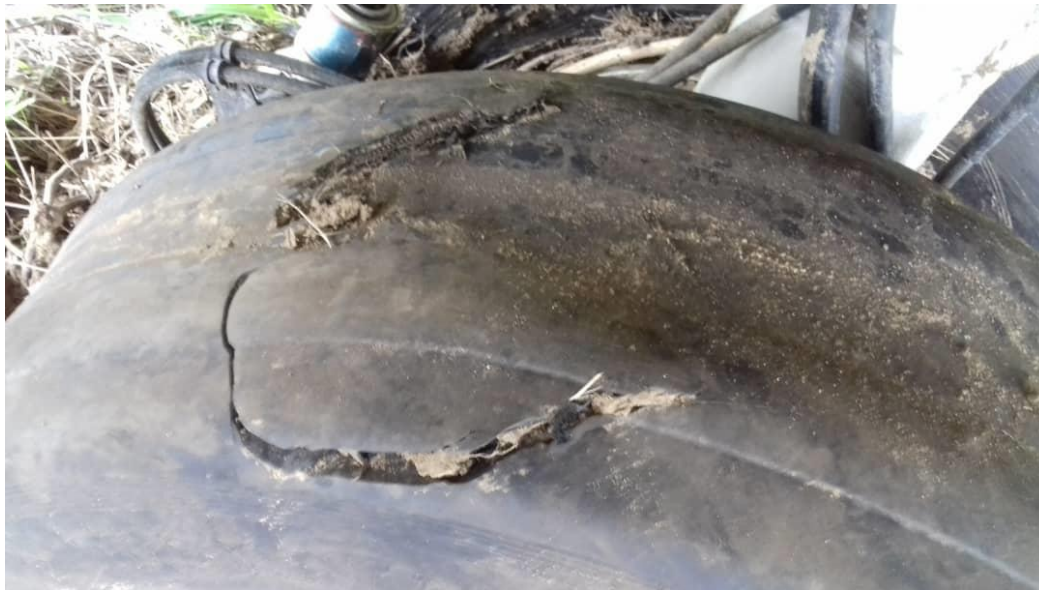
**Figure 8:** Photo of Main wheel No. 4 tyre

Despite two of the tyres on the left and right main landing gears were found to have tread wear, the investigation does not believe that the condition of the tyres contributed to the loss of aircraft directional control or to a condition of dynamic tyre hydroplaning.

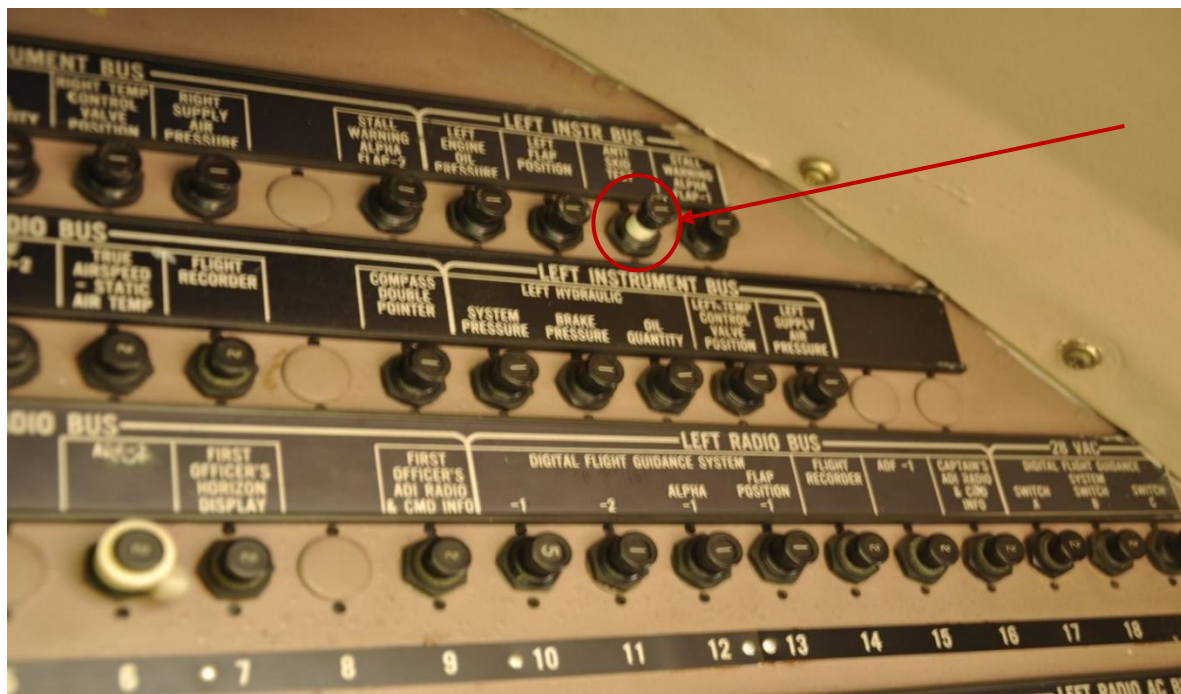
During post-accident inspection by the Bureau's safety investigators, two circuit breakers (Anti-Skid Test and VHF No. 2) were found popped out.

- 2. An in-flight test is initiated when the landing gear is selected down in preparation for landing. An automatic power up test sequence is initiated when 28VDC is provided to the Brake Control Unit contact 35. This power is provided by Circuit Breaker B1-215 through relay R2-85 contact C, Nose Gear Squat Left and Nose Gear Squat Right. Should the automatic power up test sequence detect a failure, the related antiskid light(s) will illuminate in the overhead annunciator panel B5-6, indicating a system failure to the flight crew (See figure 10)*

**Figure 10:** Popped-out anti-skid test circuit breaker
