# ACCIDENT INVESTIGATION BUREAU

## AIB INTERIM REPORT

Accident to Beechcraft 1900D Registration 5N-JAH at Bushi Village in Obanlinku Local Government Area of Cross River state, Nigeria on 15<sup>th</sup> March, 2008.

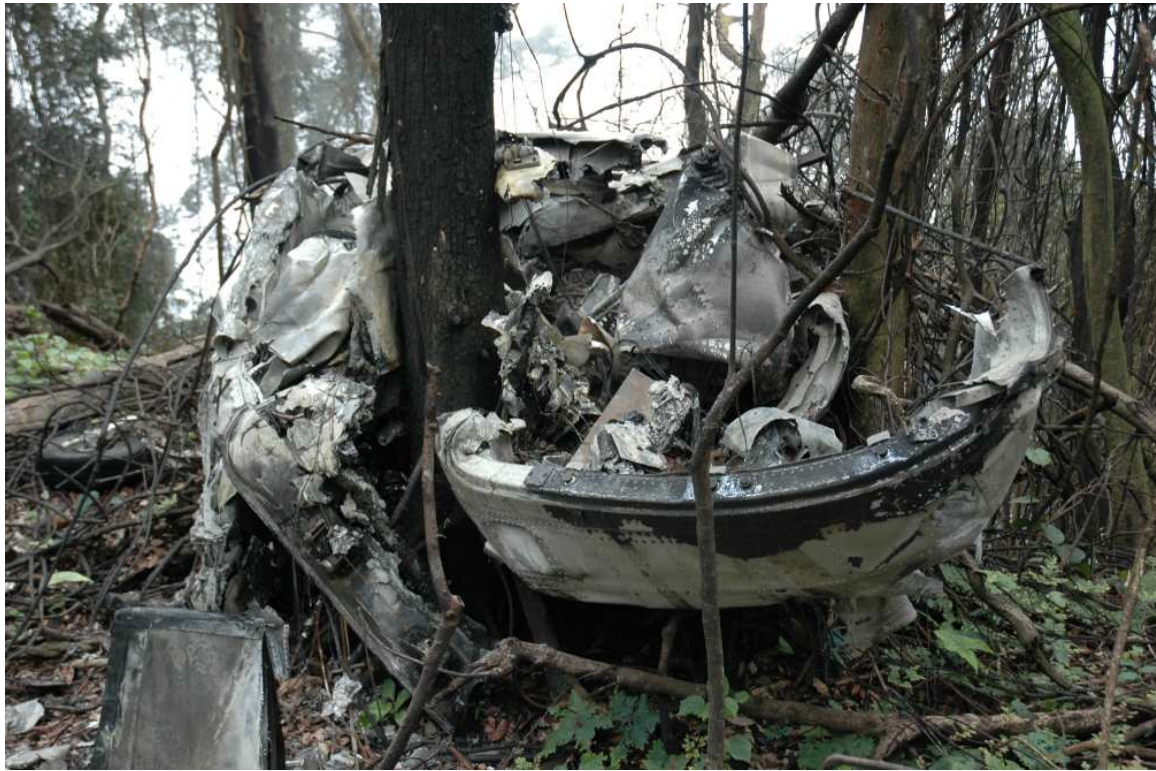
The wreckage was contained within a sizeable area in a wooded valley with several trees typical of a thick forest. The main parts of the aircraft i.e fuselage, engines, landing gears, tail section were found. The main fuselage and wings suffered severe fire damage. The trees served as breakers and helped in confining the break - ups though it was a high speed impact.

Part of the main wreckage

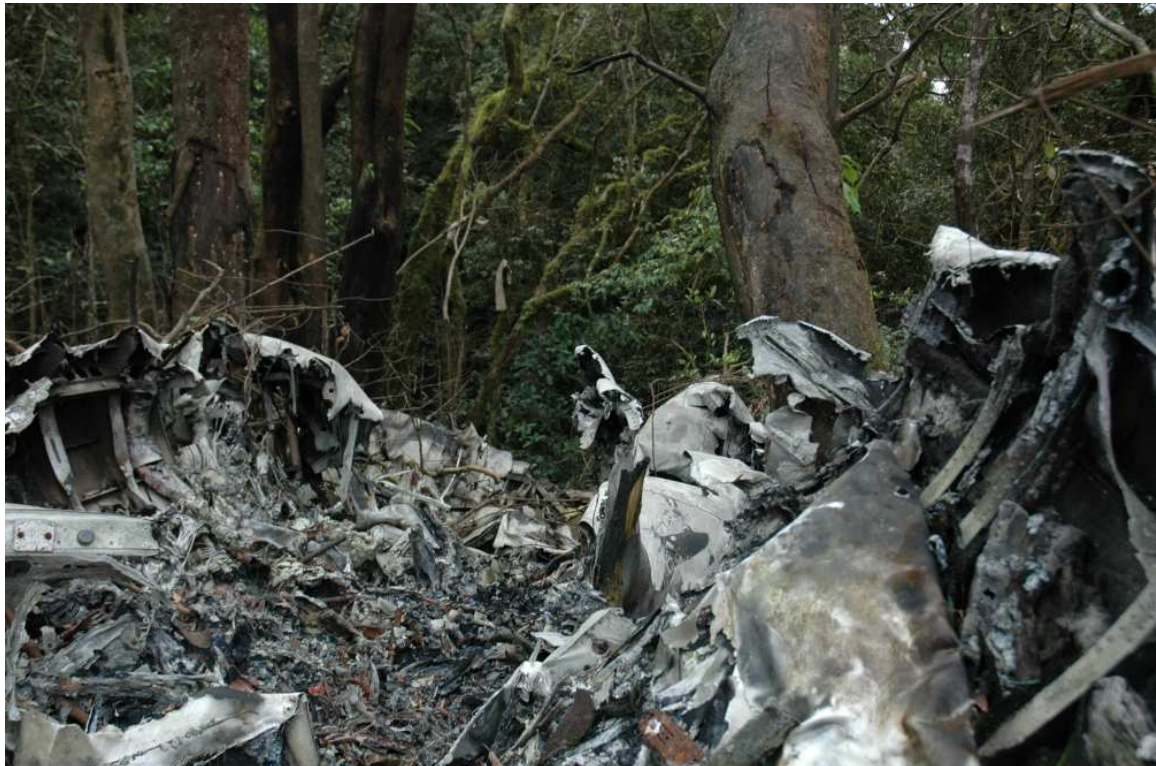
Burnt fuselage of the wreckage

Post crash fire was evident at the wreckage site. The fuselage and wings were severely burnt and charred. Most of the trees around the main wreckage had their branches broken and effects of fire damage were seen extensively on many trees. Shortly before the aircraft crashed, it had a fuel endurance of three and half hours signifying there were several gallons of fuel on board the aircraft before the accident.

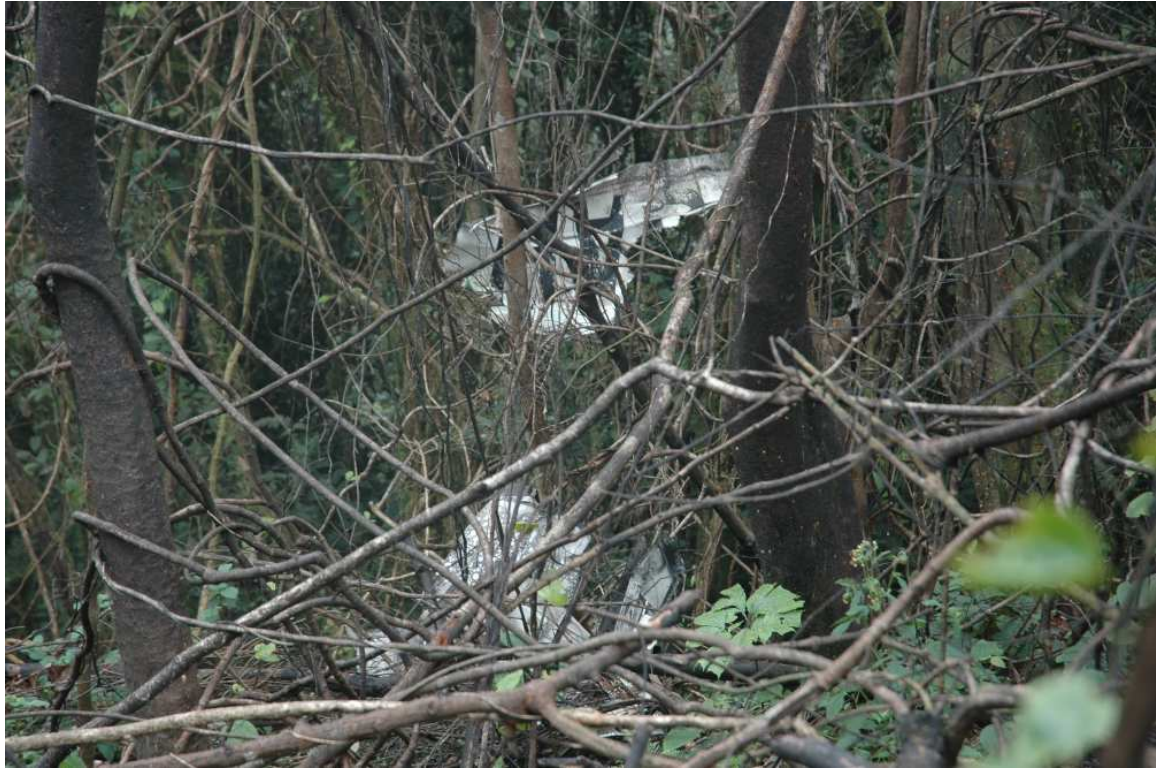
Wreckage showing section of the tail of the aircraft

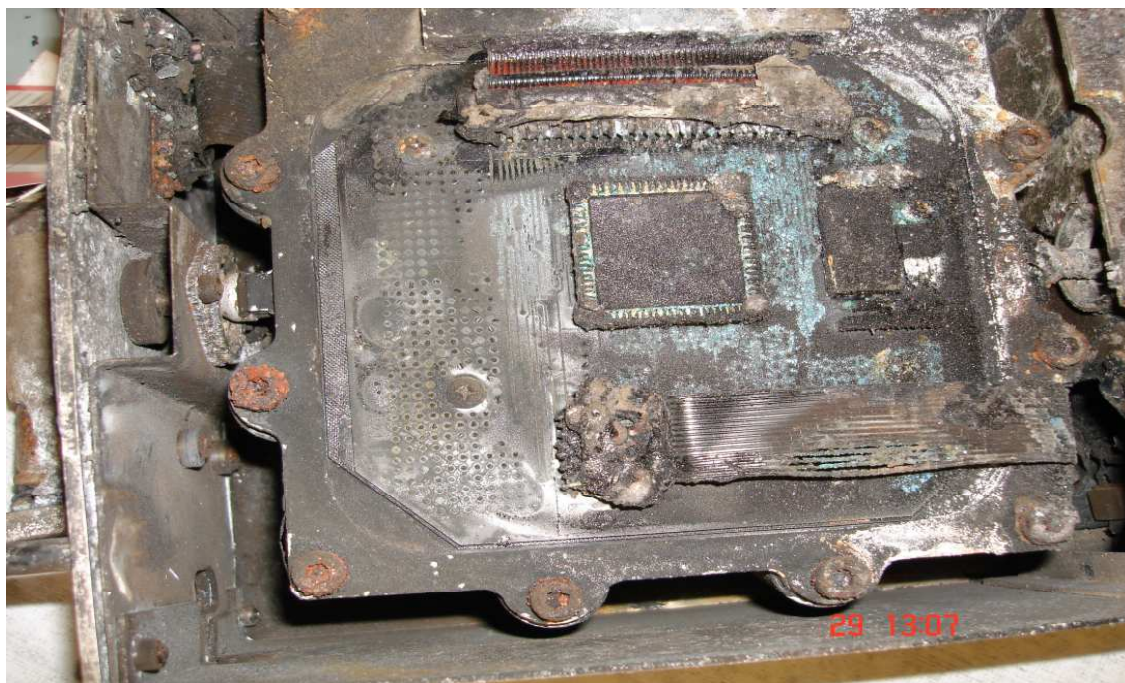
Cockpit voice recorder

The aircraft was fitted with a solid – state cockpit voice recorder (CVR) of 35 minutes duration and a Fairchild solid – state flight data recorder (FDR) both of which were successfully downloaded by the Air Accident Investigation Branch (AAIB), United Kingdom. The recorders exhibited impact and severe fire damage. Data could not be extracted from units in normal manner. The crash protected memory were removed from the damaged accident box and transferred to a surrogate units in order to download the data. The FDR contained many hours of recorded data of which the event flight was the last data with a recording duration of 120 minutes. The three plots in this report contained data which illustrate the event flight on the 15<sup>th</sup> march, 2008. Flight recorders parameters revealed that all engine and flight control inputs were functioning normally up till the moment the aircraft impacted terrain.

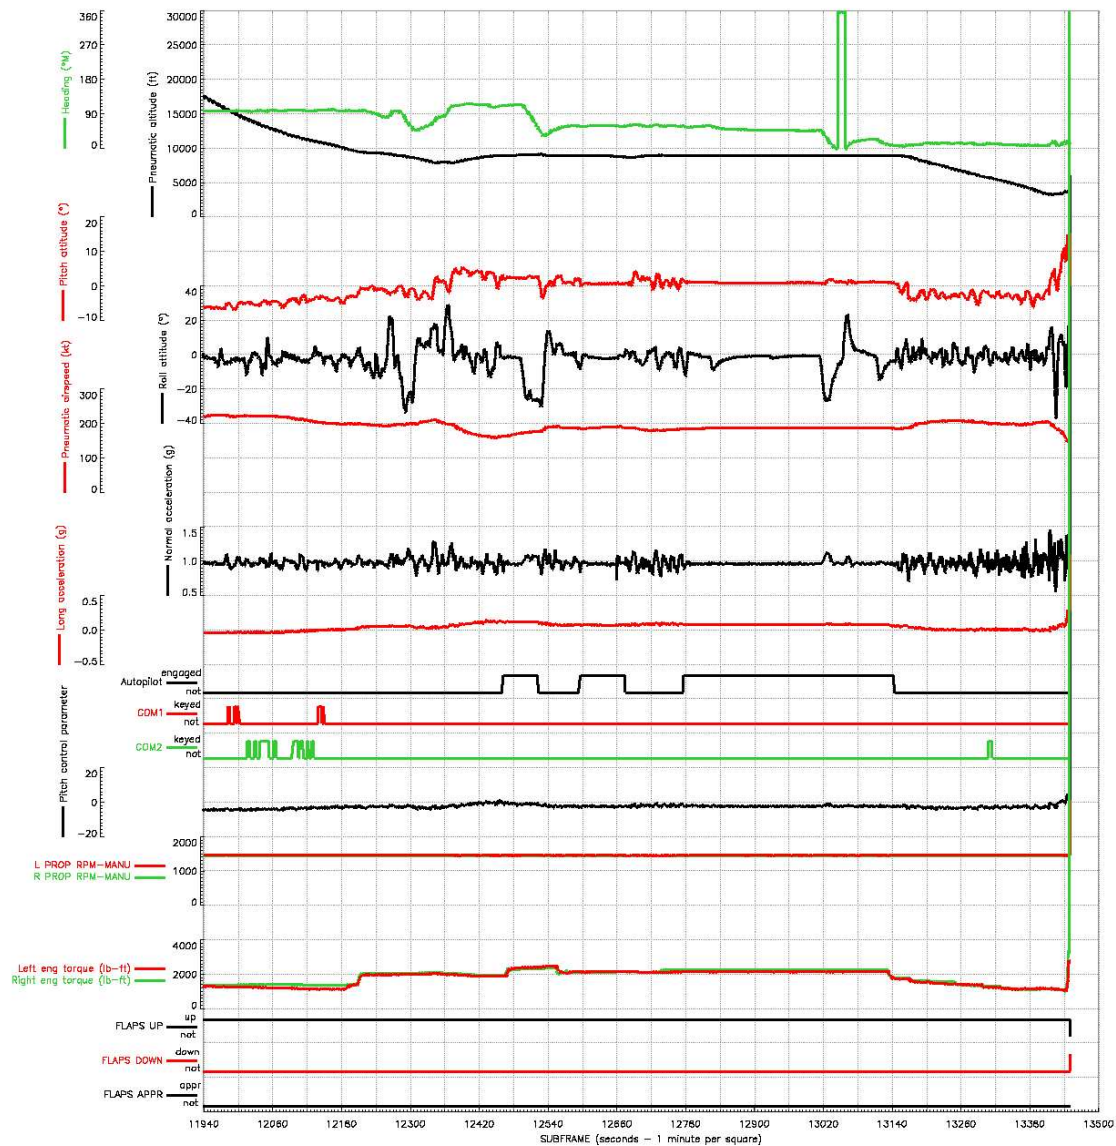
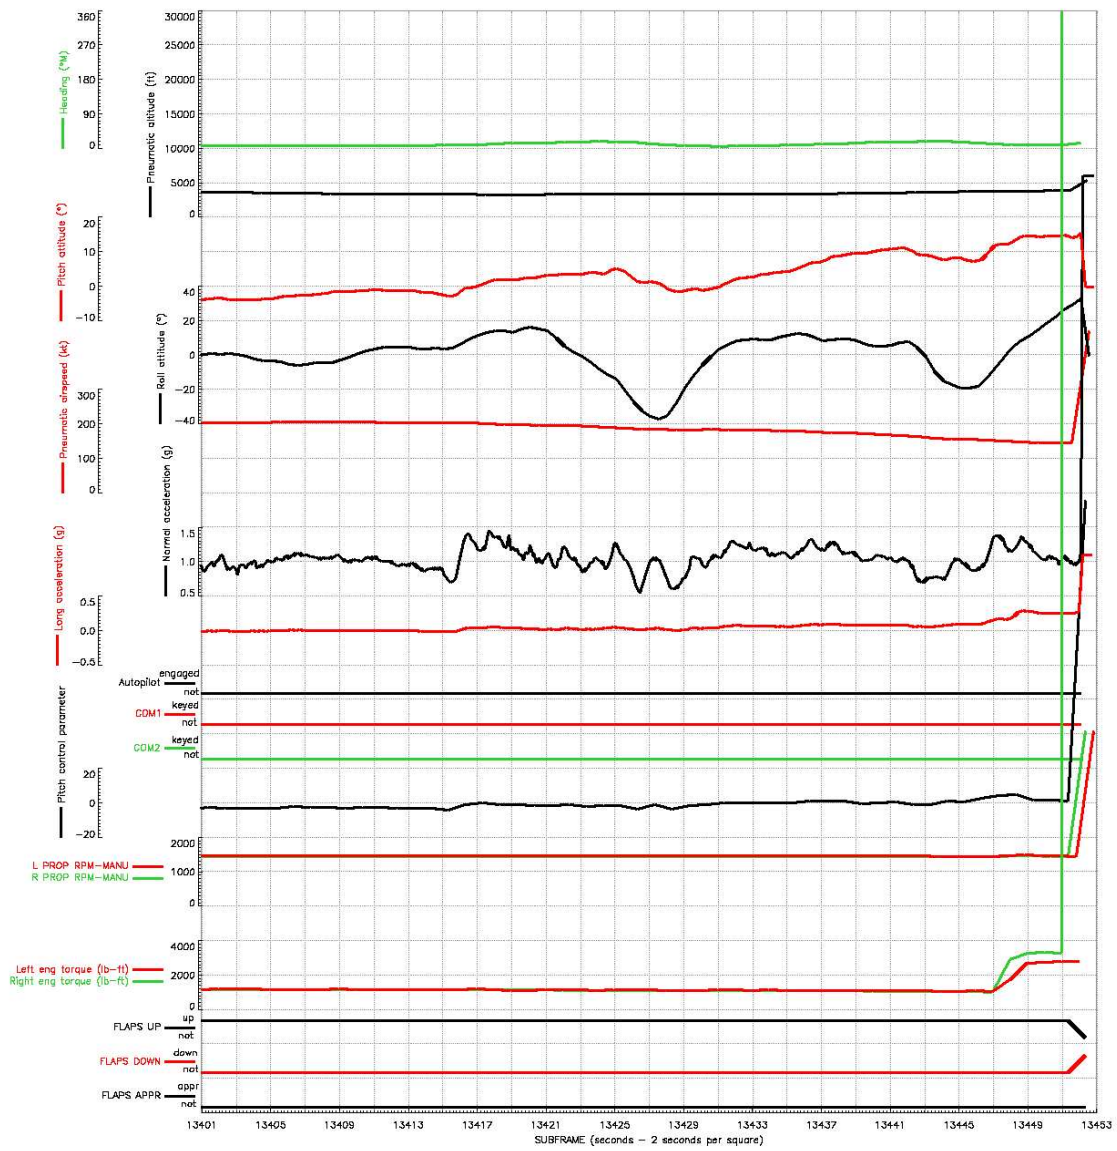
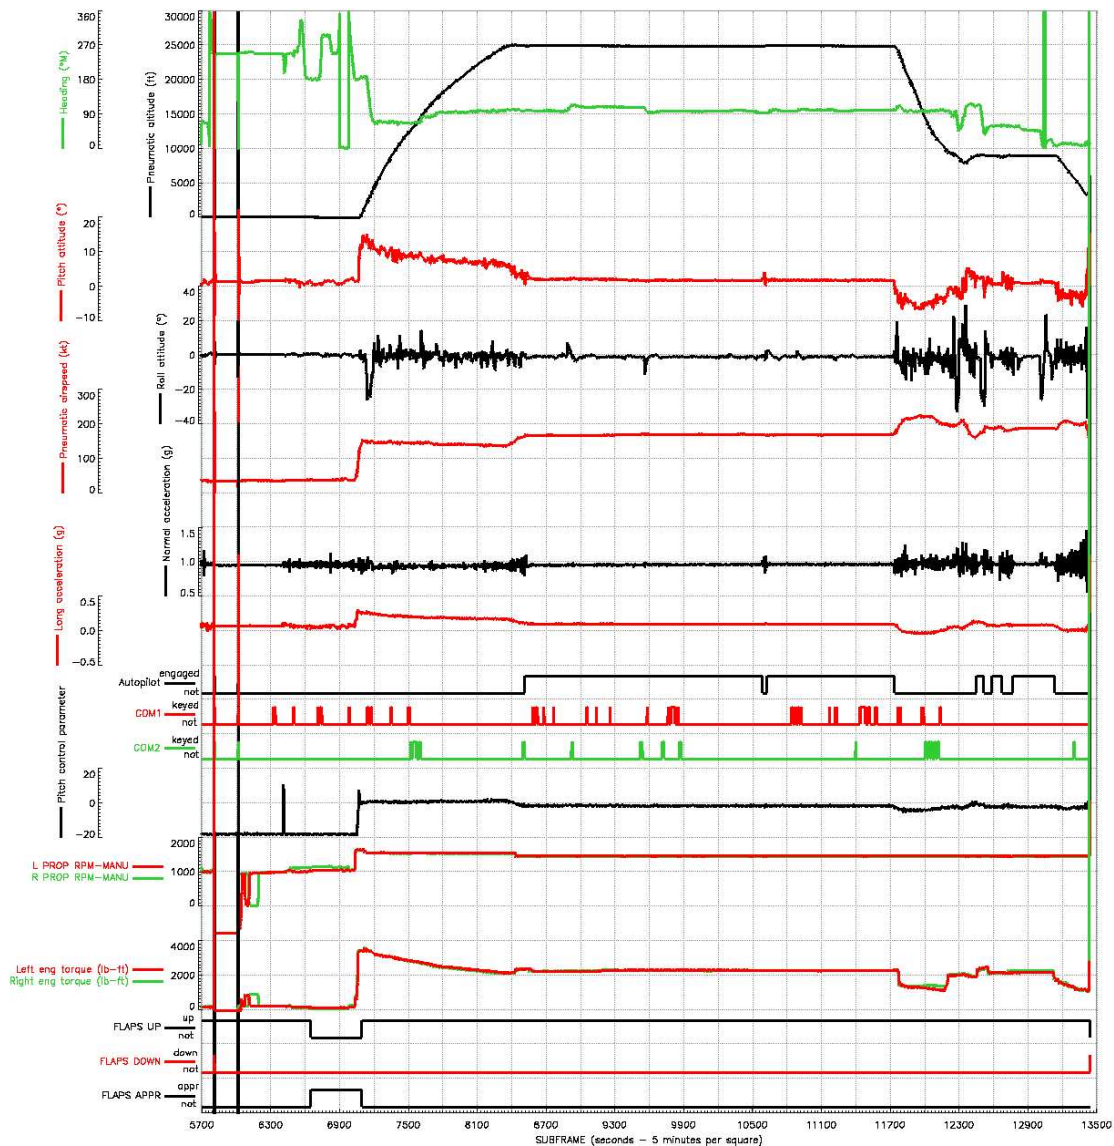
FDR Plot

29 minutes 42 seconds, the first terrain proximity warning came from the EGPWS followed by multiple EGPWS warning at 29 minutes 51 seconds and continuous EGPWS warning at 30 minutes 7 seconds and finally at 30 minutes 13 seconds the captain shouted 'shit' while the copilot shouted 'climb'. The aircraft impacted terrain at 30 minutes 18 seconds after 60 seconds of EGPWS persistent warning. See the FDR plots below.

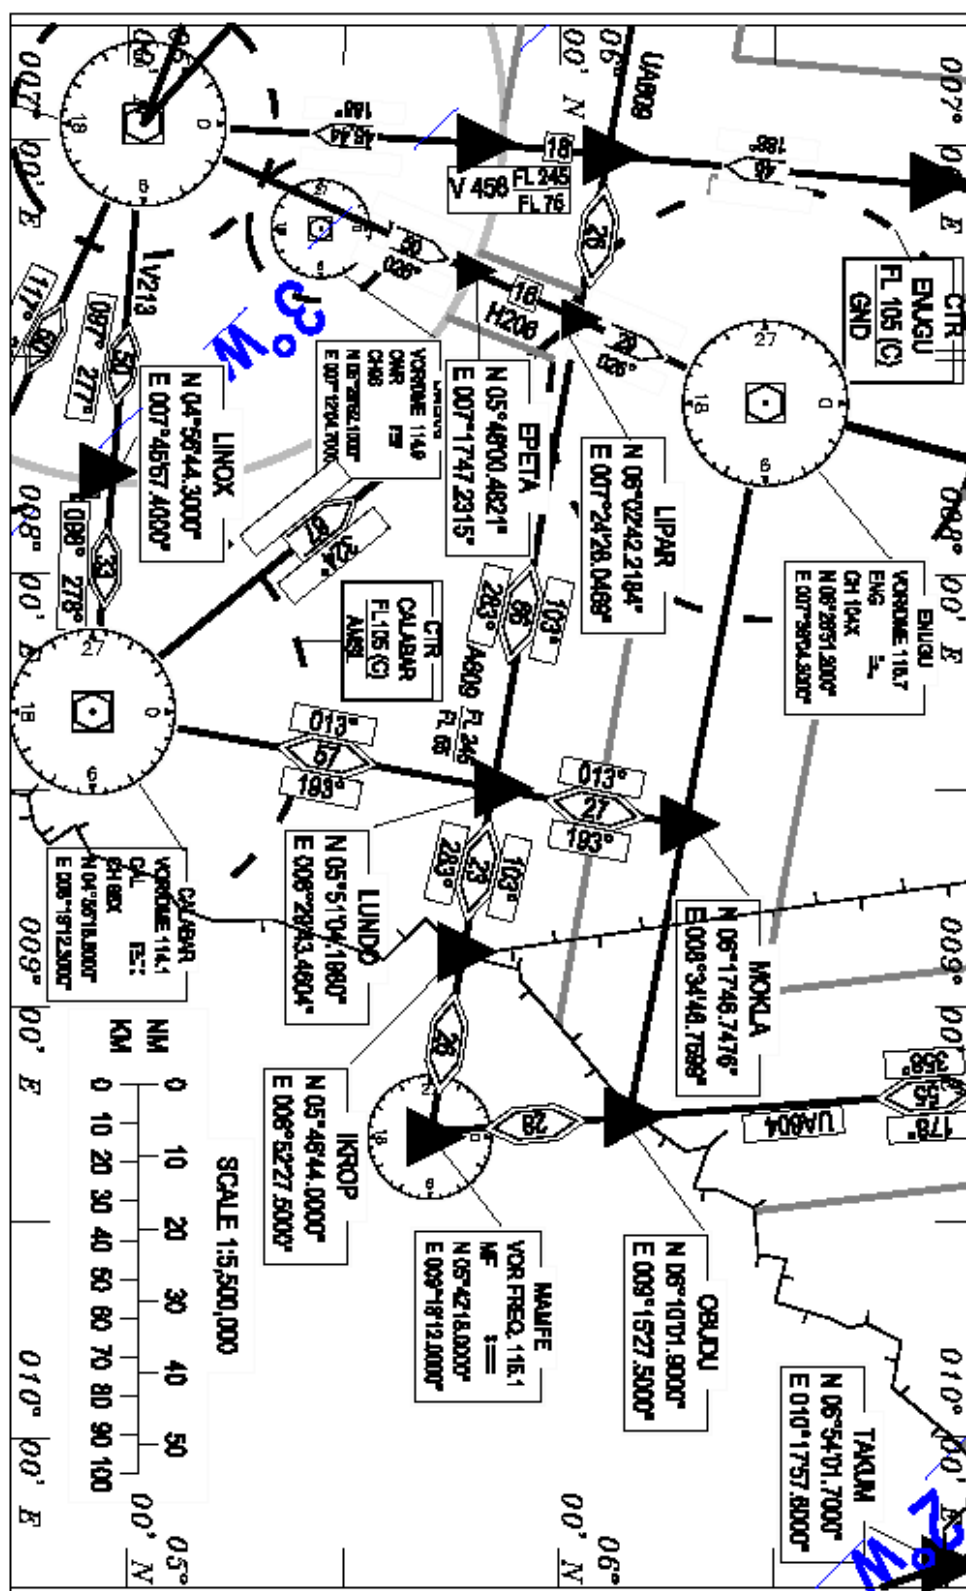
052802N, 0073332E and from ground level to 10,500ft (FL105). From FDR analysis, it descended to 8000ft AMSL (FL080) and climbed back to 9000ft (FL090) within 80 seconds. The aircraft maintained 9000ft for another 720 seconds, again descended to 3500ft within 240 seconds. This time the EGPWS came on warning them of terrain and to pull up. By the time the crew reacted, the aircraft flew into terrain at 4, 200ft.
