ACCIDENT REPORT

NO. 04/365

FINAL REPORT ON THE ACCIDENT TO THE CHANCHANGI AIRLINE'S BOEING
737-200 AIRCRAFT REGISTERED YU-ANU, WHICH OCCURRED AT KADUNA
AIRPORT ON SUNDAY THE 22nd OF FEBRUARY 1998.

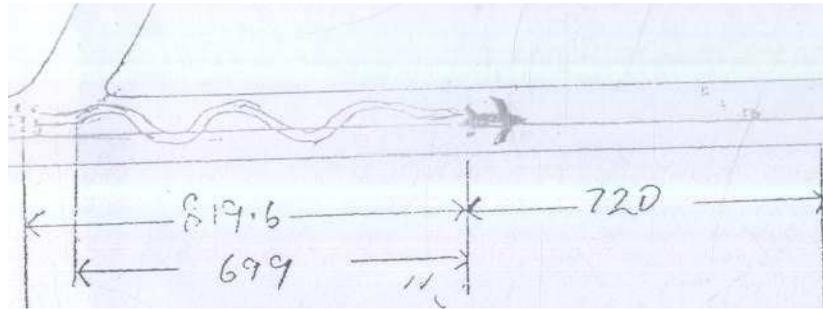
VIE C. DE
BROKEN RIM

WHERE BRAKE FLUID SPILAGE STARTED
(50m FROM TRESHOLD)
