CIVIL AVIATION ACCIDENT REPORT

No, FMA/AIPB/424

FINAL REPORT ON THE ACCIDENT TO
SOSOLISO AIRLINES DC 9-32 AIRCRAFT
REGISTERED 5N - BFD AT PORT HARCOURT -
INTERNATIONAL AIRPORT ON 10TH DECEMBER
2005

JULY 2006

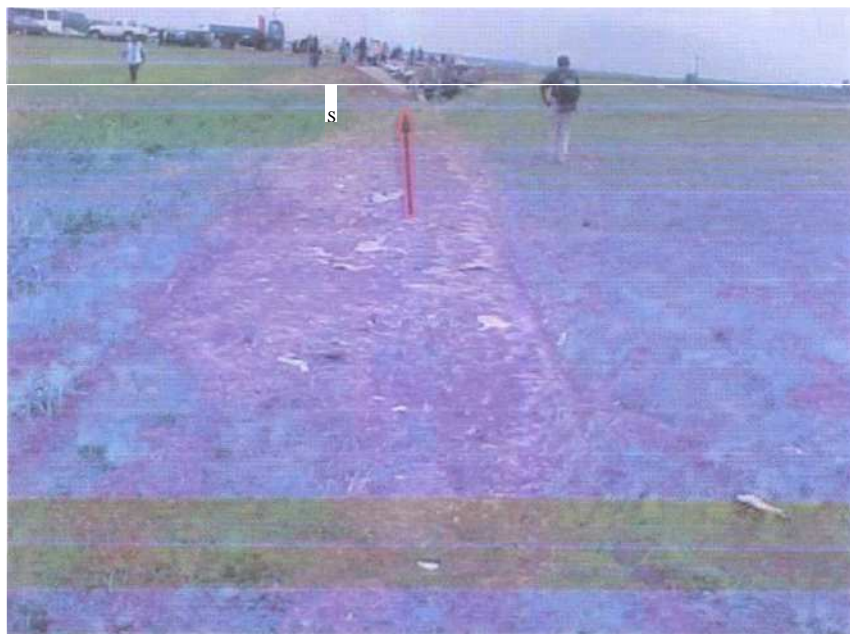
APPENDIX 5.2

Mr. Dennis Jones of NTSR, USA assessing the impact/wreckage of the aircraft
