**CIVIL AVIATION ACCIDENT  
REPORT NO 04/375**

ON THE ACCIDENT TO THE  
EXPRESS AIRWAYS AIRCRAFT  
BANDEIRANTE EMB 110  
REGISTERED 5N-AXM  
ON

FINAL APPROACH TO  
KADUNA AIRPORT

ON SATURDAY 17TH MARCH, 2000.

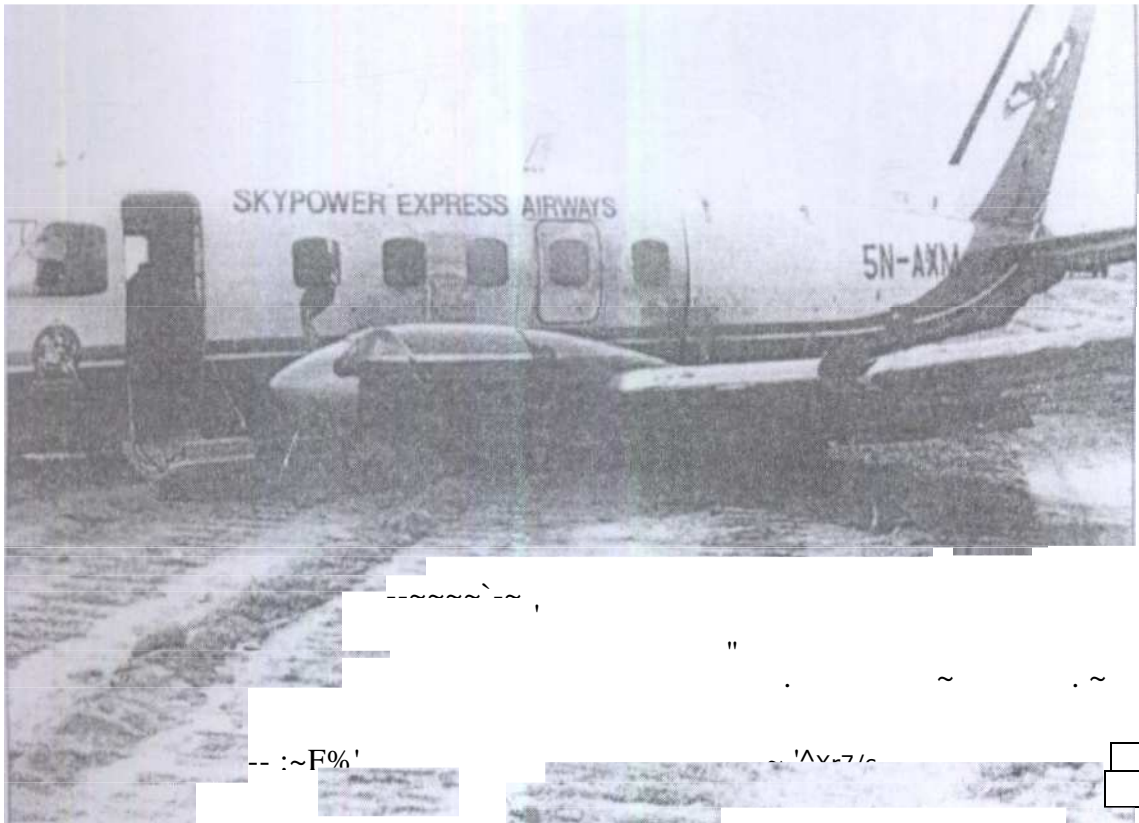
There was severe flexural damage to the port propeller including the tips (chips off) compared with the right propeller blades.

The port side of the aircraft showing the damage to the aircraft and the escape hatch still intact.

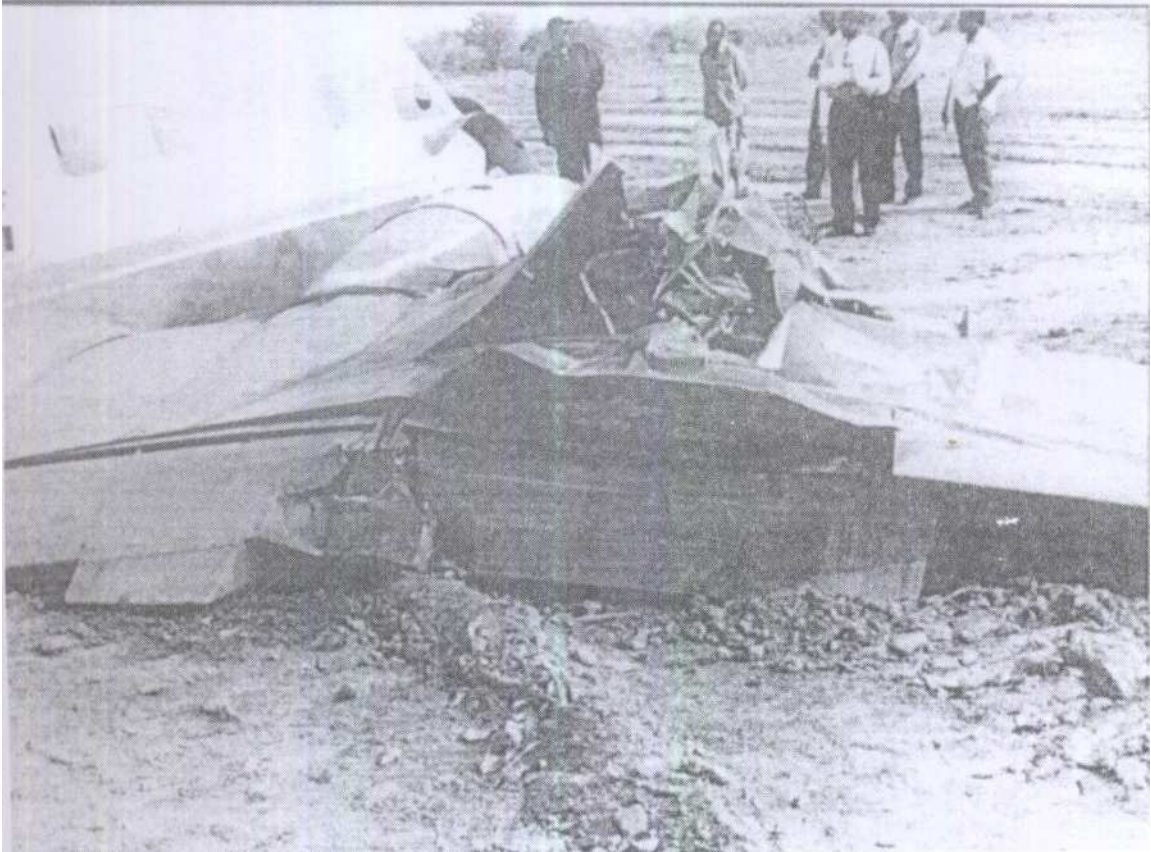
Photograph showing serious damage to the starboard wing and engine.
