C IVIL AVIATION ACCIDENT

Report No. 04/350

REPORT ON THE ACCIDENT TO THE
DASSAULT AVION FALCON 20F
REGISTERED 5N-EPN, ON RUNWAY
19R AT MURTALA MUHAMMED AIRPORT
ON THE 5TH SEPTEMBER 1995.

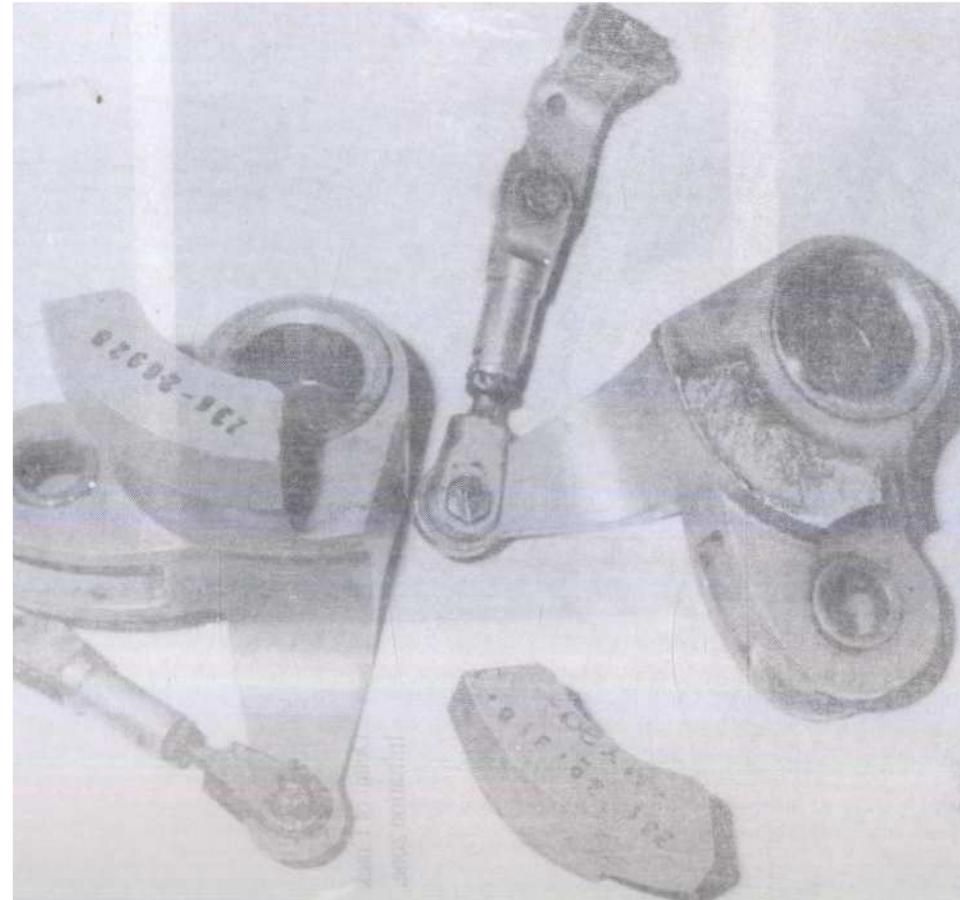
After the aircraft was towed back to the hangar of the airline, the left main landing gear was stripped. It was found that the left main landing gear actuator bellcrank had broken off. When the 'D' ring was pulled off, the doors and the left main landing gear were found unlocked. The actuator bellcrank was therefore removed and taken to the facilities of DASSAULT AVIATION in Paris (APPENDIX 1) for Metallurgical examinations and the result were as follows:

- 3.1.8 A detailed examination of the bellcrank at the laboratories of Dassault Aviation, France on the 26th September 1995 revealed a fatigue fracture of the actuator bellcrank of the left main landing gear (Appendix IV).

Photograph showing the broken actuator bell crank

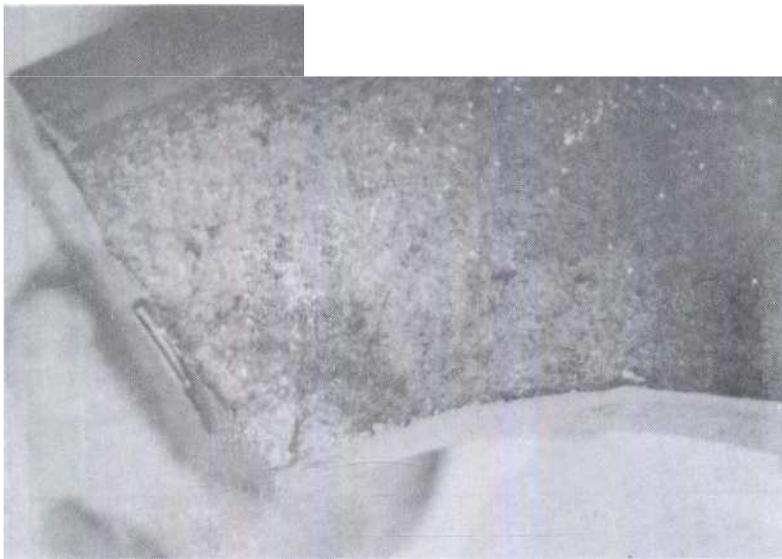
Fig 2 Detail of Crack Initiation zone.

There was evidence of interference between the actuator bellcrank and the door structural stop (Appendix V).
- 3.1.10 There were striations on the micrographs of the fractured surface which were characteristic of fatigue failure (Appendix V).

Details of crack initiation zone (Fig. 2)

- o The rupture plan examination did not revealed any material defect or material manufacture process defect.
- a The rupture has been initiated in the inner angle of the bellcrank close to the damaged area. This damaged area is due to interference with the bellcrank structural stop. This interference has generated formation of metal chips on the contact surface of the

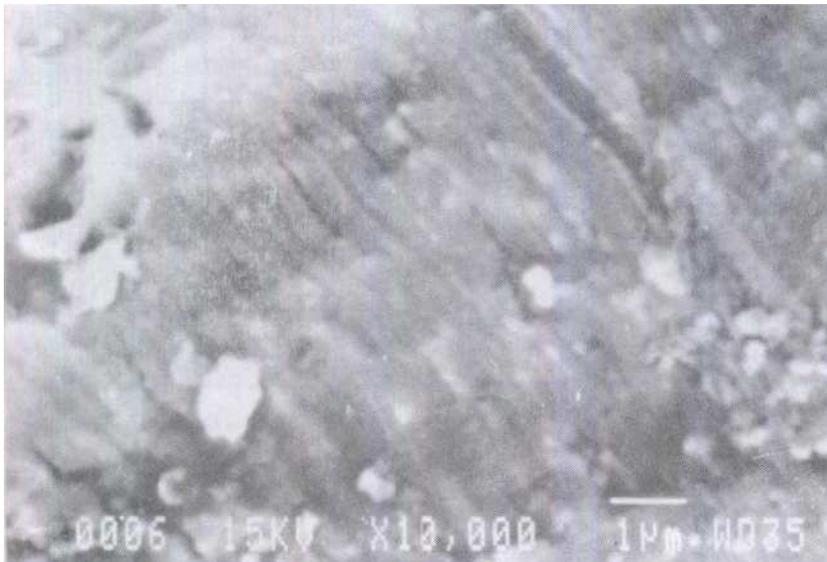
Fig 3 Characteristic aspect of Fatigue propagation.

The micrograph showing series of striations which indicate fatigue failure of the bellcrank (Fig.3)

- o The plan of rupture was peened and oxyded which is characteristical of fatigue crack propagation.
- u This plan of rupture shows marks (stop lines) which can be explained by interruption (fl' operations due to maintenance or any other reasons.
