**CIVIL AIRCRAFT ACCIDENT REPORT  
ON ALOUETTE II S. A. 3180 NEAR  
WARRI AERODROME on 12th JULY,  
1976**

[Ref. No. CAD. 52/9/77171](#)  
20th September, 1977.

CIVIL AIRCRAFT ACCIDENT REPORT

Summary.-The Alouette 11 helicopter registration 5N-AHO was on private flight from Port Harcourt to Lagos with a proposed re-fuelling stop at Warri. About 12 nautical miles from Warri aerodrome the helicopter developed a left spin about its vertical axis which eventually ended in a crash into a thick vegetation 213.4 m. below.

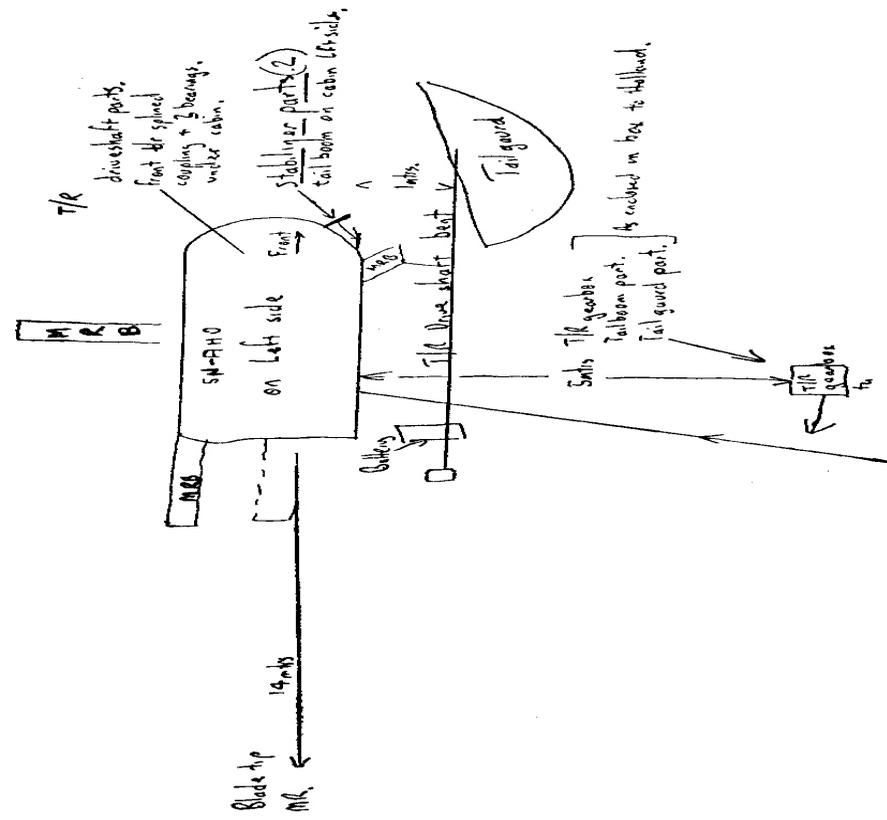
# WRECKAGE SKETCH

in rubber plantation  
Approx 17 mts tip of tree.

Point of impact  
17 mts tip of tree.

General perspective  
etc in flight  
path

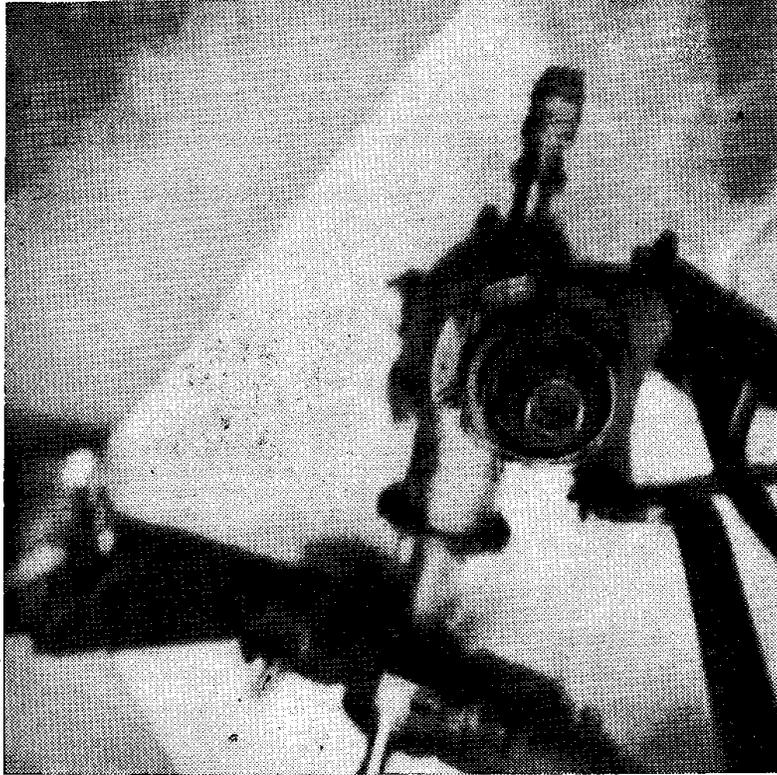
A detailed laboratory investigation was carried out. The findings at the National Aerospace Laboratory of the Netherlands revealed that the probable cause of the tail rotor malfunction was the failure of the tail rotor gear-box input coupling. This resulted from excessive fretting wear on the splines on the input drive shaft and the internal splines of the coupling ring.

View of the ring-gear (which probably failed)

The time between overhaul of the tail-rotor gear-box should be limited to 1200 hours until strip reports could justify the 1500 hour time between overhaul which is now permitted.

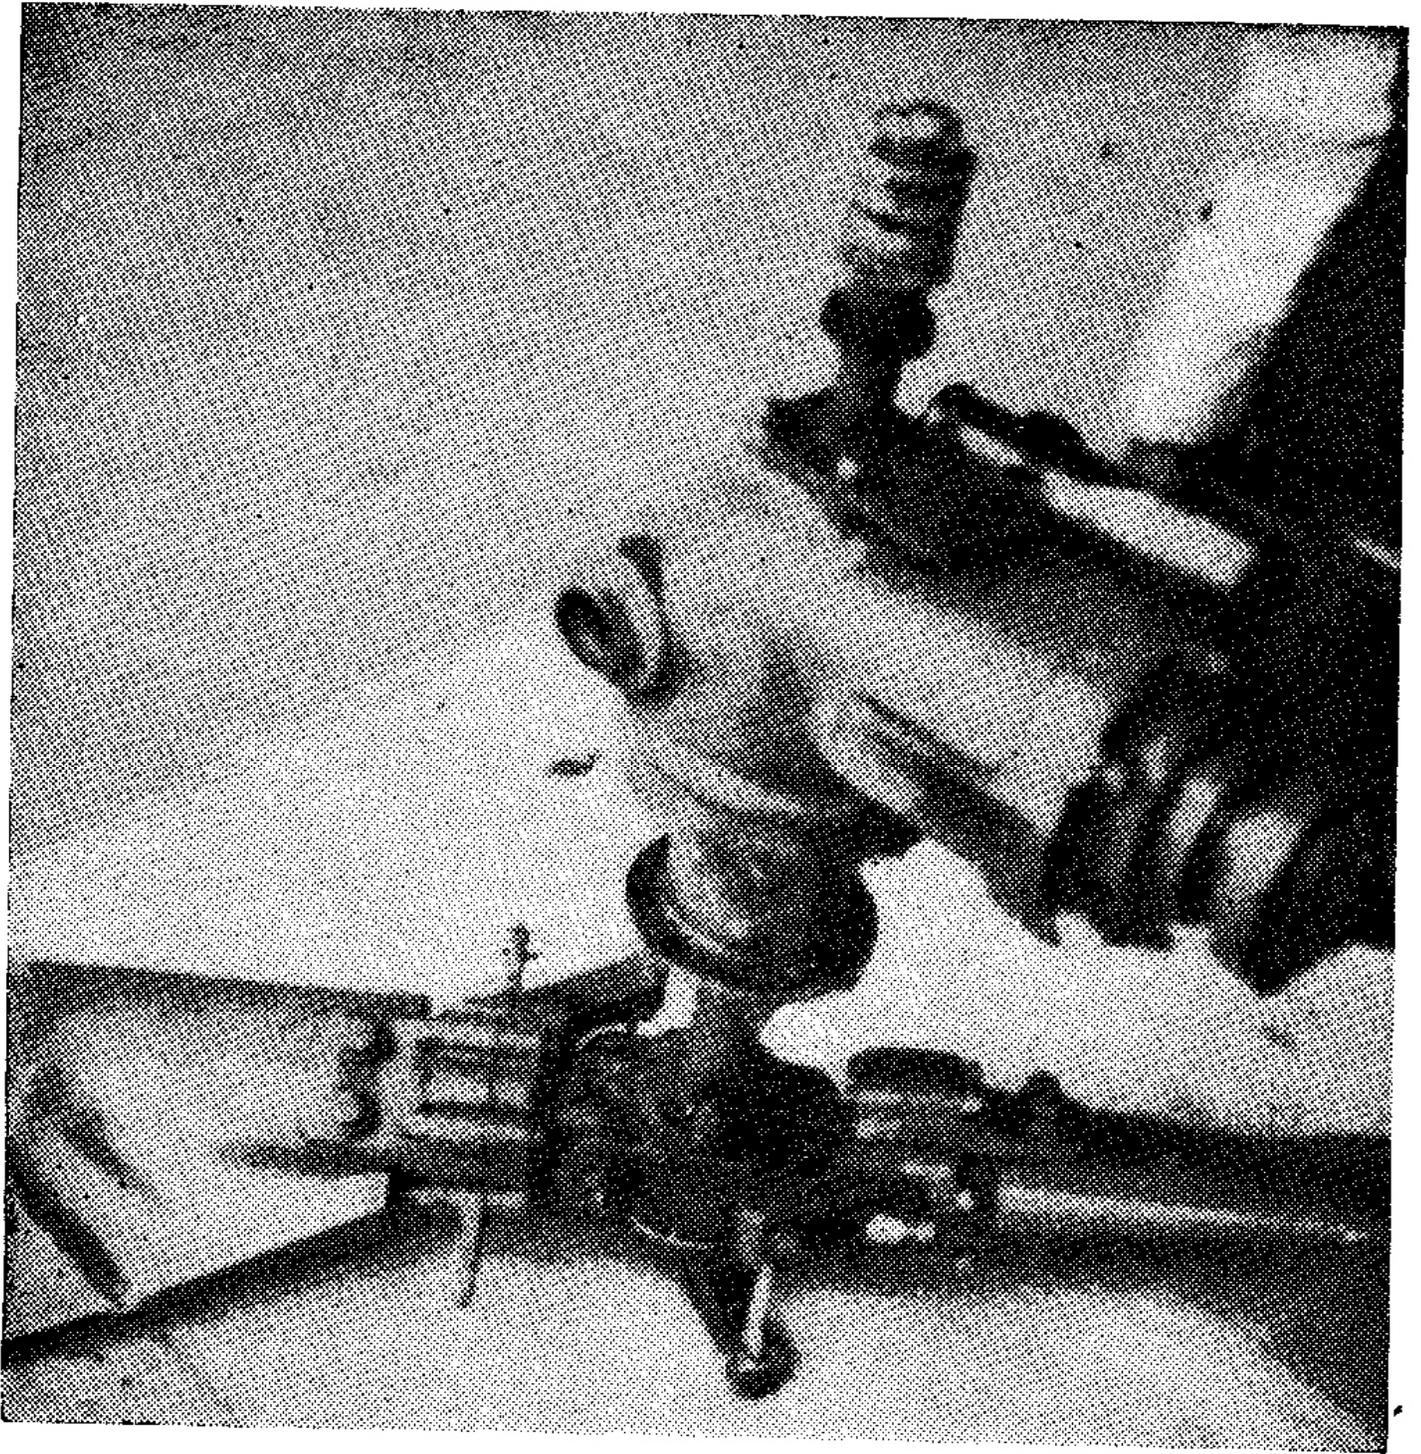
Tail-rotor gear-box showing position of the ring gear relative to the tail-rotor float stops

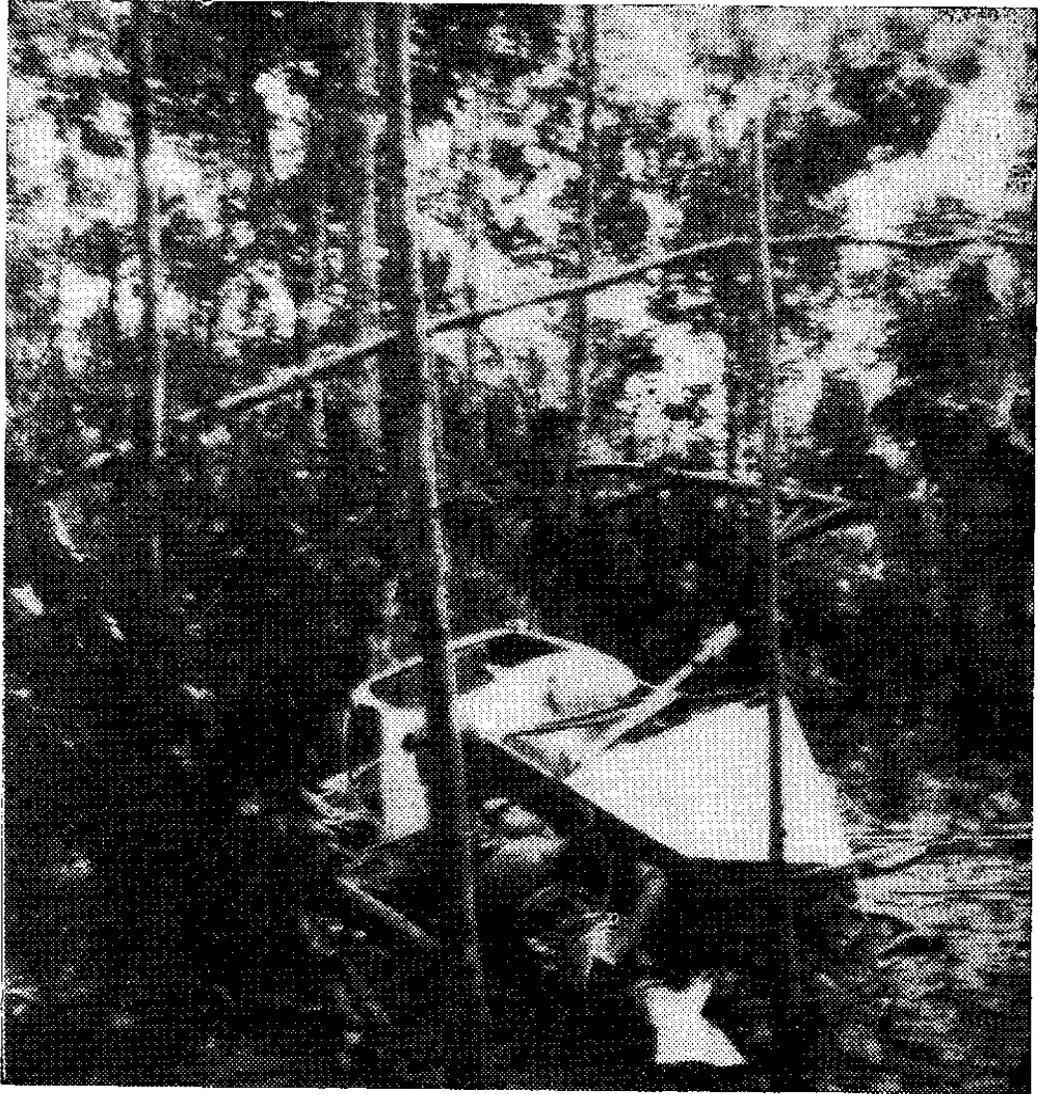
Crash scene showing the wreckage
