PRELIMINARY REPORT ON INCIDENT INVOLVING TAMPICO CLUB TB-9 AIRCRAFT OPERATED BY NIGERIAN COLLEGE OF AVIATION TECHNOLOGY (NCAT), ZARIA WITH NATIONALITY AND REGISTRATION MARK 5N-CBP WHICH OCCURRED AT RUMA VILLAGE, BIRNIN-GWARI LOCAL GOVERNMENT AREA, KADUNA STATE ON 1st MARCH, 2019

Aircraft Type and Model: Tampico Club TB-9

Nationality and Registration Marks: 5N-CBP

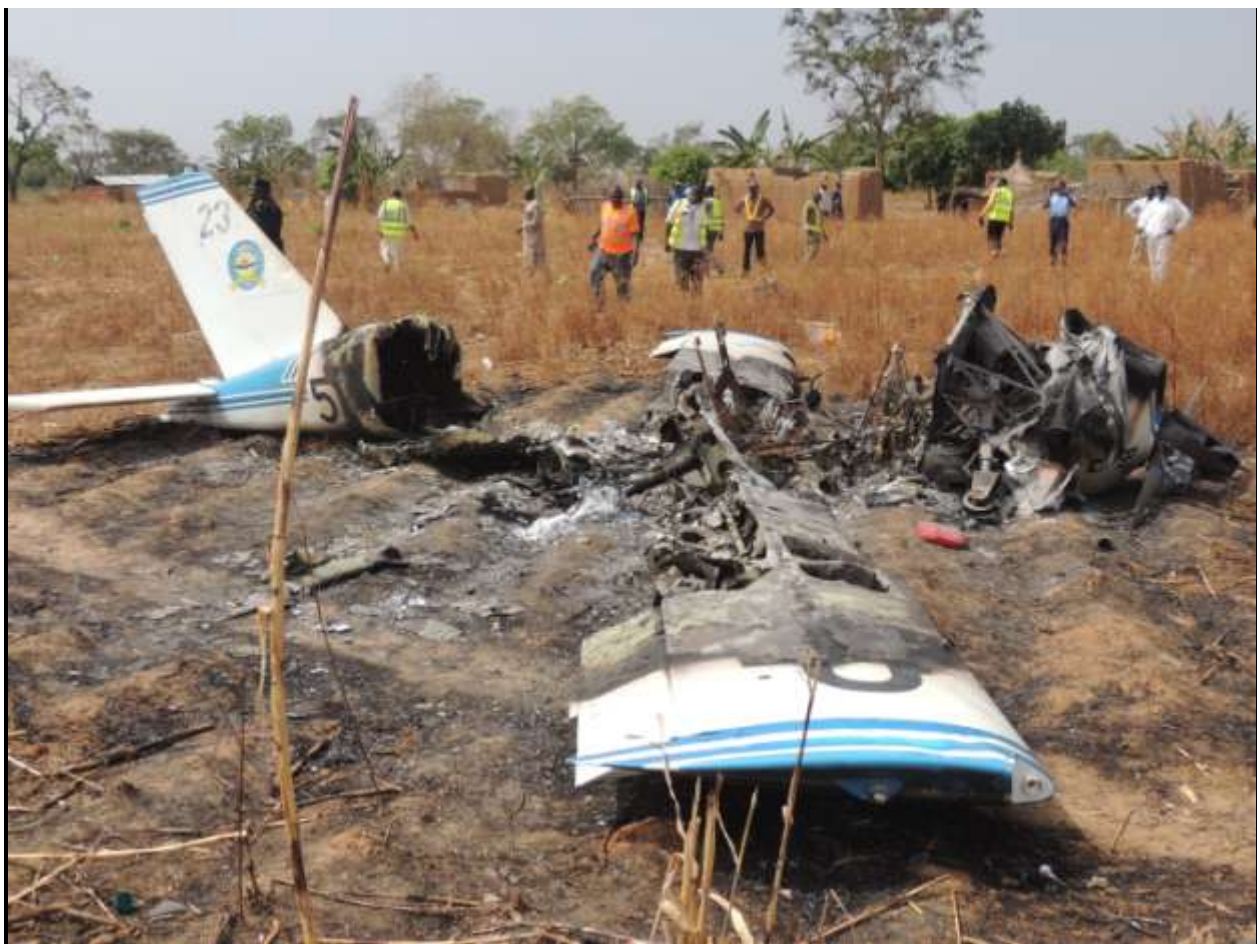
The aircraft was set a result of shootings by Rustlers.

Figure 2: Side view of the burnt aircraft
