**AIRCRAFT ACCIDENT REPORT**  
**AIB/ AERO/ 2008 /03 /24/F**

**Report on the Accident to**  
**AERO CONTRACTORS NIGERIA LIMITED**  
**AS 365 N2 Registration 5N-BJF at Bonny Airstrip,**  
**Bayelsa State, Nigeria**  
**On 24 March 2008**

**Aircraft Accident Report No:** (AERO/2008 /03 /24/F)

**Registration:** 5N-BJF

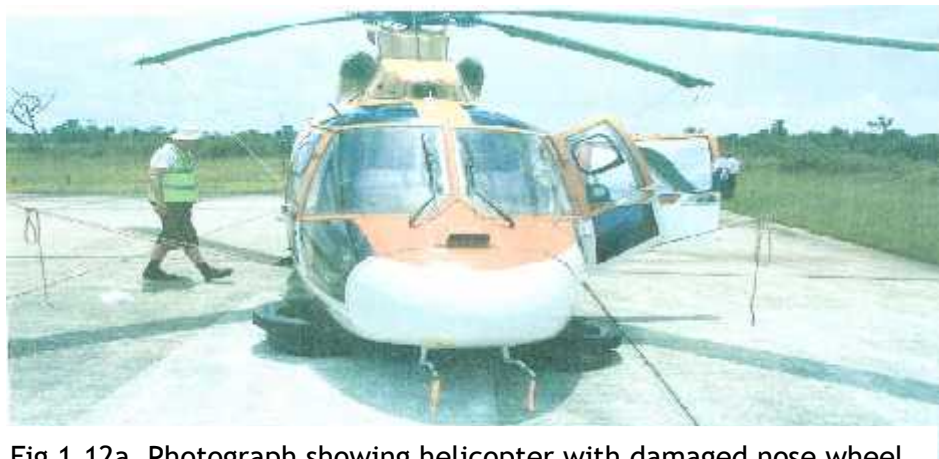
The helicopter impacted the ground with the tail guard and the main landing gear sustained serious damage. The nose wheel collapsed while the left hand main landing gear was damaged. There was damage also to the structure around the nose wheel and the left hand main landing gear (See figures 1.12a, 1.12b and 1.12c).

Fig 1.12a Photograph showing helicopter with damaged nose wheel

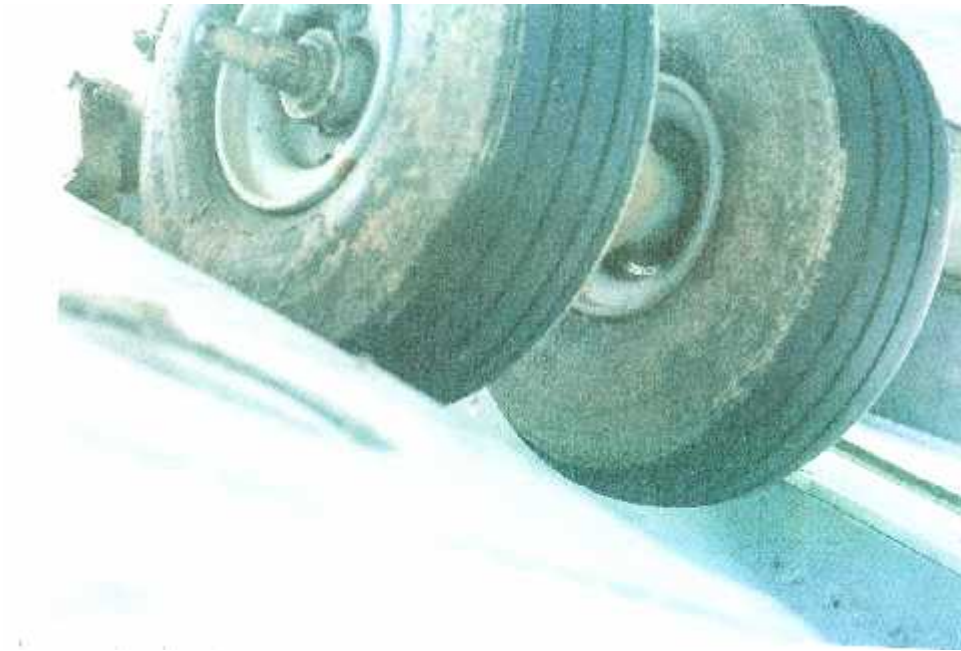
Fig.1.12b Photograph showing damaged wheel assembly

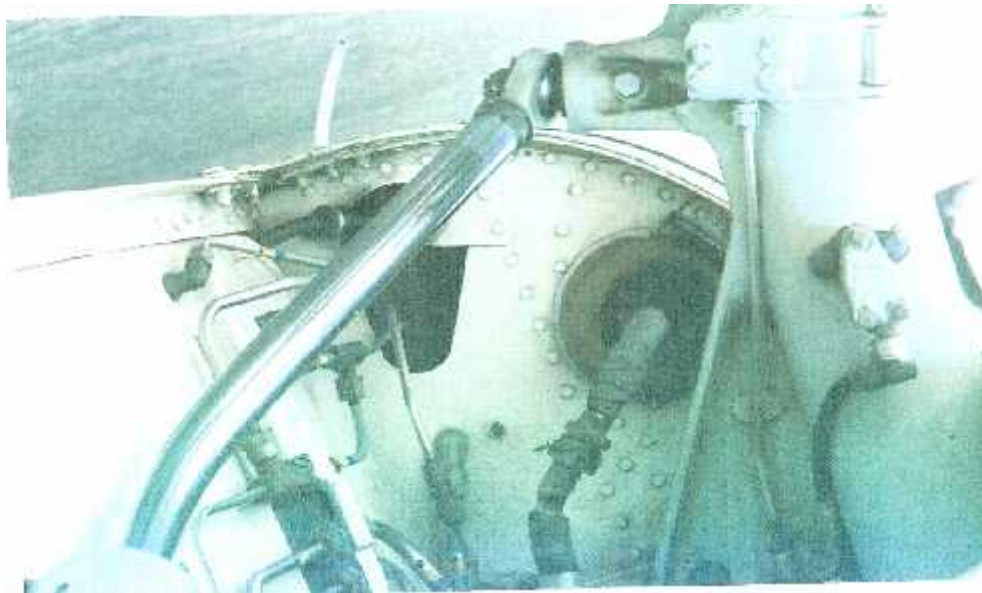
Fig. 1.12c Photograph showing bent strut
