AIRCRAFT ACCIDENT REPORT

NAHCO-AERO/2014/04/29/F

**Report on the Serious Incident involving a NAHCO
Aviance Baggage Loader Vehicle Fleet No. L3-23 and a
parked Bombardier DHC-8-400 aircraft belonging to Aero
Contractors with registration 5N-BPT which occurred at
Aero Ramp, MMA, Lagos State
on the 29th of April, 2014**

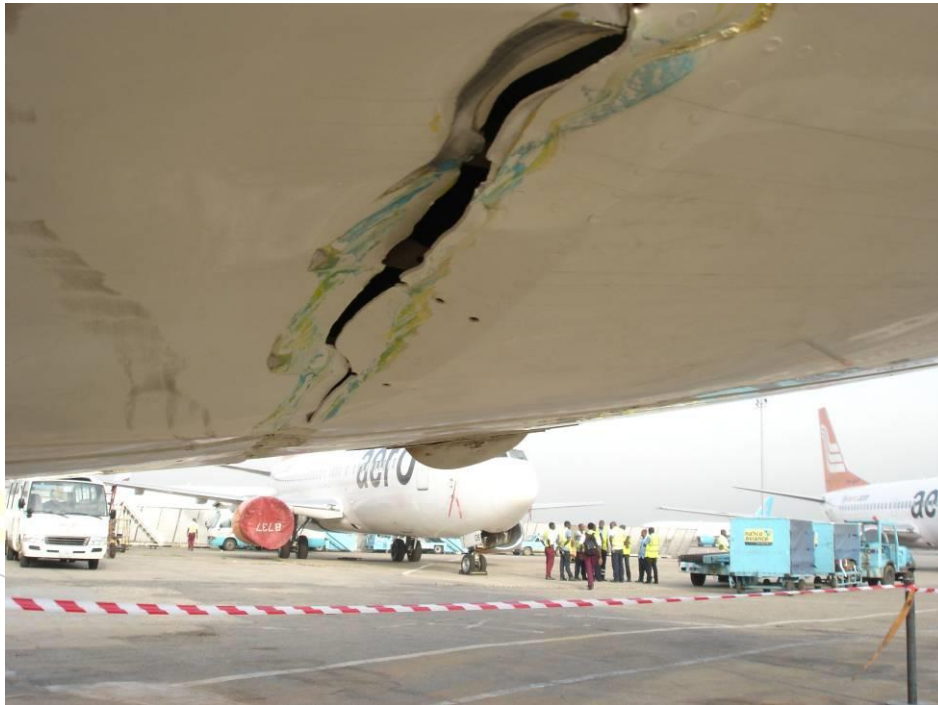
The aircraft sustained damage at the pressurized area of the lower fuselage section of the cargo compartment, which affected the skin and stringers. The baggage loader vehicle steering wheel and seat were damaged from the impact. The incidence occurred at the Aero ramp and the vehicle stopped at a distance of 110ft from the aircraft. See figures 3, 4, 5 and 6.

Figure 2: Damage to lower aft section of the aircraft

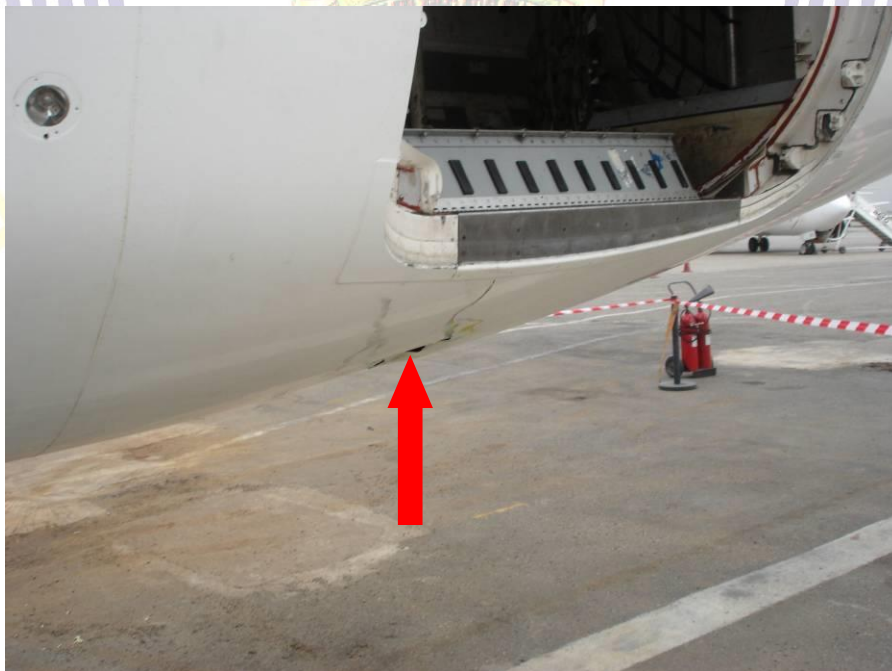
Figure 3: Damage to the lower section to the fuselage's cargo compartment

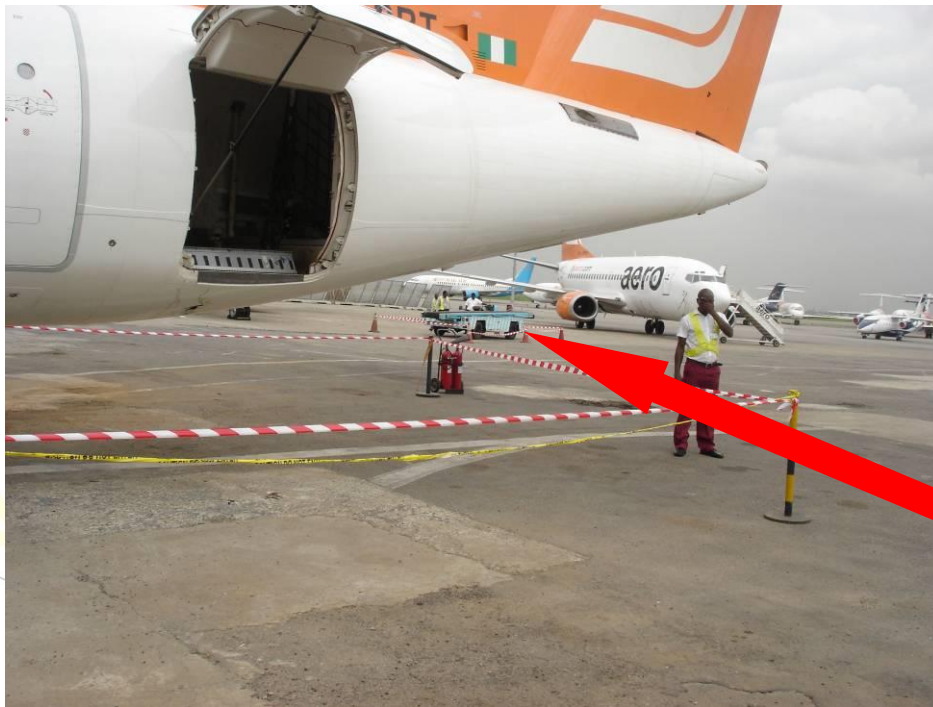
Figure 4: The position of the Baggage Loader Vehicle after the incident (a distance of about 110ft from the incident aircraft)

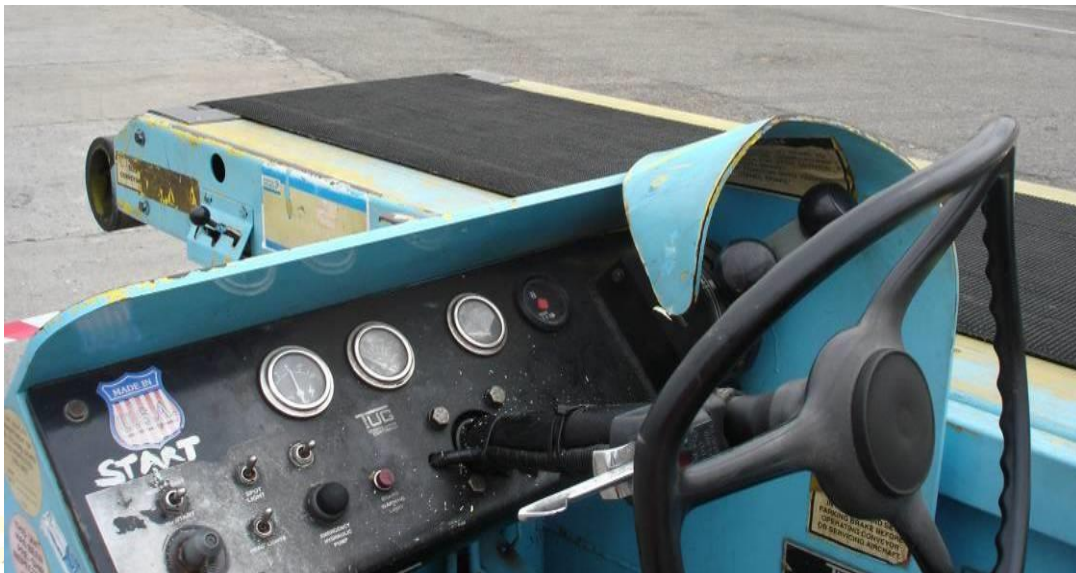
Figure 5: The damaged steering wheel of the baggage loader vehicle

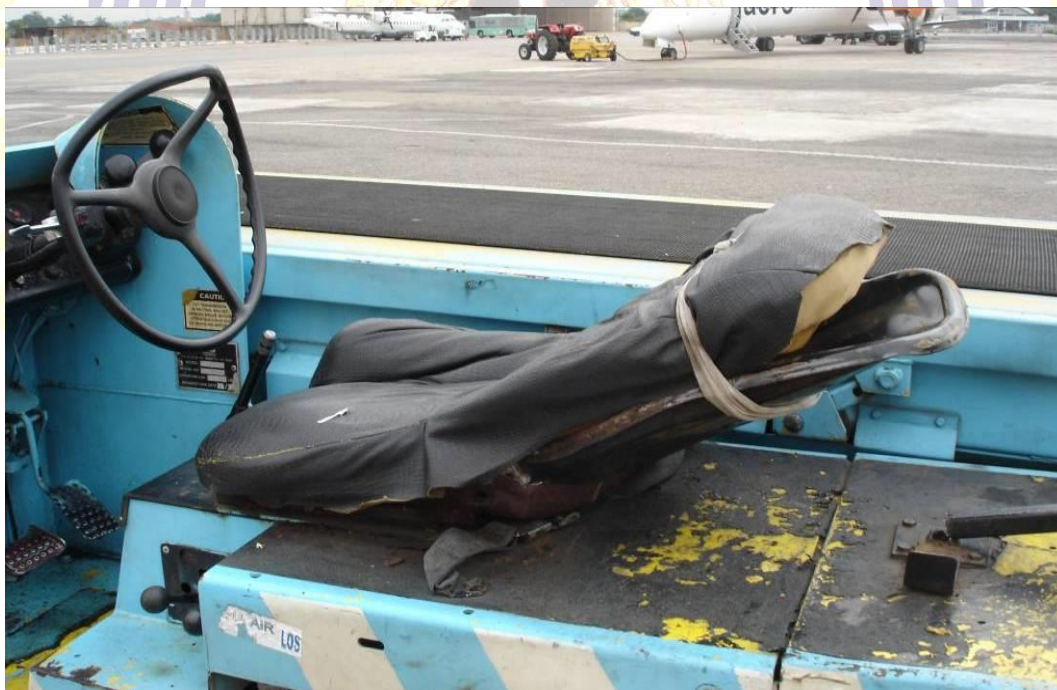
Figure 6: The damage to the steering and seat of the baggage loader vehicle
