# AIRCRAFT INCIDENT REPORT

NCAT /2012/10/04/F

**Final Report on the Serious Incident involving a  
Nigerian College of Aviation Technology (NCAT)  
Aircraft Tampico Club TB9 with Registration Number  
5N-CBE which occurred at Zaria Aerodrome, Kaduna  
State, Nigeria on 4<sup>th</sup> October 2012**

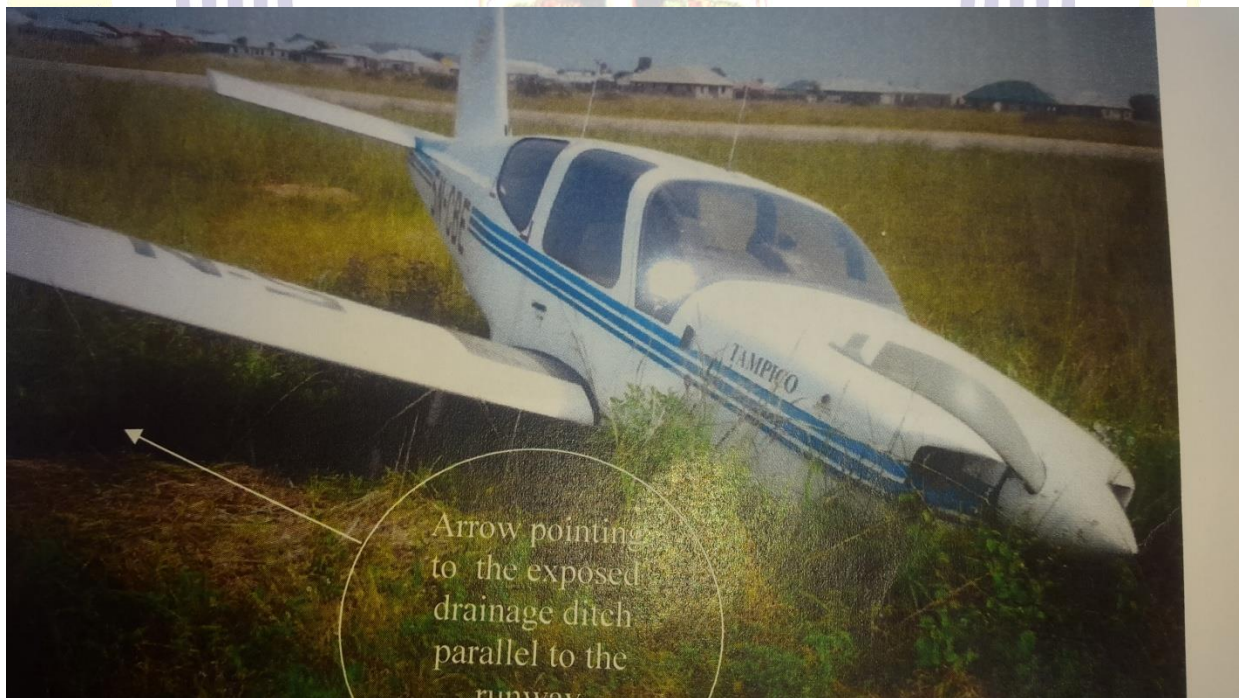
- i Both propeller blades were damaged
- ii Nose landing gear sheared off from its attachment points
- iii Landing and taxi lights on the Left wing were broken
- vi Cockpit floor panels and rudder pedals were damaged

**Figure 1: Damaged Propeller blades**

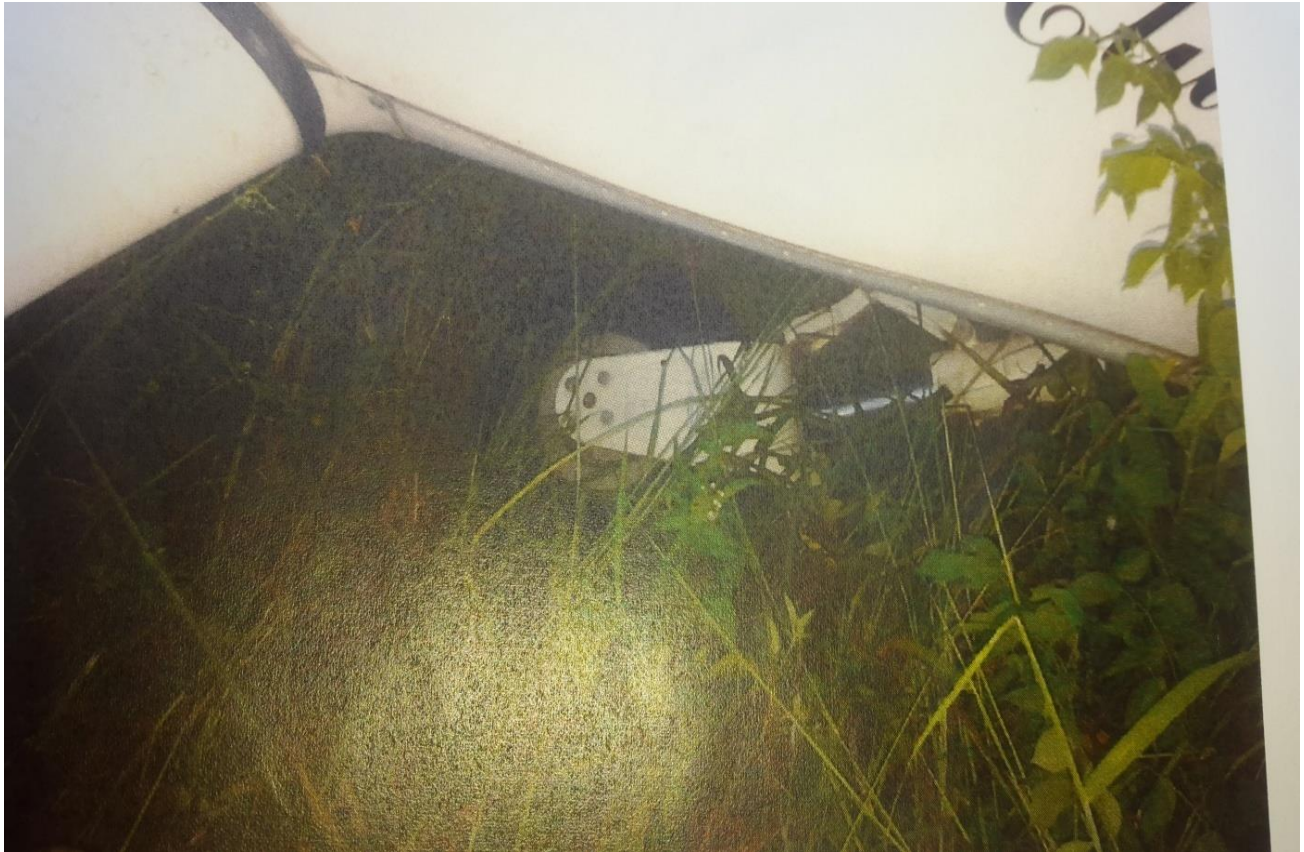
***Figure 2: Sheared off Nose Landing Gear***

The aircraft touched down on Runway 24, bounced and veered off to the right of the runway and was stopped by the drainage that runs parallel to the runway. The nose landing gear sheared off from its attachment point due to high impact. Both propeller blades were damaged, landing and taxi lights were broken, cockpit floor panel and the rudder pedals were also damaged.

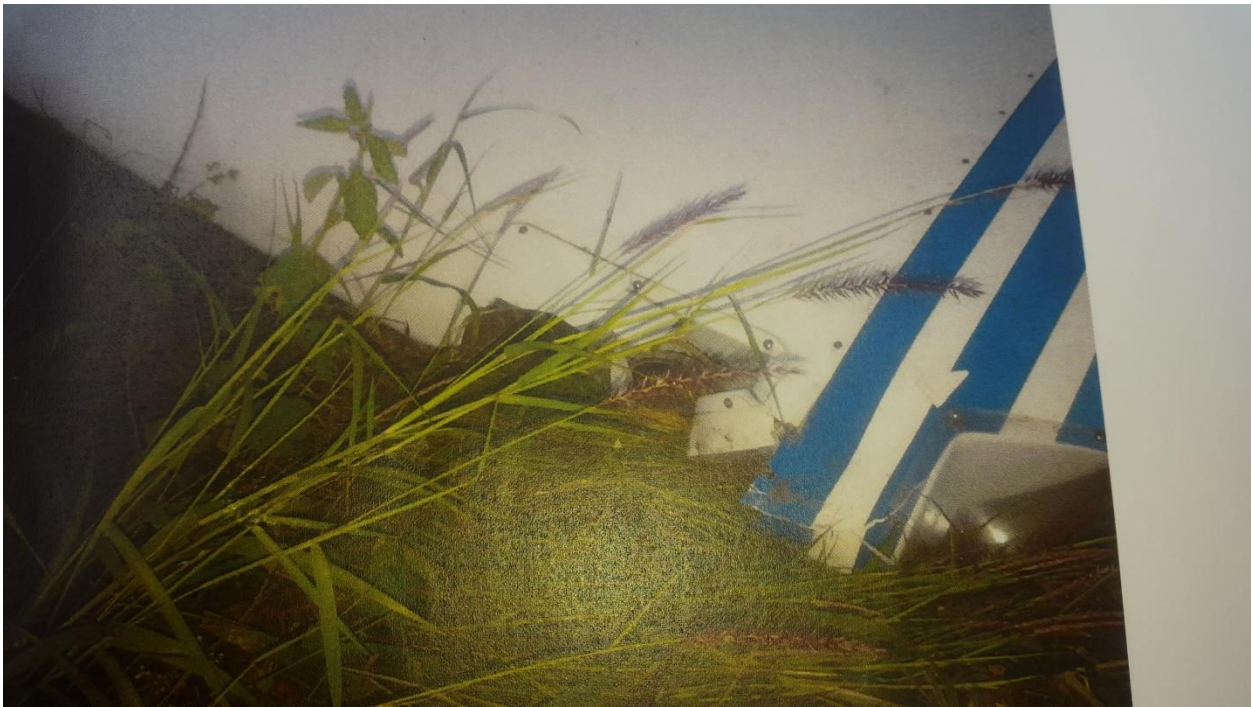
**Figure 3: Broken Landing and Taxi Lights**

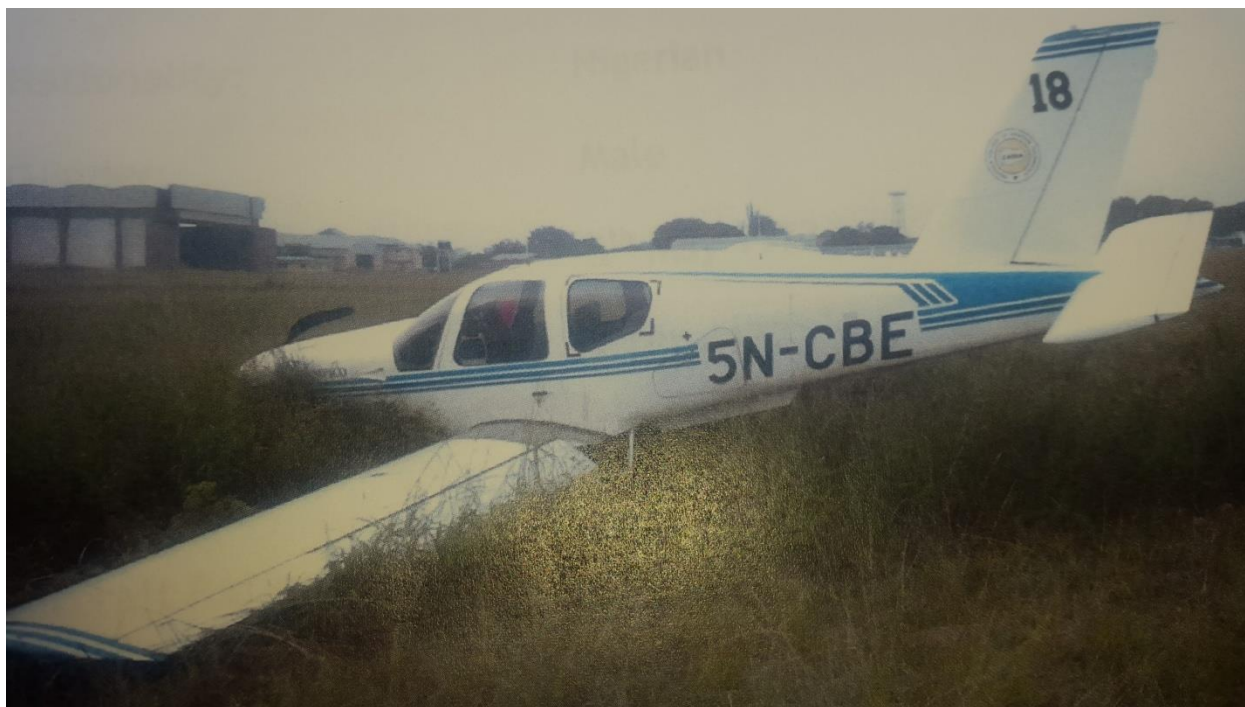
The aircraft veered off to the right of the runway to a grassy area and stopped in a drainage that runs parallel to the runway.

**Figure 4: Aircraft's final resting position**

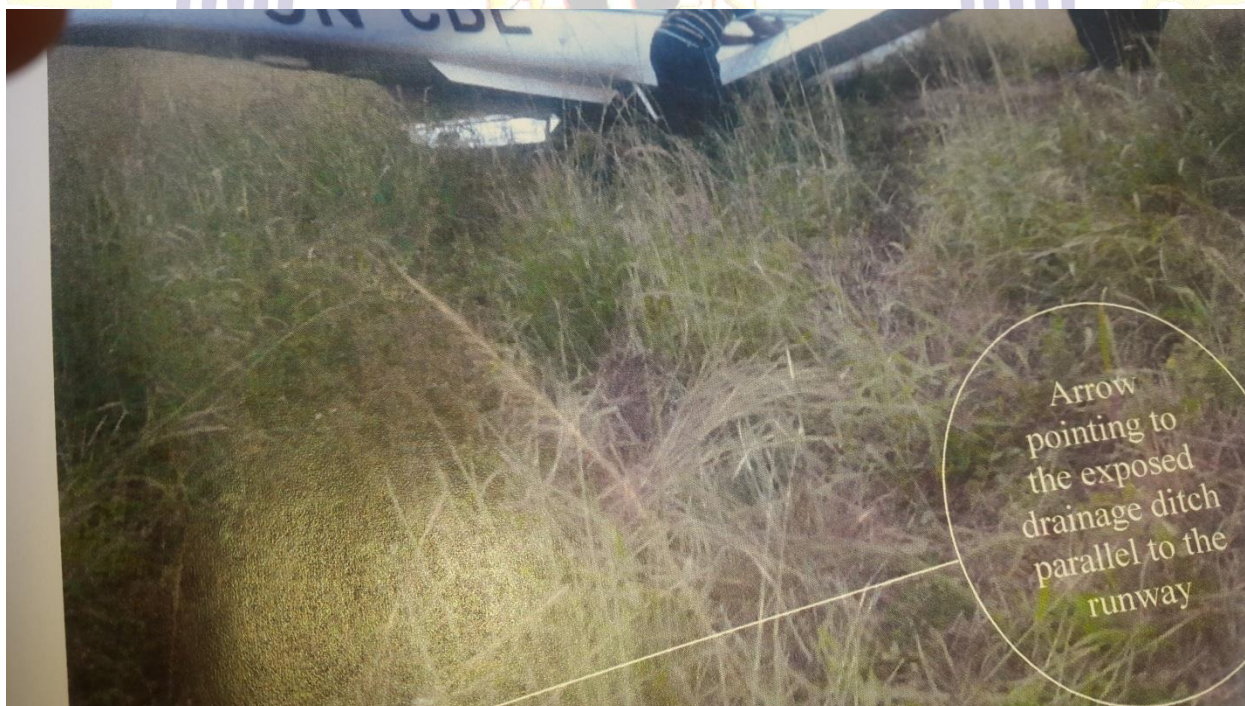
**Figure 5: Exposed Drainage, parallel to the Runway (see Arrow)**

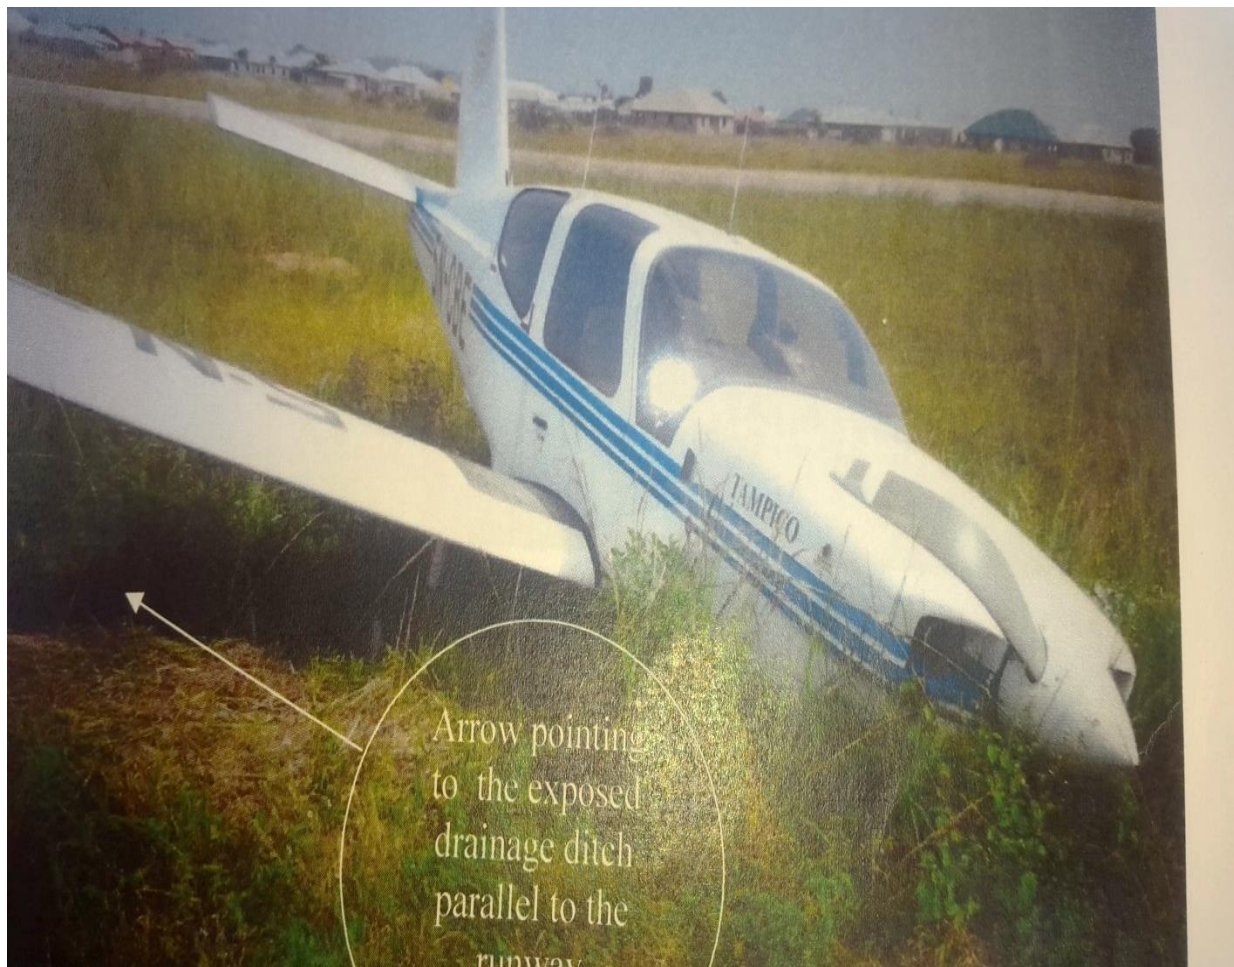
**Figure 6: Aircraft's final resting position viz a viz drainage (see Arrow)**
