AIB BULLETIN

AIRPEACE/2017/04/20-001

**Report on the ground collision incident involving Air
Peace Airlines Limited aircraft Boeing 737-500,
Registration 5N-BQR and Boeing 737-300,
Registration 5N-BQP which occurred close to Bay 4
of the apron at the General Aviation Terminal
of Murtala Muhammed Airport, Ikeja, Lagos
On 20th April, 2017**

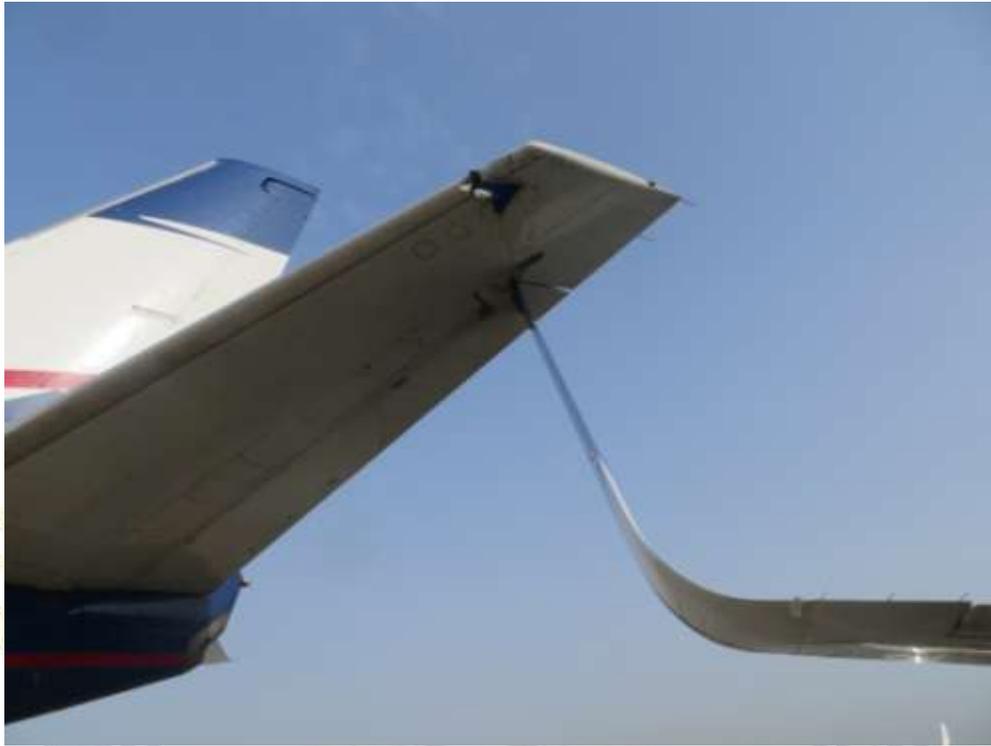
The Crew disembarked without injury. 5N-BQP sustained damage to the left horizontal stabilizer leading edge and its skin while 5N-BQR sustained damage to its left winglet tip and strobe light.

Figure 1: Picture showing damage to the leading edge of horizontal stabilizer of 5N-BQP and the winglet tip of 5N-BQR

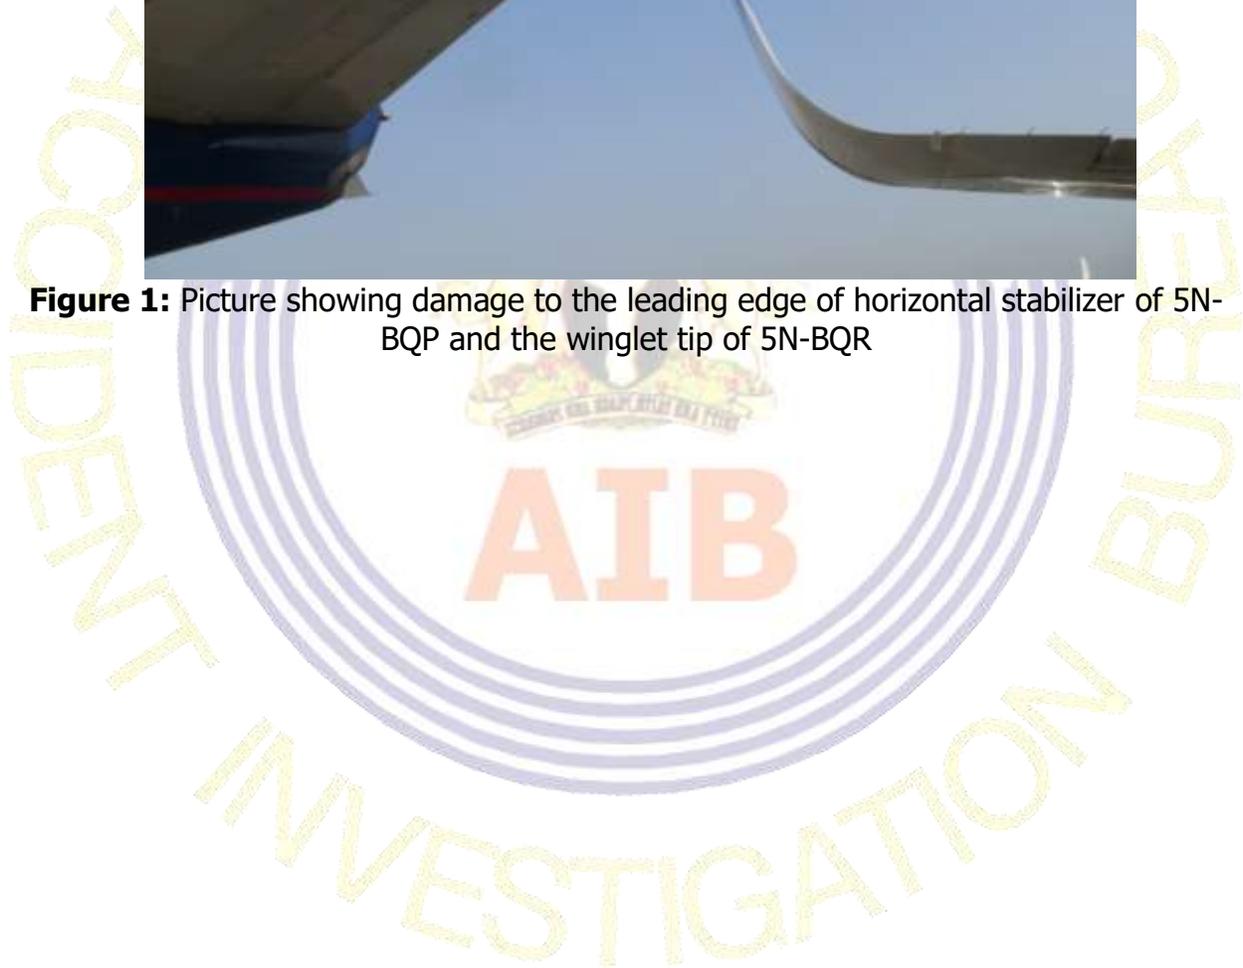
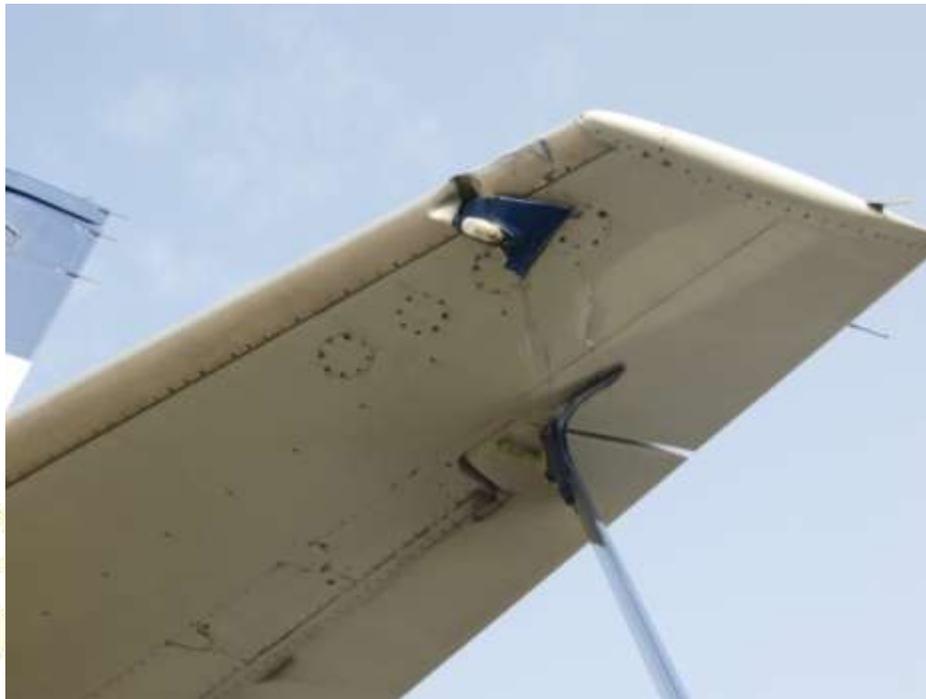
Figure 2: Picture showing damage to the leading edge and skin of horizontal stabilizer of 5N-BQP

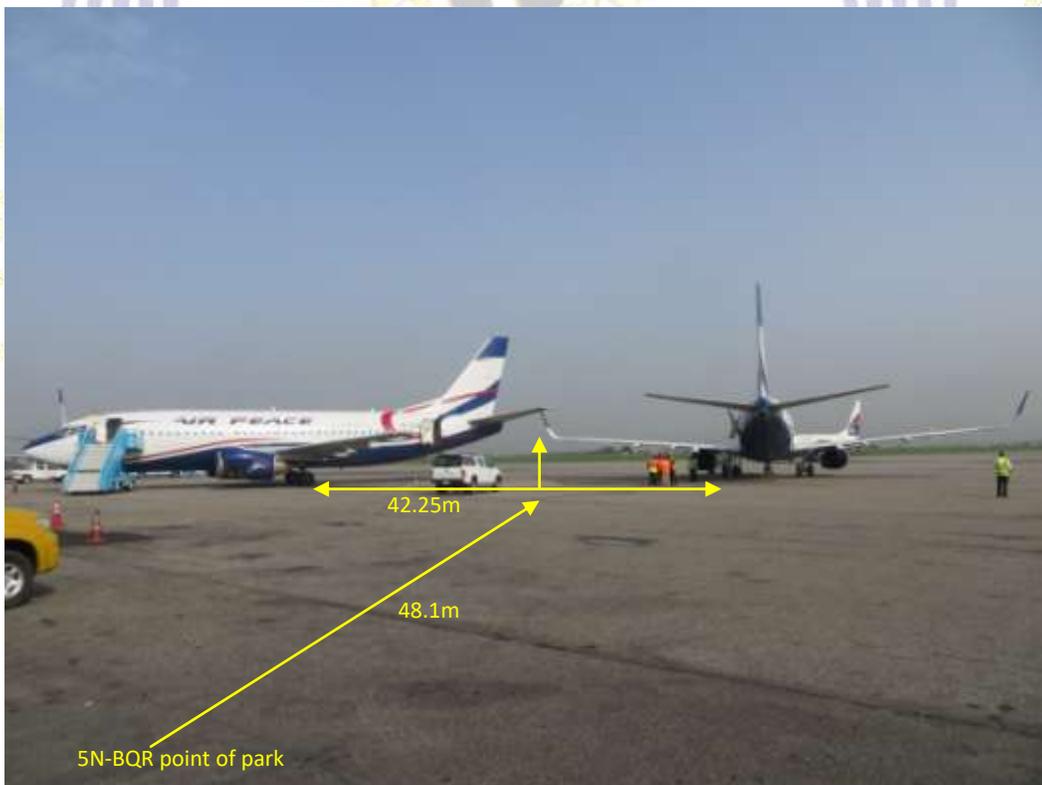
Figure 3: From Left: Picture showing final position of 5N-BQP and 5N-BQR after the incident

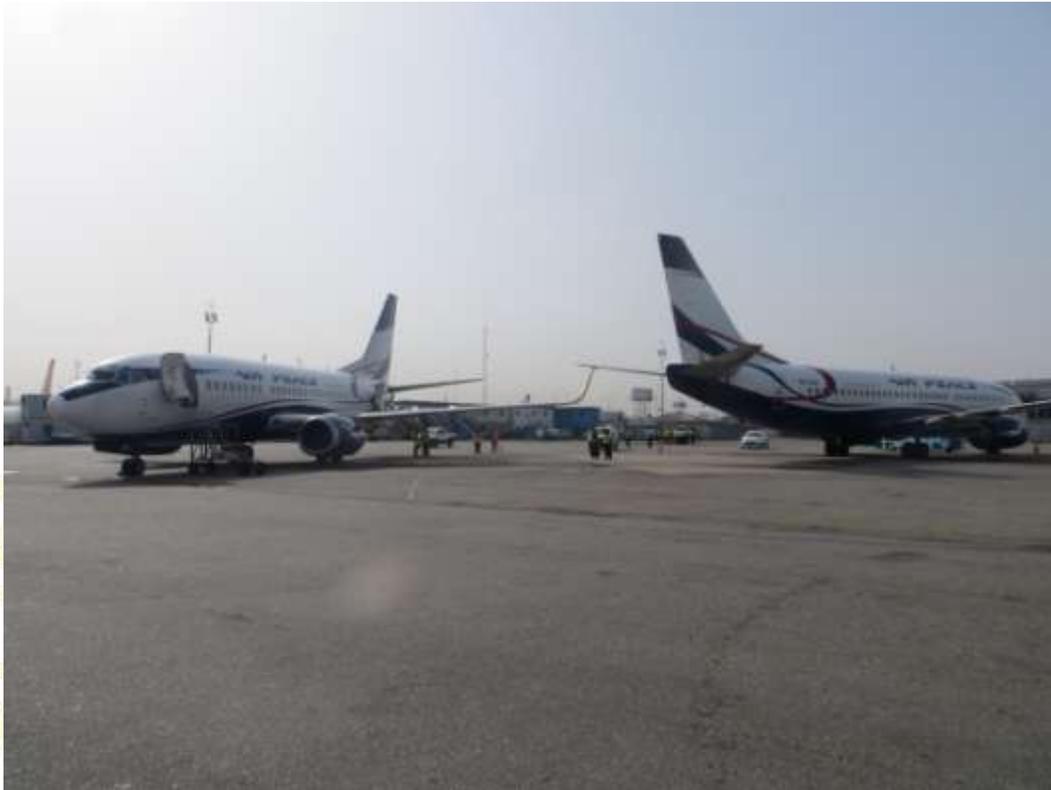
Figure 4: Front view showing the final positions of 5N-BQR and 5N-BQP after the incident from the
