CIVIL AVIATION ACCIDENT

Report No. 04/344

REPORT ON THE ACCIDENT TO THE NIGERIA
AIRWAYS LTD'S BOEING 707 - 320C ON
MONDAY THE 19TH DECEMBER 1994 AT KIRI
KASAMA, HADEIJA LOCAL GOVERNMENT
AREA.

Civil Aircraft Accident Report No. 04/344

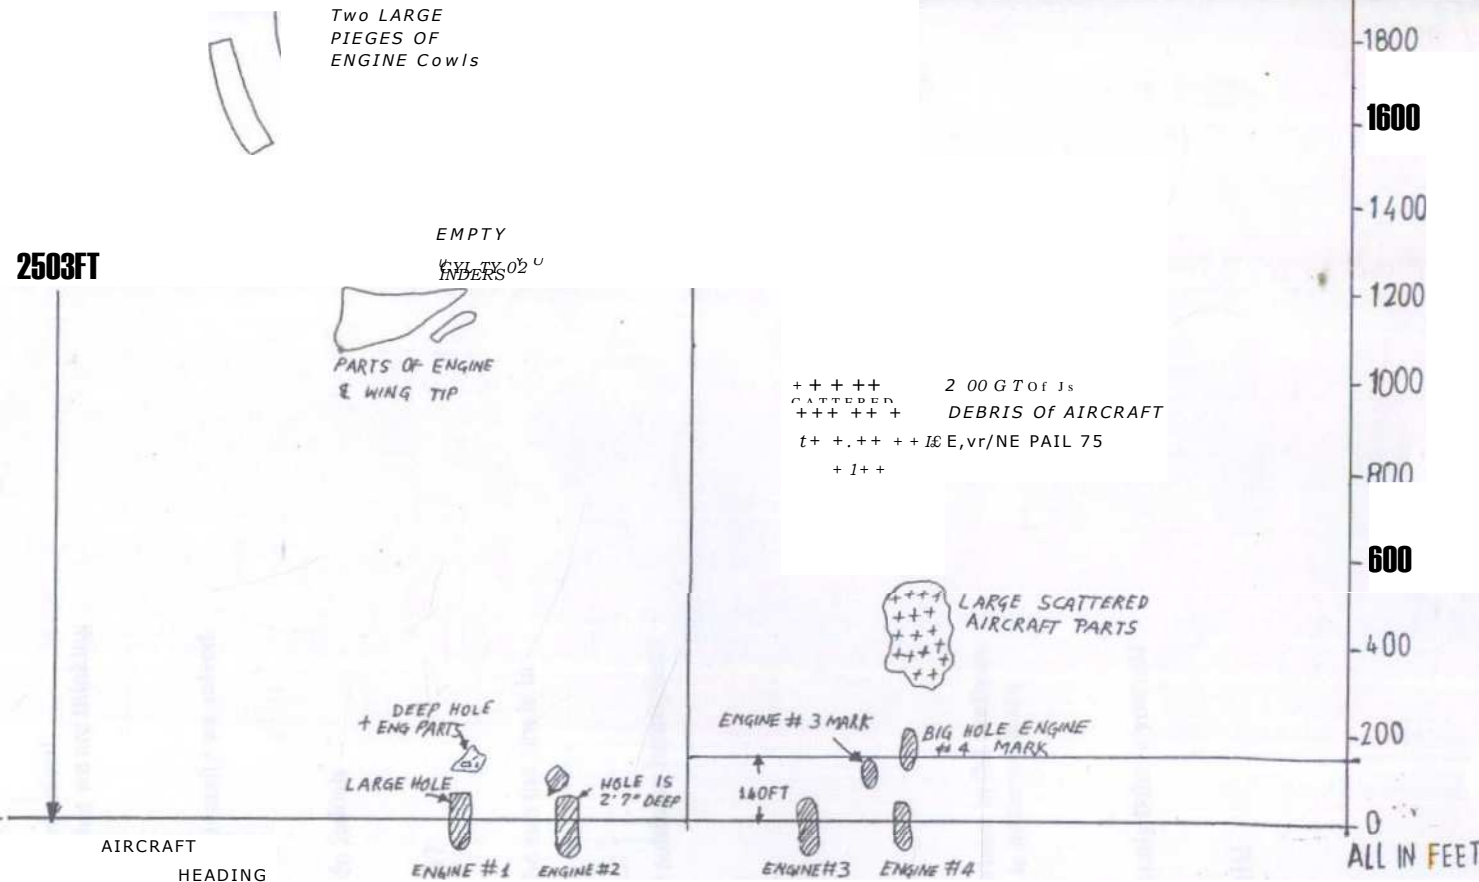
The wreckage pattern displays the typical laws of inertia in that heavier masses tend to dissipate their kinetic energy over a longer distance before coming to a stop. Within the incipient energy, it is discernible that the total energy of the crash suggests an aircraft at high speed. Even though the aircraft did not dive into the ground as there were no deep craters to support the suggestion, it was clearly flying to the ground at a high speed. The scatter covered a distance of 5,005 feet with a width of close to 1,500 feet. The cockpit area of the aircraft that remained fairly intact was the heaviest particle at the crash site and this section ended up at the furthest extreme of the wreckage distribution. The fact that the vertical stabilizer went further than the main

sections of the wings (a heavier mass) gives credence to the suggestion of the aircraft went into a somersault as the wheels got embedded in the mud on the initial impact. The detailed wreckage distribution chart is attached in an appendix (1)
