Civil Aircraft Accident Report
No. CIA 122

REPORT ON THE ACCIDENT

BELL 206B JET RANGER III HELICOPTER REGISTERED 5N-AQC AT A LOCATION 7 NAUTICAL MILES N.N.W. OF KADUNA AIRPORT, NEAR THE VILLAGE OF IFIRA ON SATURDAY THE 26TH OF APRIL 1986.

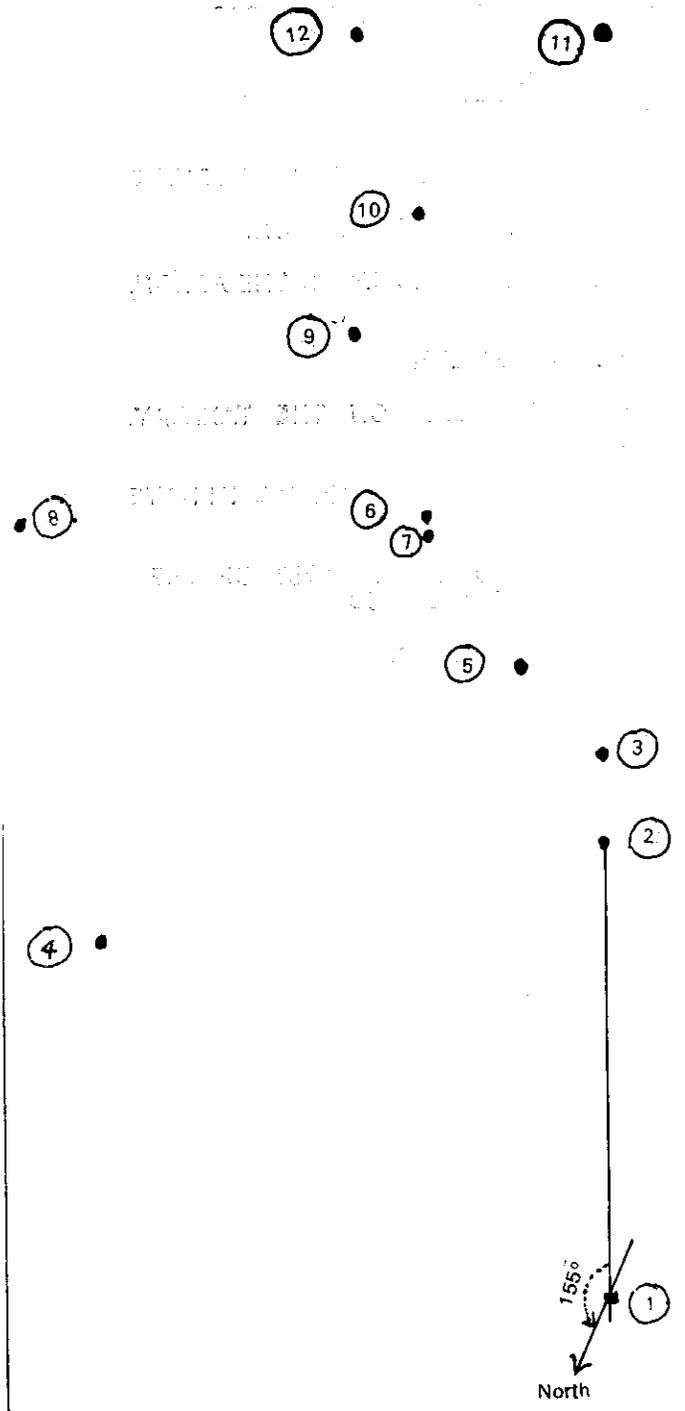
Wreckage Distribution

The tail boom of the helicopter made the first impact with a six inch diameter trunk of a tree after which the boom was sheared off. The helicopter made a heavy impact with the ground, rolled over its right side and ended up in an inverted position on top of a mound of pebbles.

Scale 1cm = 1 meter	
Index	
1.	Tail boom 8ft. long with tail rotor intact
2.	Fuel Tank
3.	Baggage Compartment door
4.	Rear left hand skid (1ft. long)
5.	Float gauge
6.	Rear door
7.	Part of skid 4' long
8.	Skid 2' long
9.	Side Window
10.	Skid 6' long
11.	Main Wreckage
	(a) Main Fuselage
	(b) Doors
	(c) Main rotors both bent at right angles 3' from root
12.	Port front door
13.	Skid 8' long

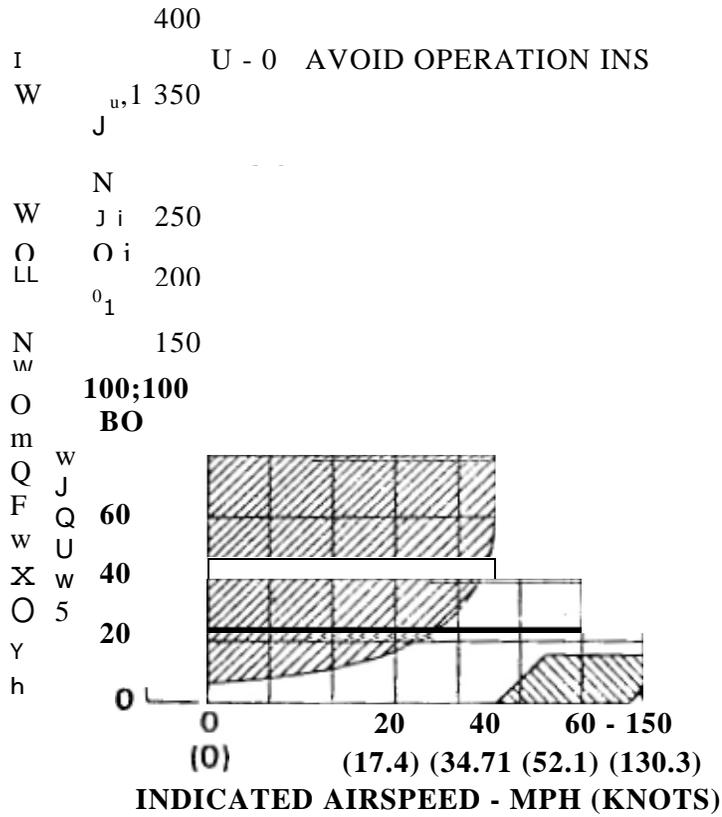
HEIGHT VELOCITY
D I A G R A M

Thirdly, was it permitted to simulate an engine flame-out at that point in time where the helicopter was maneuvering? The answer to this would be found in the Height Velocity Diagram (see Appendix III). This diagram is usually called the "Avoid Curve".

The Height- Velocity diagram defines the conditions from which a safe landing can be made on a smooth, level, firm surface following an engine failure. The procedure is to immediately put the helicopter into autorotation and effect a landing. The criterion is that auto-rotation would be possible provided the height and indicated airspeed of the helicopter are not in the shaded area of the diagram. From the evidence of the Captain in Check i.e. Pilot in the controls, the indicated speed of the helicopter was 60 knots and the height was 200ft. (This point has been marked on the diagram). The helicopter was definitely not inside the shaded area, therefore it would have been possible to go into an auto-rotation and effect a safe landing.

Position of
helicopter
at the point of
flame-out
