**CIVIL AVIATION ACCIDENT  
REPORT NO CIA 169**

**ACCIDENT TO THE NIGERIA POLICE FORCE  
BELL 412 HELICOPTER REGISTERED ON AOT  
AT PORT HARCOURT AIRPORT ON THE 20TH JANUARY 1992**

Civil Aircraft Report No. CIA. 169

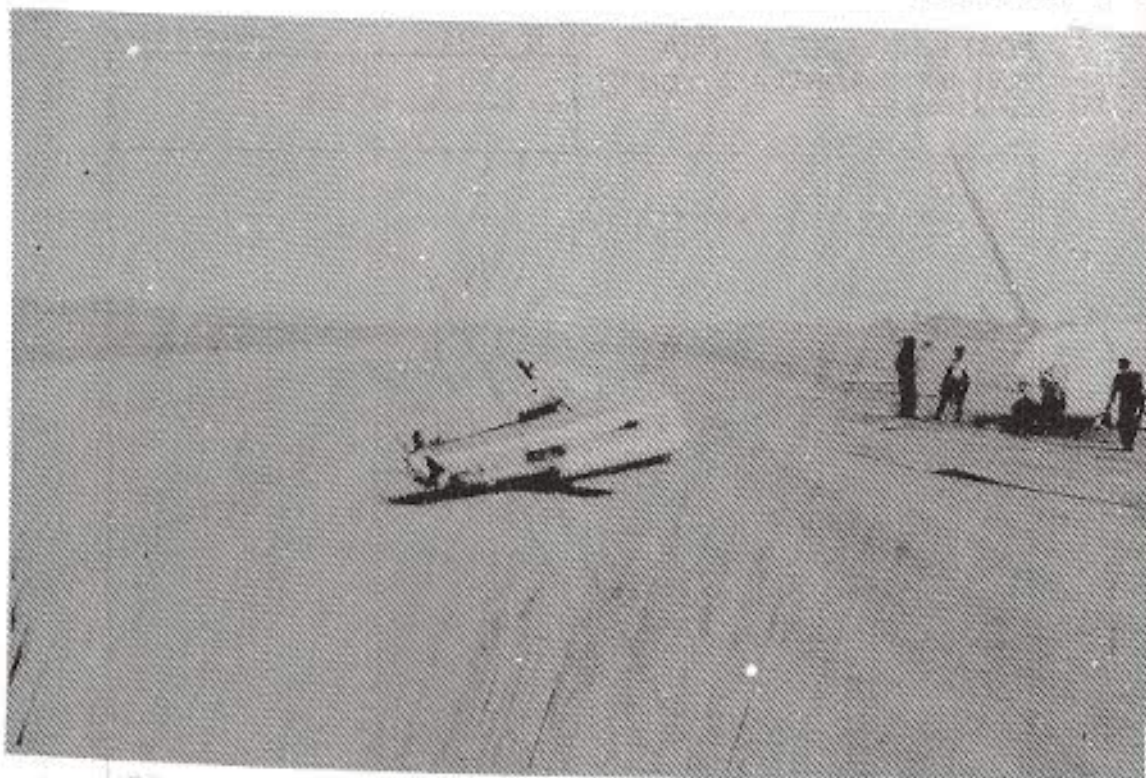
The skid tubes were broken off when the aircraft impacted with the ground and the tail boom fractured from the fuselage while the tail rotor and its gear box broke away the end section of the tail boom. The main rotors were totally destroyed. The engines and the engine cowls were badly damaged. There were evidence of various types of damages on the fuselage before coming to rest on its staboard side. The main transmission gearbox must have also been seriously damaged.

The picture of the taxiway where the accident occurred showing the severed tail boom.

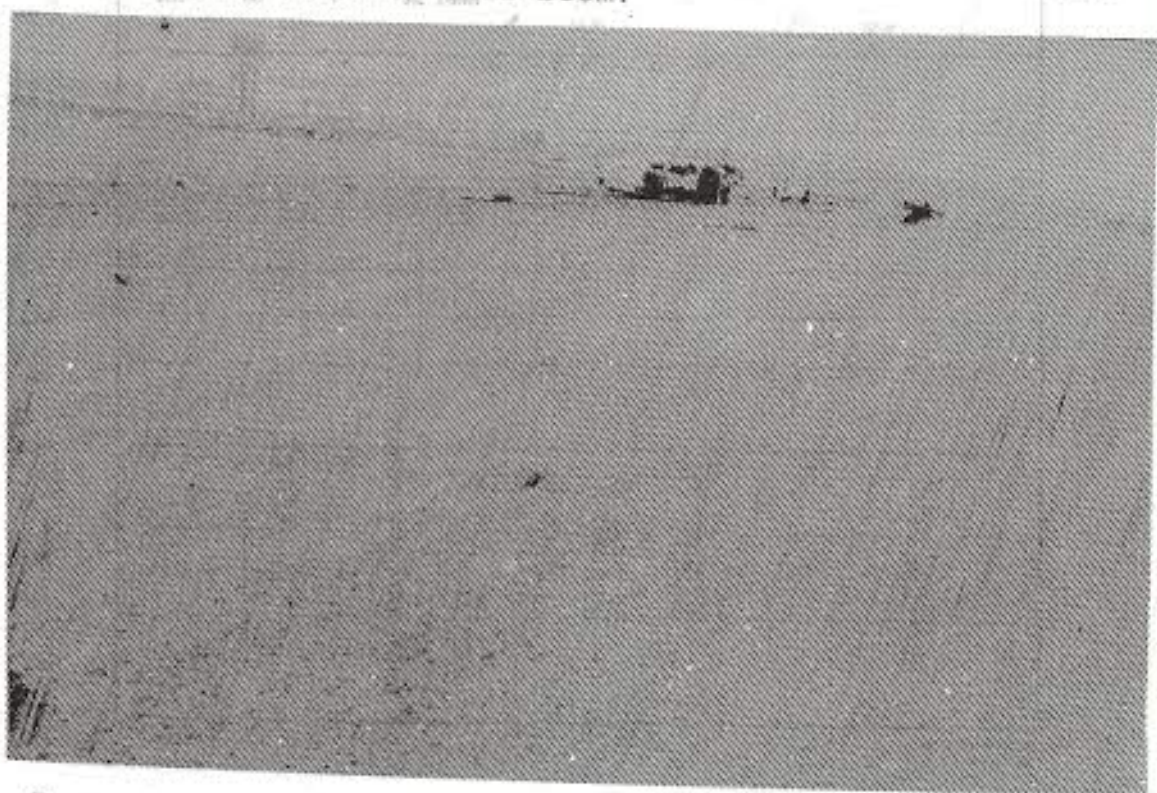
The aircraft started to break up after impacting severely with the ground surface. The tail rotor hit the tarmac first before the skids hit the surface and broke-off. The fuselage then impacted with the surface, then still in some considerable amount of forward motion, the aircraft skidded along the taxi-way before overturning on its starboard side and careered on its side for about 26.5 meters before coming to rest in that position.

The helicopter wreckage lying on its side after a failed attempt to reach the main apron.

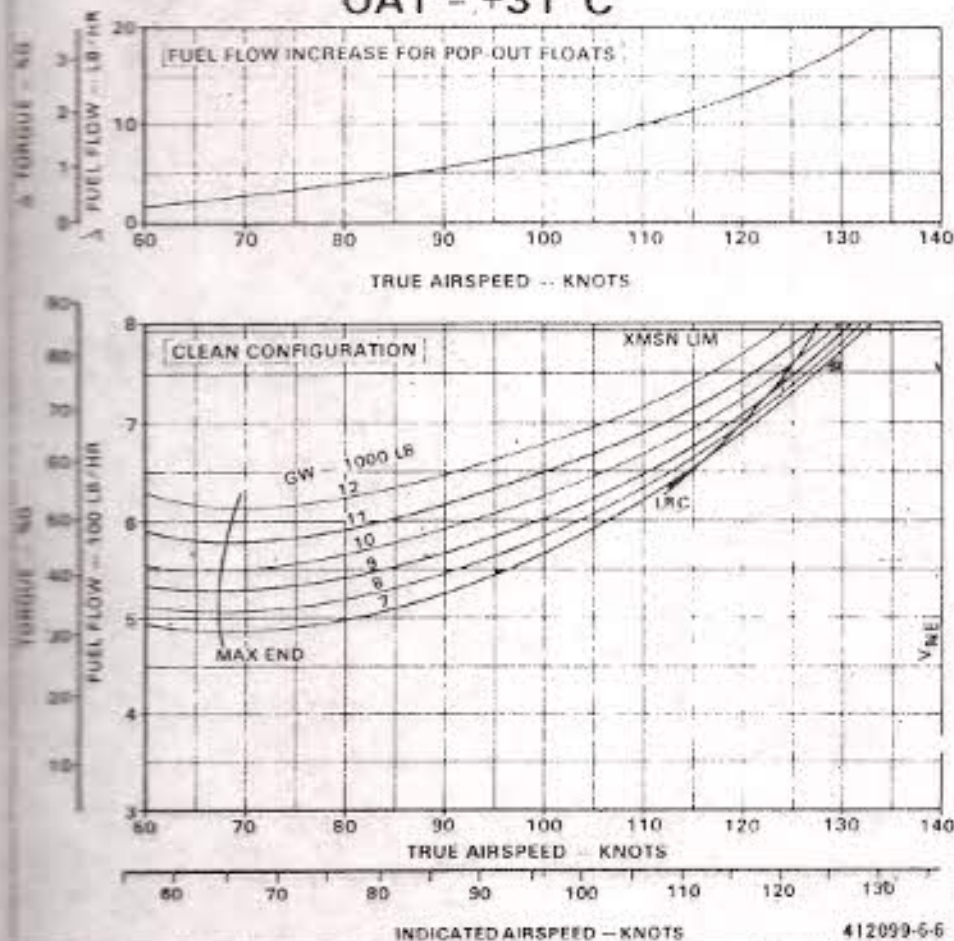
Figure 3-1. Fuel flow (Sheet 6 of 18)

Fuel flow vs Airspeed Chart used for calculating the trip segment fuel consumption rate.
