AIRCRAFT ACCIDENT REPORT

DELTA/2018/02/13/F

Accident Investigation Bureau

Report on the Serious Incident involving an Airbus A330-223 aircraft operated by Delta Air Lines Inc. with nationality and registration marks N858NW which occurred after take-off from Runway 18R, Murtala Muhammed International Airport, Lagos on 13th February 2018

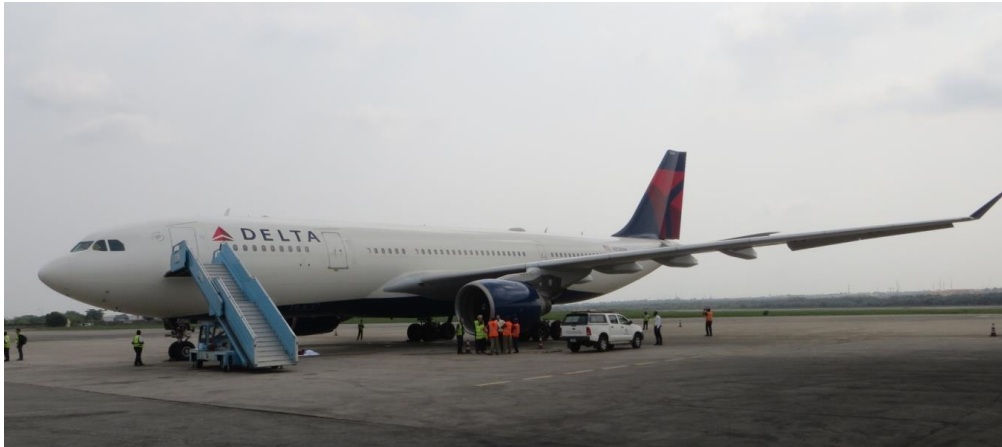
The aircraft was not damaged.

Figure 1: The aircraft after the incident

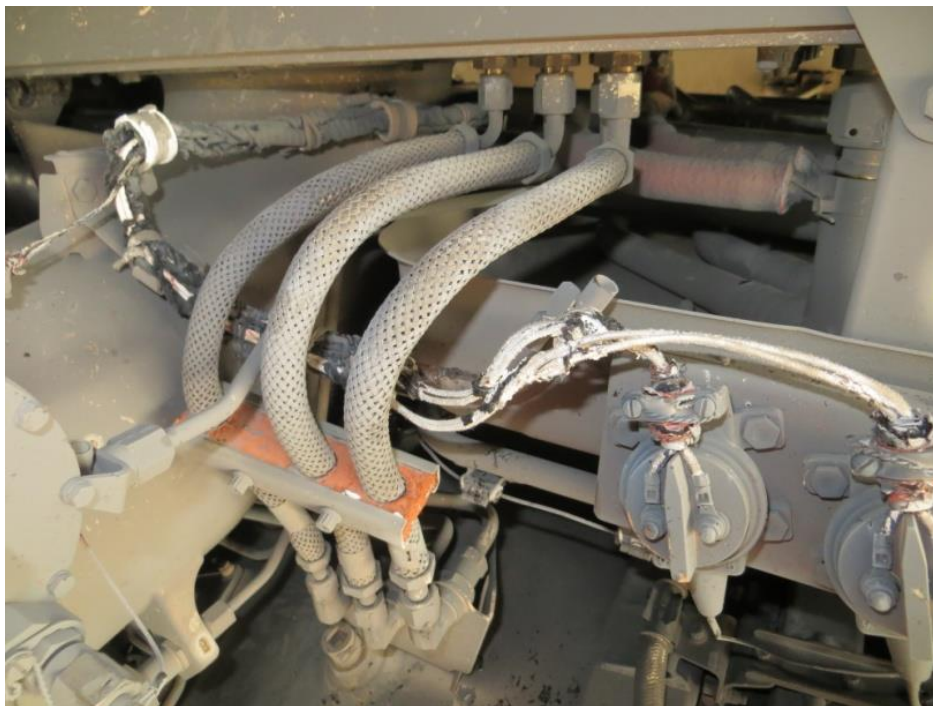
There were indications of fire and evidence of soot within the No. 1 engine cowling. In addition, during the examination of the engine No. 1 in-situ, there was evidence of an overtemperature condition within the engine cowling, consisting of melted plastic sheathing of the fire detector loop and wire harness.

Figure 2: Photo showing melted plastic sheathing of the fire detector loop and wire harness within the engine cowling

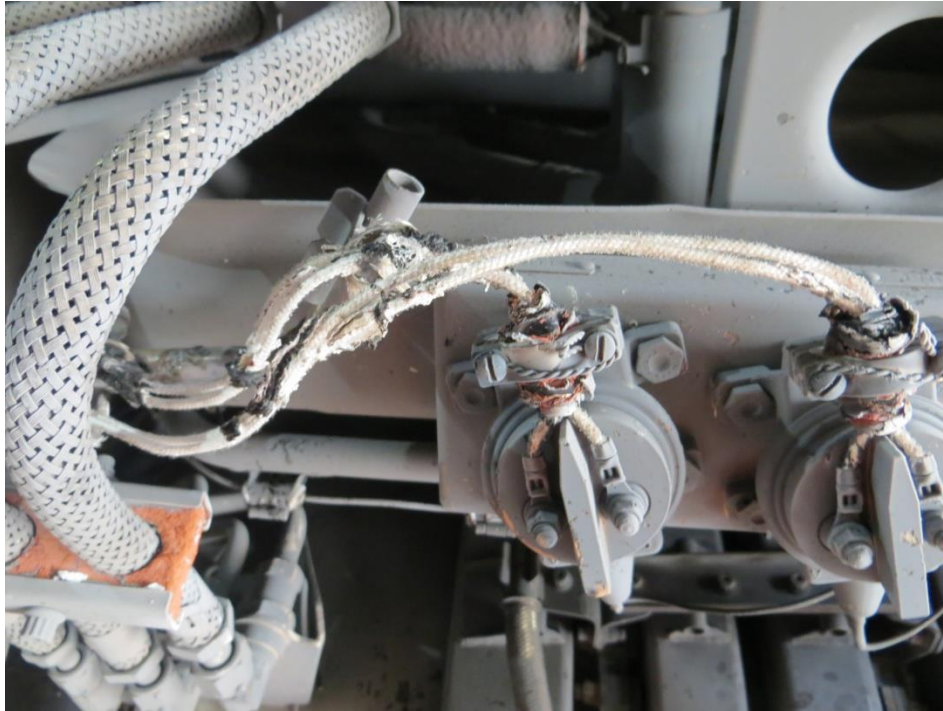
Figure 3: A close-up view of melted plastic sheathing of the wire harness

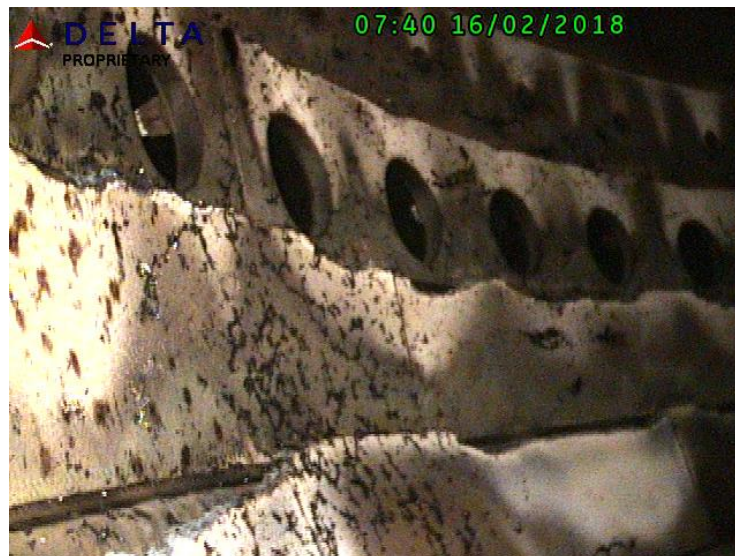
A borescope inspection was carried out on the No. 1 engine. It showed some discoloration/foreign deposits in the turbine section and combustion chambers. These deposits were attributed to the fire extinguishing agents deployed by the ARFFS.

Figure 4: A view of the interior of the combustion chamber of No. 1 engine

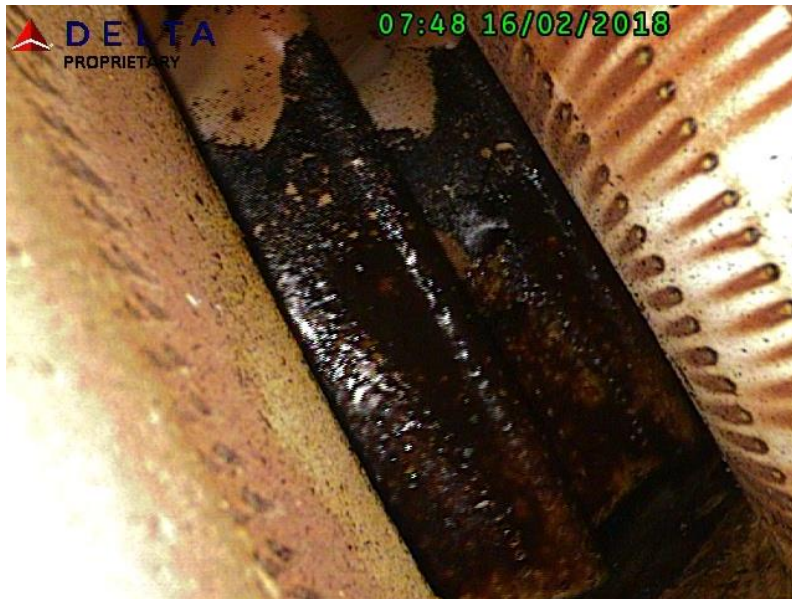
Figure 5: Photo showing discoloration/foreign deposits in the turbine section

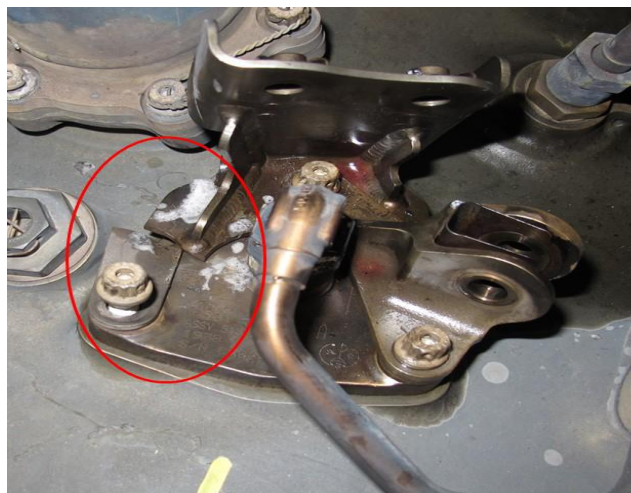
Examination of the fractured bracket found that the fracture progressed in high cycle fatigue from an origin area at the toe of the weld. No defects or anomalies were found to be associated with the cracking.

The engine teardown report showed that during removal of fuel nozzle 1, the intermediate cooling duct support bracket bolted to the fuel nozzle 1 pad was found fractured on the left side (See Figure 6 below). The fuel manifold cracking is due to a structural mode of the fuel manifold being excited by a combustor acoustic tone.

Figure 6: Photo showing the fractured support bracket (circled in red) adjacent to fuel nozzle 1.

Nevertheless, a Service Bulletin, PW4G-100-73-48 released on 14th March 2018, after the occurrence, recommended the installation of triplet clamps to reduce vibration stress. Although an Airworthiness Directive had not been issued by the FAA to that effect.

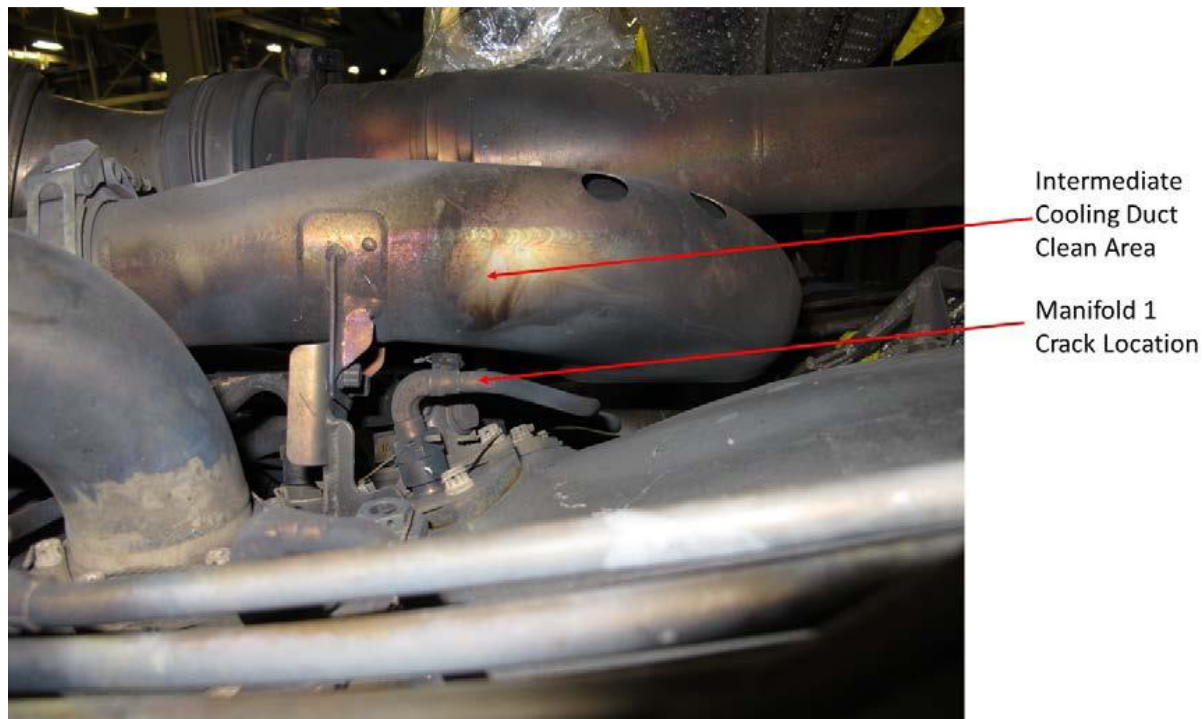
The engine teardown report showed an area of localized discoloration and sooting between the 11:30 to 1 o'clock positions, axially from the diffuser case forward flange (K-flange) to the aft end of the fuel manifold triplets (about 15 in). The discoloration and soot were concentrated around the fuel nozzles/manifold lines (nozzles 1, 2, 3, 4, and 24). The intermediate cooling duct (piccolo tube) and starter air duct were discoloured and contained soot immediately above and aft of fuel nozzle 1 located at the 12 o'clock position. Within the area of soot on the intermediate cooling duct was a localized clean area consistent with a fluid spray pattern, see Figure 7. The spray pattern corroborated the extent and effect of the leak found during the engine teardown. The discoloration, soot and localized area clean of soot was consistent with where the fuel was propagated from the fracture during the occurrence.

Figure 7: The pattern of soot on the intermediate cooling duct

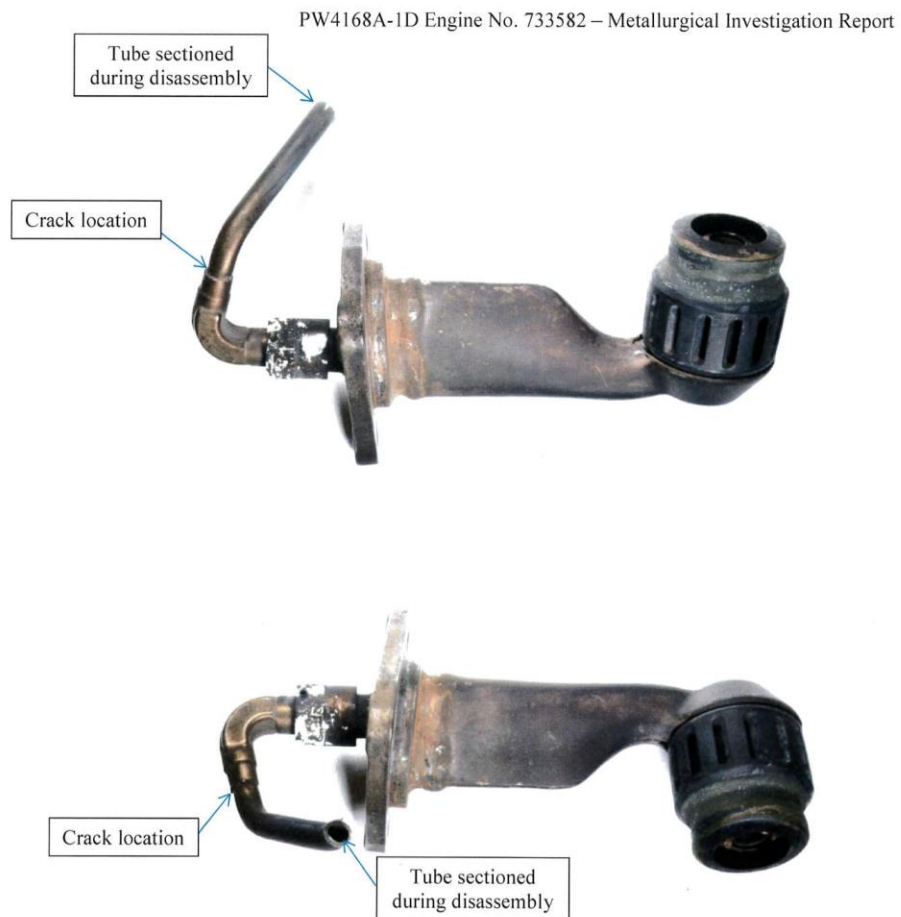
Visual examination of the fuel manifold and nozzle found that the parts were dark in color. The joint between the nozzle and the manifold was intact; the manifold had been sectioned in order to facilitate removal from the engine without disassembling the joint. The fuel nozzle was identified as being from position 1 (Figures 1-5).

Figure 1: Overall appearance of the fuel nozzle and partial fuel manifold in the as-received condition.

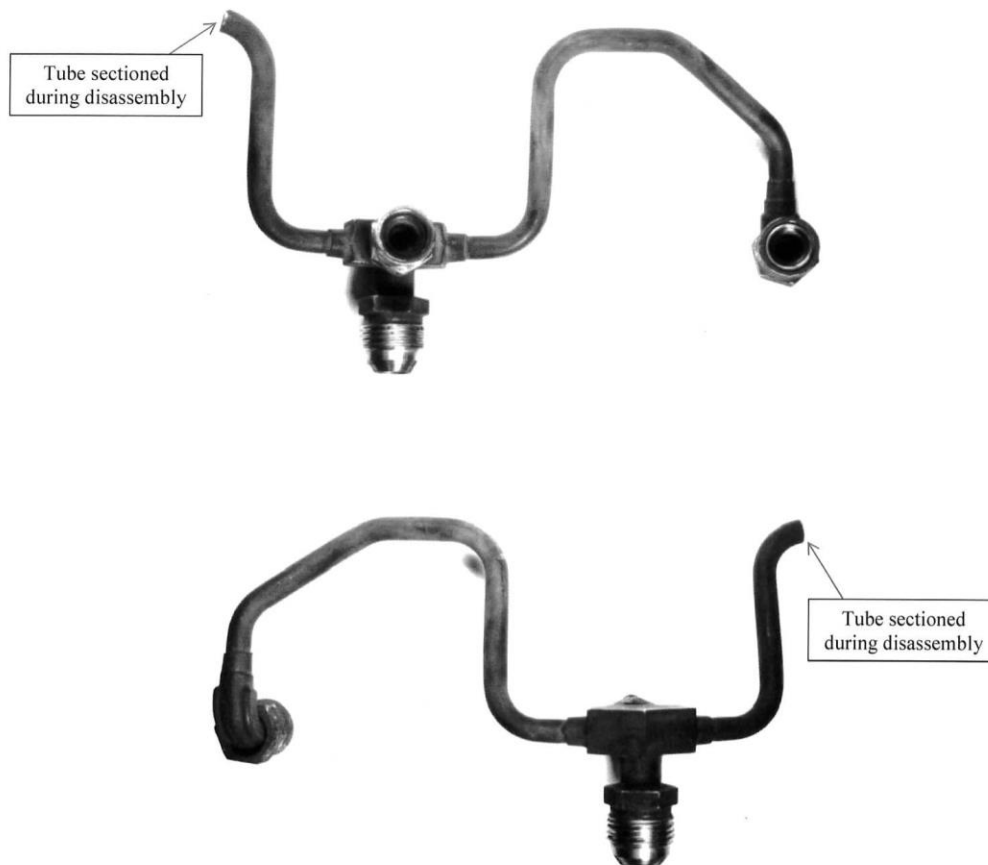
Figure 2: Overall appearance of the fuel manifold in the as-received condition

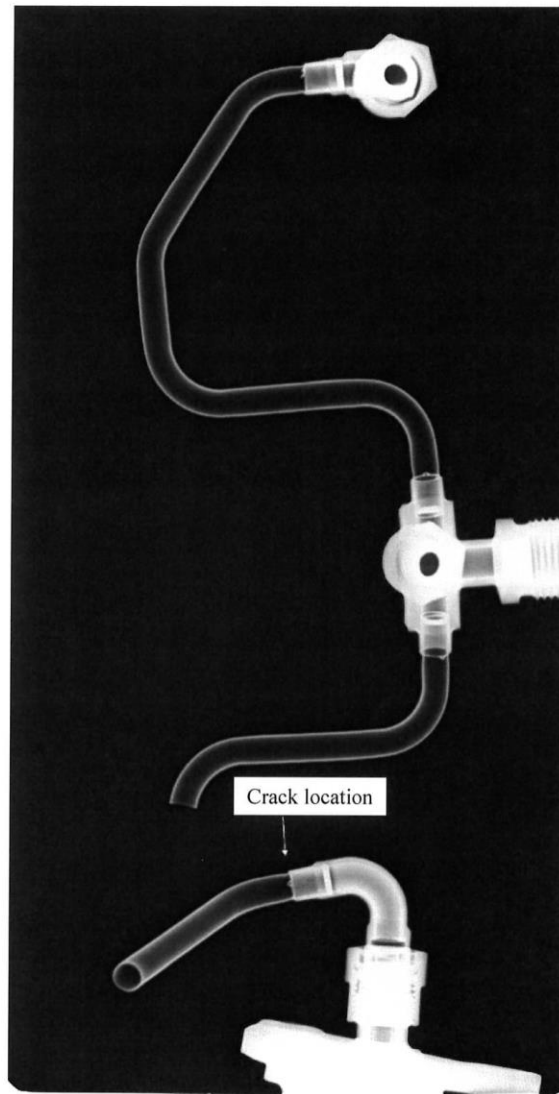
Prior to any further analysis, the fuel manifold and nozzle were submitted to the Pratt & Whitney Quality & Standards Laboratory for X-ray examination. X-ray found that the manifold braze joints appeared to have nearly 100% braze coverage. The only crack identified was the one observed during teardown (Figure 6).

Figure 6: X-ray image of manifold showing location of crack and appearance of braze joints.

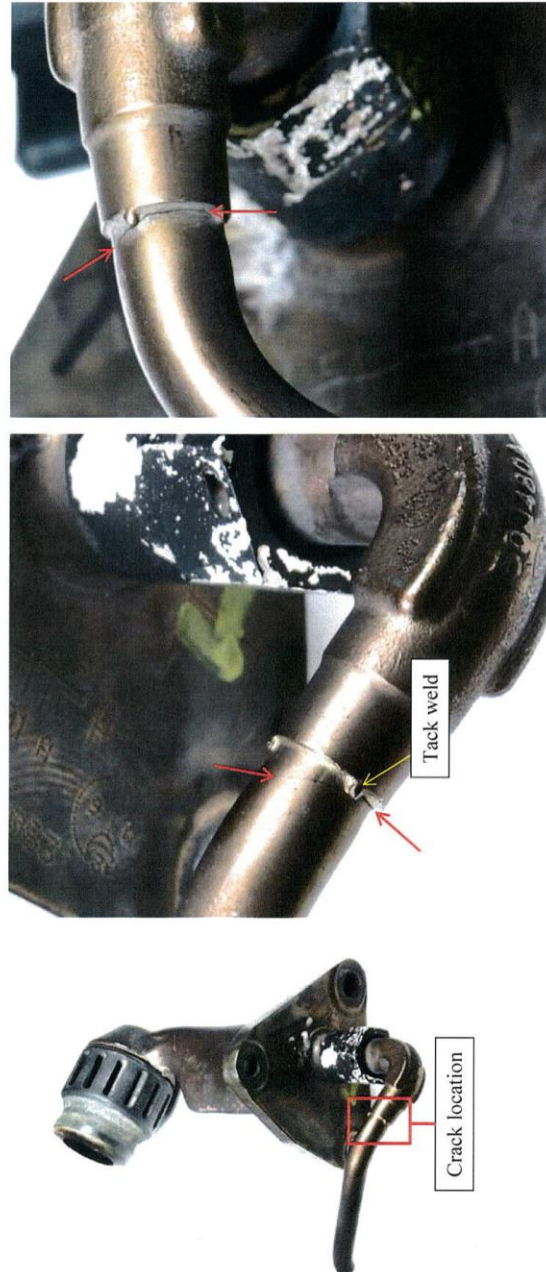
Continued visual examination of the fuel manifold confirmed the crack located at the braze near the fuel nozzle attachment. The crack extended for approximately half of the circumference of the tube. The crack was approximately aligned with a tack weld, but was not through the tack weld (Figure 7).

The crack was fractured open and examined using a binocular microscope. Binocular examination identified fatigue progressing through wall from an origin on the outer diameter of the tube. The origin was located in line with the toe of a ball tack weld. The total crack length was approximately 0.4" along the outer diameter (OD) surface of the tube.

Scanning electron microscope (SEM) evaluation of the crack surface identified cleavage features consistent with high cycle fatigue (HCF) progressing through wall from an origin area on the outer diameter of the tube. No anomalies or defects were observed at the origin.

Figure 7: Images of the crack (red arrows) at the fuel manifold braze joint near the fuel nozzle.

The NTSB may consider recommending to the FAA to issue an Airworthiness Directive with respect to Pratt & Whitney Service Bulletin PW4G-100-A73-47 and PW4G-100-73-48 to address the fuel nozzle and fuel manifold failure modes.

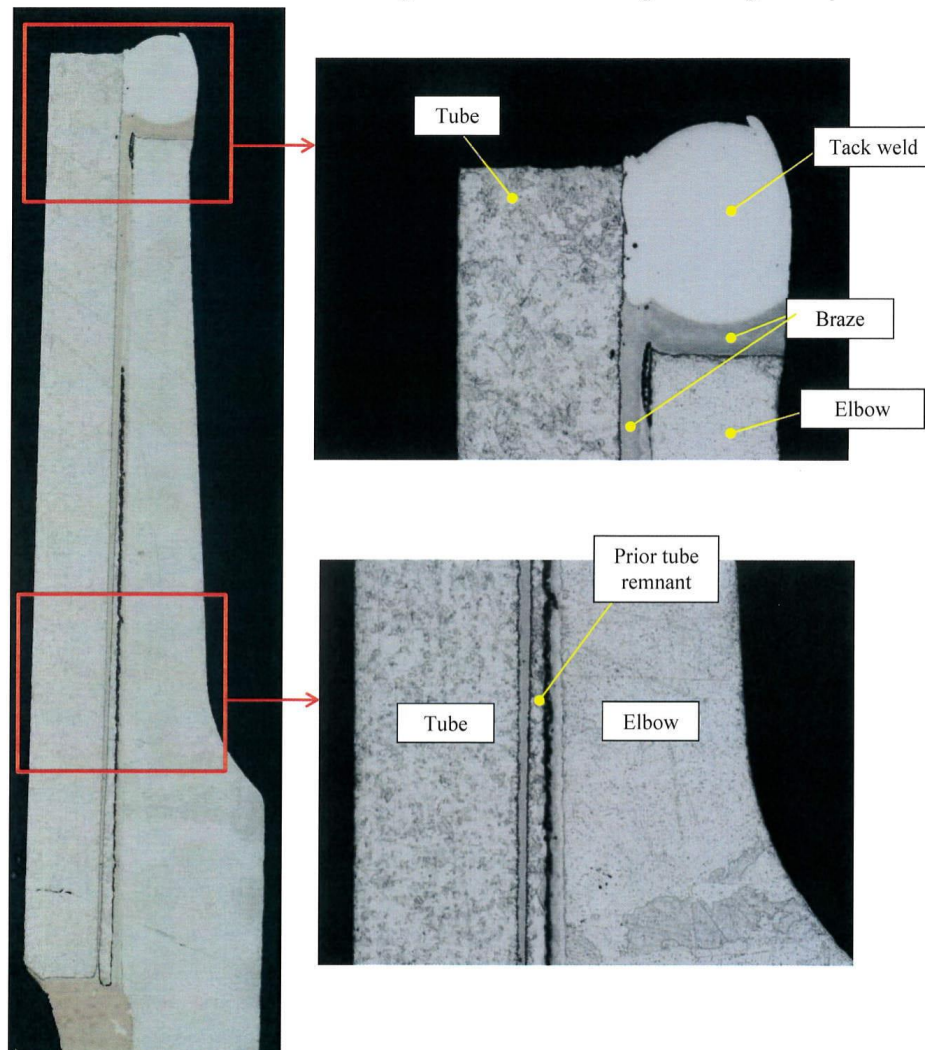
A metallographic section was prepared through the origin area on the braze side of the crack. Review of the section found that the braze appeared to be in good condition with limited porosity observed. Bulk microstructure of the tube material appeared typical of properly processed 321 stainless steel. At the crack location, the tube wall thickness conformed to the drawing requirement. It was noted that a portion of remnant tube material was observed in the joint away from the crack location, likely due to a prior repair (Figure 8).

Figure 8: Photomicrographs showing appearance of the braze joint at the crack location.

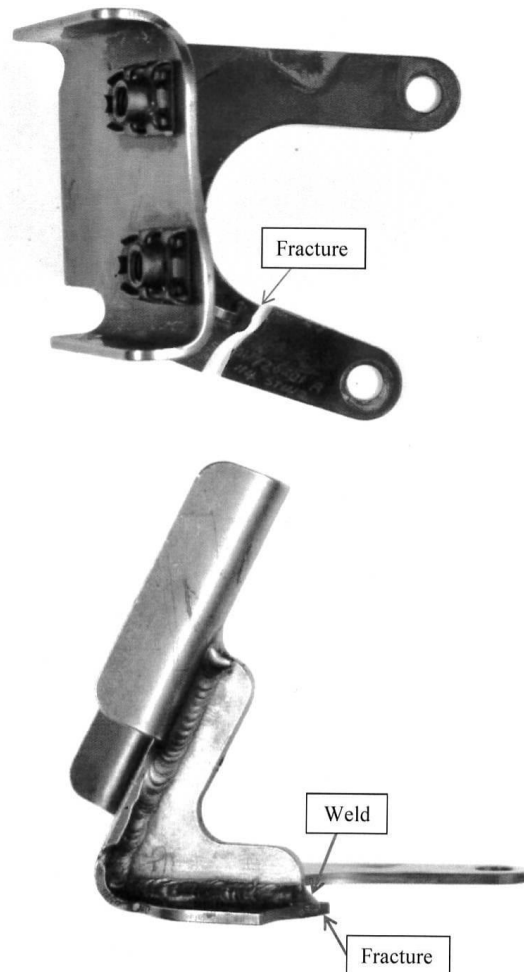
Visual review of the bracket as received found that the fracture was located at the edge of a weld in one of two legs (Figures 9-10). Binocular review of the fracture surface found that it progressed in fatigue from an origin area at the toe of the weld. SEM examination identified crystallographic features typical of HCF progression extending from the edge of the weld. No evidence of any material/weld defects was observed.

Figure 9: Images of the bracket showing location of fracture at the edge of a weld.

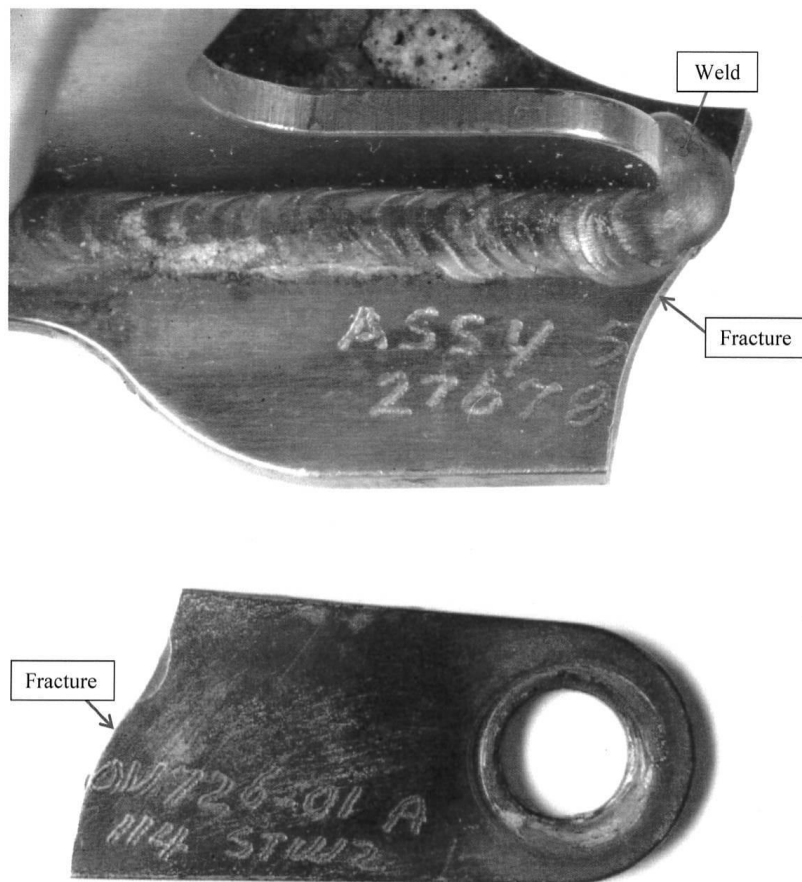
Figure 10: Location of fracture and part markings observed on bracket.
