# AIRCRAFT ACCIDENT REPORT

GITTO/2009/10/21/F

**Report on the Accident involving Gitto Construzioni  
Generali Nigeria Limited Bell 407 Helicopter  
Registered 5N-BIC at Uyo Airport,  
Akwa Ibom State, Nigeria  
On 21st October, 2009**

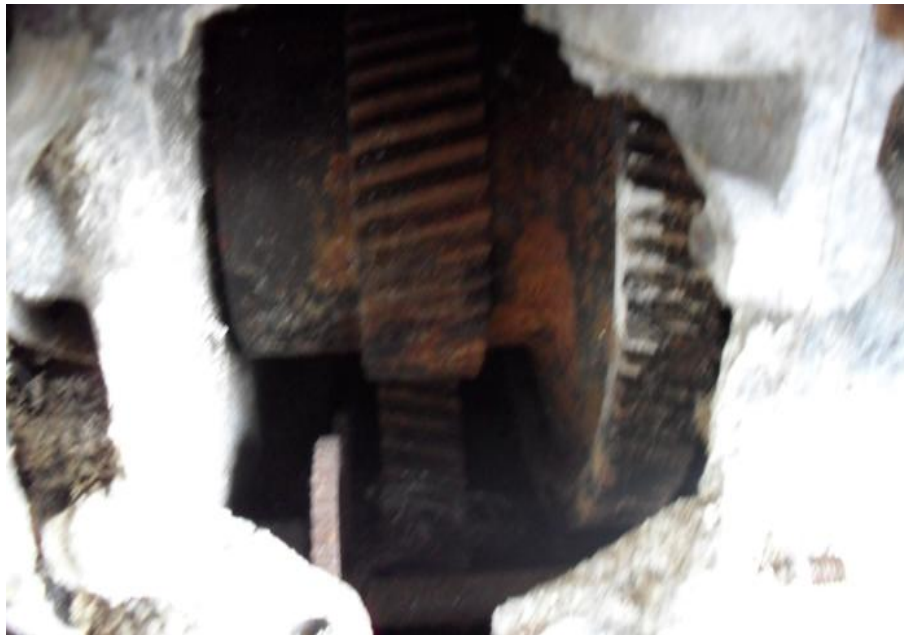
**Figure 1:** A Section of turbine area of the engine that was ripped open exposing the turbine wheels

The turbine splined adapter was deformed outwards when it was examined which would cause the splined adapter to become decoupled from the second stage turbine wheel. This deformation and smearing observed on the turbine splined adapter was indicative of rapid heating. The 1<sup>st</sup> stage turbine nozzle airfoil exhibited impact damage on the trailing edges. The nozzle diaphragm also exhibited radial impact marks and punctures. The 1<sup>st</sup> stage turbine stub shaft was retained for failure analysis in the laboratory.

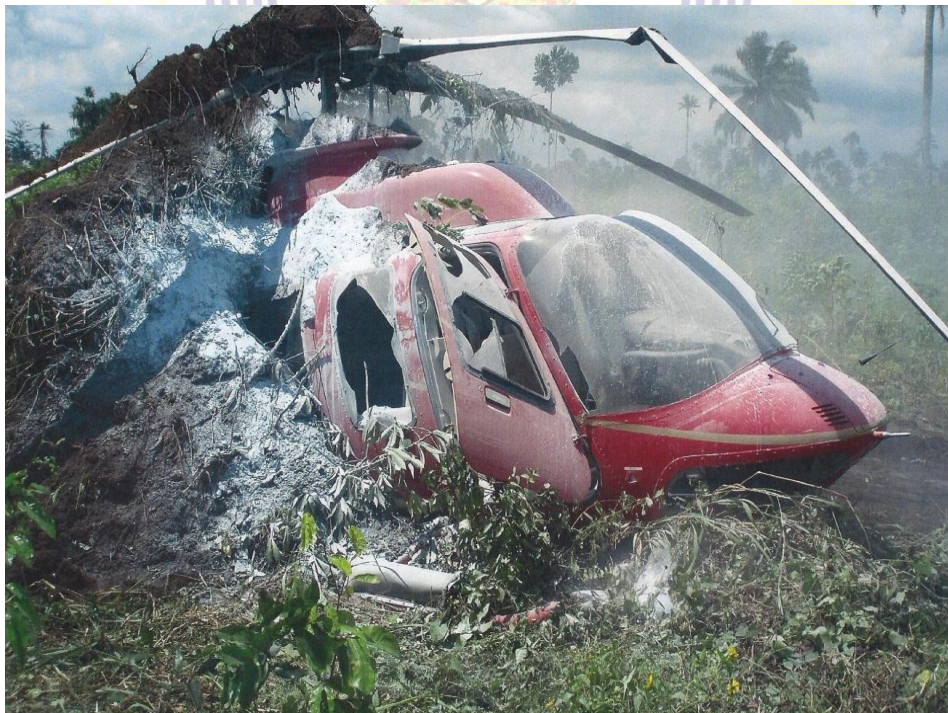
The helicopter crashed short of Gitto helipad at Uyo. The crash site is a flat land covered by corn stalks and surrounded by palm trees. However, the main wreckage was largely in one piece with the engine severely burnt.

**Figure 2:** Section of the burnt aircraft wreckage

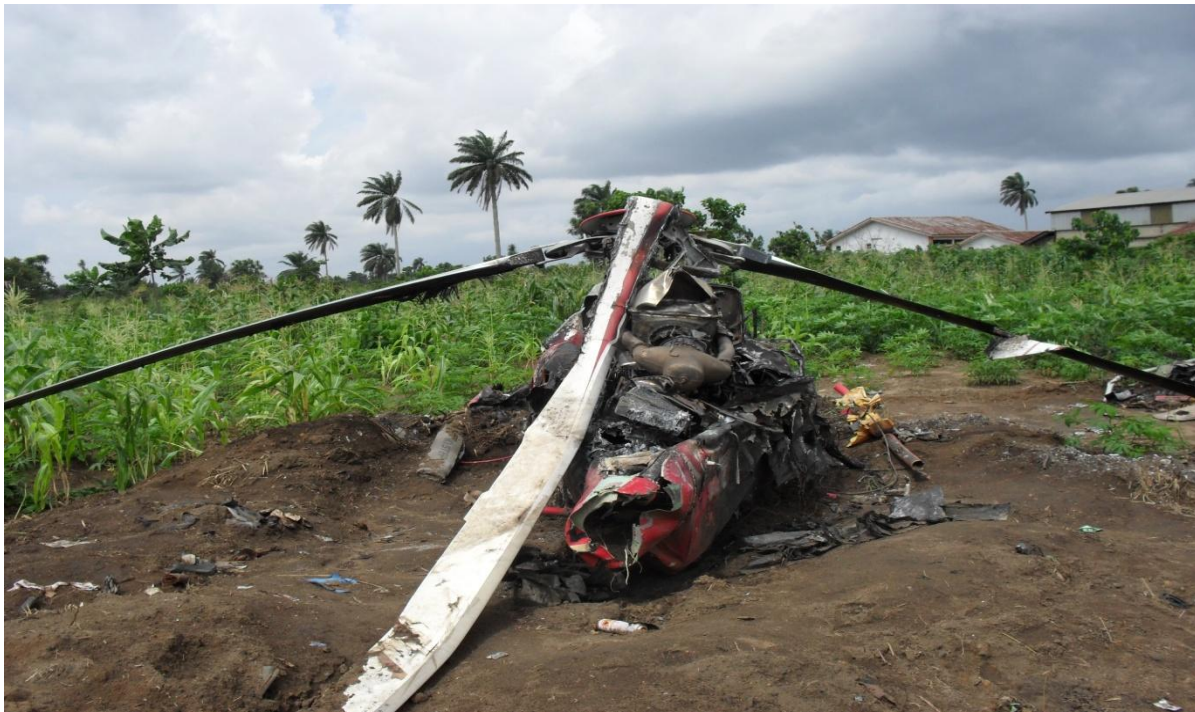
The tail rotor drive shaft, tail boom and tail rotor gear box were found about 10 meters away from the main wreckage.

**Figure 3:** Picture showing the rear view of main wreckage of 5N-BIC after the crash

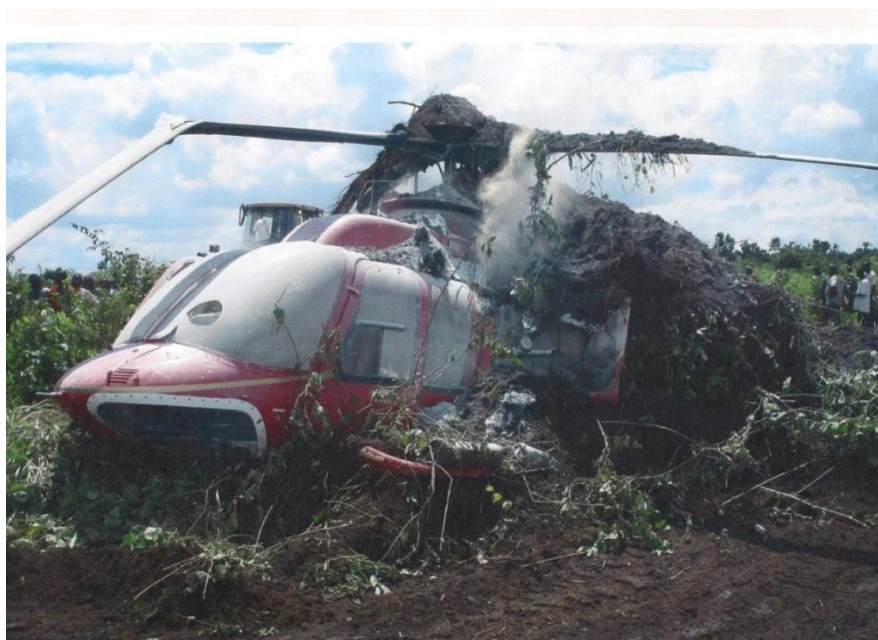
The wreckage was heavily contaminated with sand which was used to fight the fire as the available fire extinguishers were not adequate.

**Figure 4:** Picture showing heaps of sand that was used to extinguish the fire on 5N-BIC accident at Uyo Aerodrome

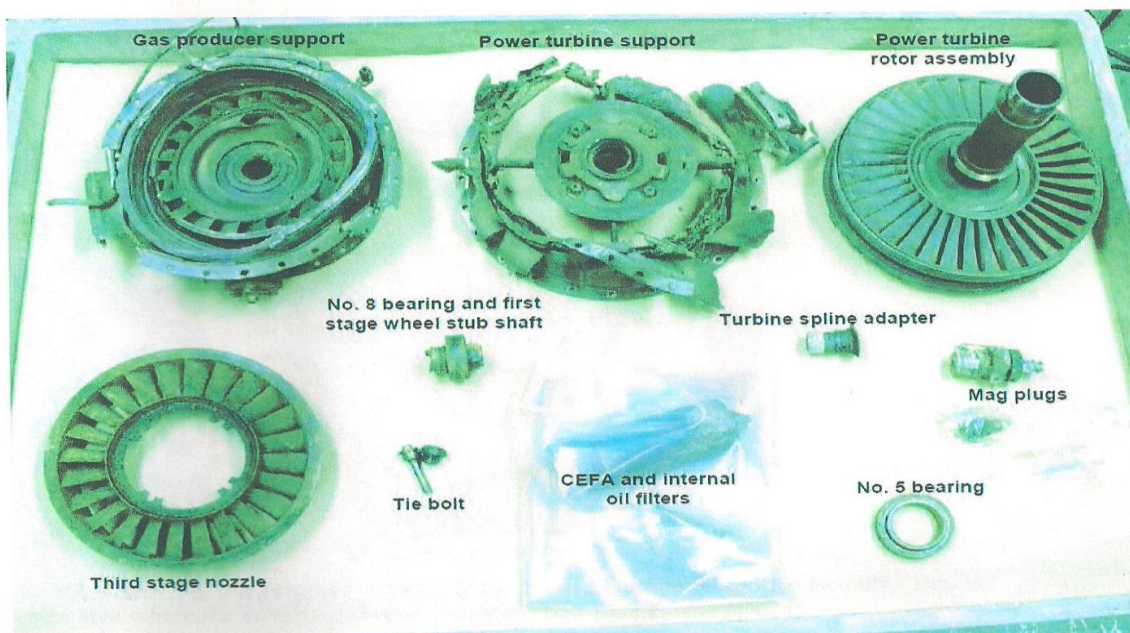
### Appendix I: Conditions of hardware as submitted for failure analyses

Figure 1. Photograph showing the as-received condition of hardware submitted for failure analysis.

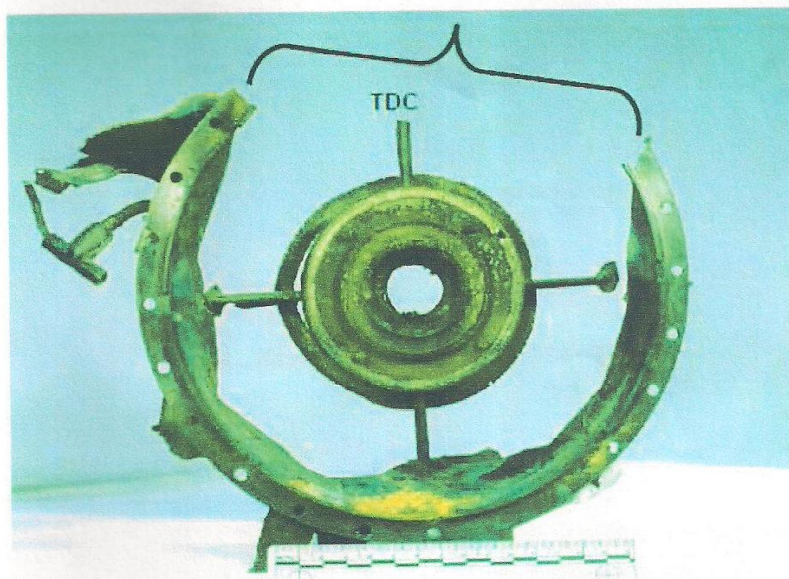
## Appendix II: Showing the general condition of power support assembly

The general condition of the Power Turbine Support Assembly is shown in Figure 2. The aft bolt flange portion of the power turbine support assembly exhibited metal which appeared to have peeled outward. This damage was consistent with damage caused by high energy fragments exiting the engine. However, the fact that the major part of this damage appears to be concentrated in one arc sector of the structure is not consistent with a classic wheel burst, which typically exhibits a three-lobed damage pattern. Approximately 80 degrees of the support circumference was absent from the top portion of the support, including the outboard portion of the oil inlet strut and the Power Turbine Pressure Oil Nozzle, which supplies oil to the No. 6 and No. 7 Bearings. The oil scavenge strut at the bottom of the assembly was sectioned and no blockage was detected. A section through the power turbine support close to the scavenge strut revealed blockage of the scavenge hole leading to the strut area. The material in this scavenge hole was analyzed using semi-quantitative x-ray energy dispersive analysis (XEDA) which determined that the material contained elements consistent with AMS 5383 (Inconel 718), and AMS 6490 (M-50), which is consistent with the engineering requirements for the Power Turbine Support Assembly and No. 6 Bearing, respectively. It could not be determined if this blockage was present before the event or occurred as a result of the event.

Figure 2. View showing the general condition of the Power Turbine Support Assembly. Bracket indicates an area where the entire outer case, including bolt flange, was missing.

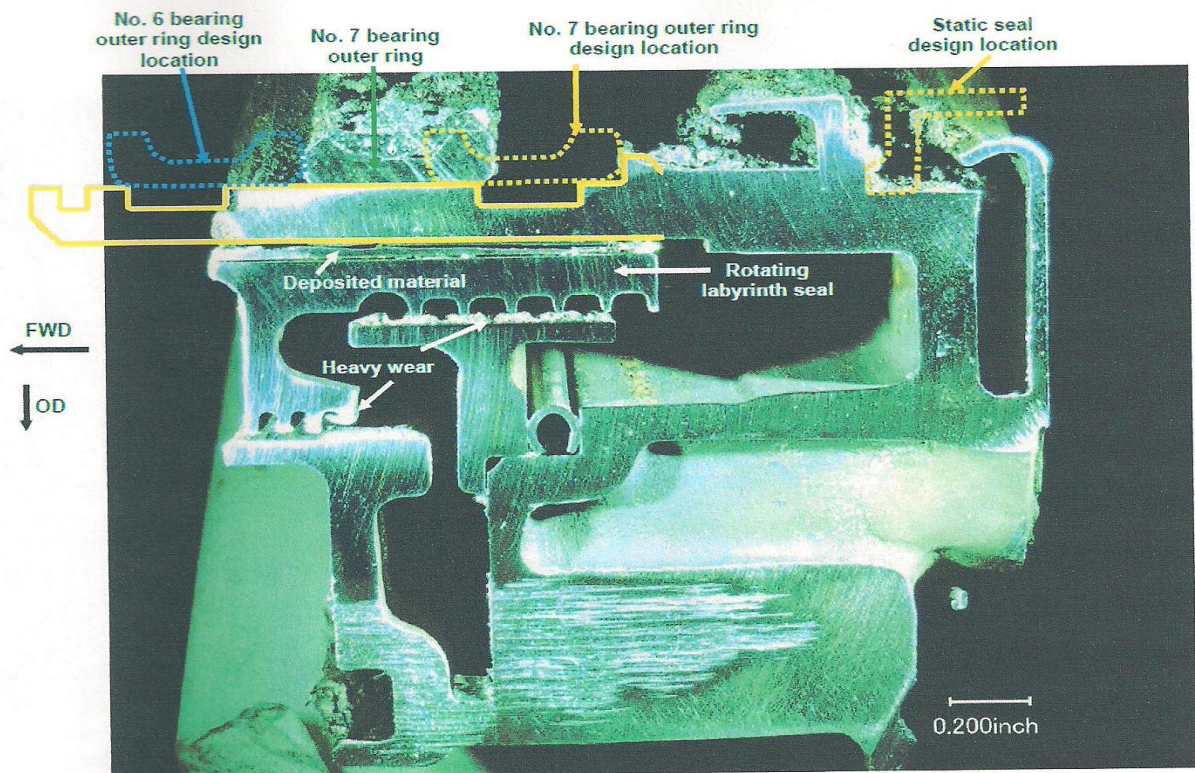
**Appendix III:** Showing the cross section through the power turbine support

A cross-section through the sump area, shown in Figure 3, revealed that the No. 6 Bearing was severely damaged and melted and the No. 7 Bearing outer ring was shifted forward from its typical position. The aft portion of the static seal was separated from the sump but still present during the engine disassembly. An axial cross-section through the No. 7 Bearing outer ring and adhered debris was polished for evaluation and is shown in Figure 4. Semi-quantitative XEDA determined that the No. 7 Bearing outer ring, as well as material deposits in the raceway, was an AMS 6491 (M-50) type material which is consistent with the engineering drawing requirements for the bearing outer ring, inner ring and rollers. One additional piece of metal debris adhered to the ring as indicated in Figure 4 was determined to be AMS 6415 (SAE 4340) which is consistent with the engineering drawing requirement for the bearing separator. Incipient melting was observed near the forward shoulder portion of the outer ring. Grain structure appeared heat affected throughout the outer ring as shown in Figure 5.

Figure 3. Detailed view of cross-section through the Power Turbine Support hub area showing that material is missing from the forward side of the sump, including the No. 6 Bearing and separator. The separator was found separate from this sump area during disassembly.

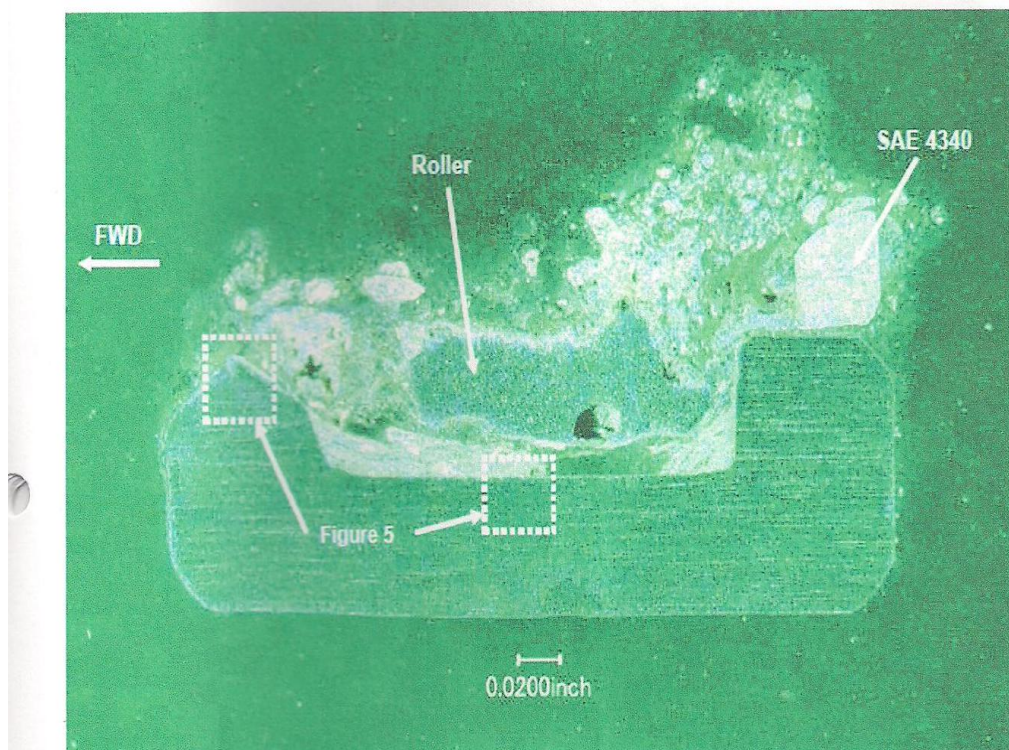
## Appendix V: Cross section of No. 7 bearing

Figure 4. View of metallurgical cross-section through the No. 7 Bearing outer raceway showing debris which was consistent with bearing roller material.

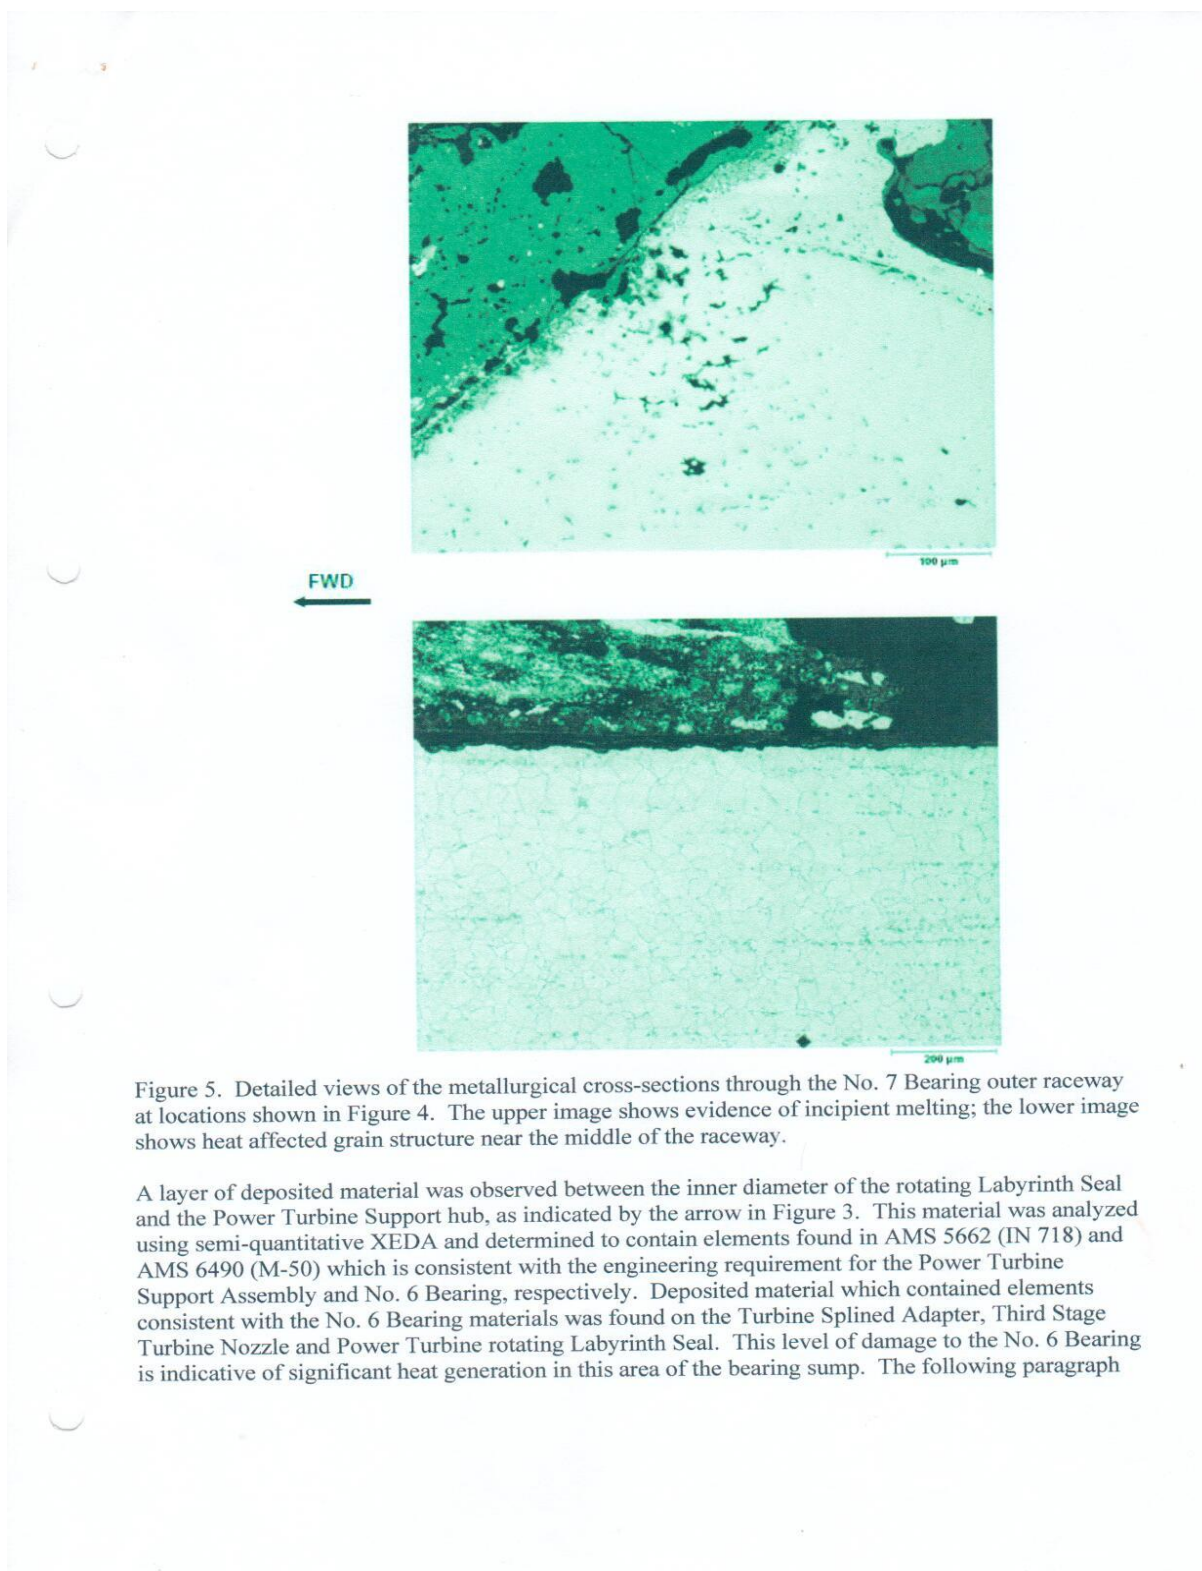
Figure 5. Detailed views of the metallurgical cross-sections through the No. 7 Bearing outer raceway at locations shown in Figure 4. The upper image shows evidence of incipient melting; the lower image shows heat affected grain structure near the middle of the raceway.

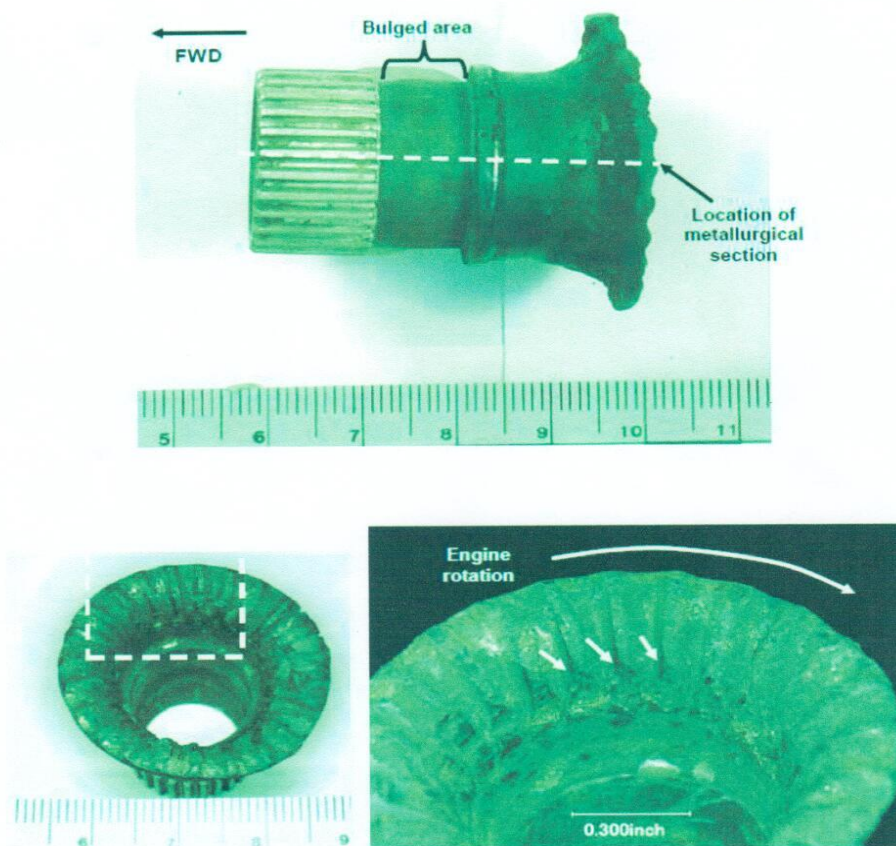
The general condition of the Turbine Splined Adapter in the as-received condition is shown in Figure 6. The internal splines at the aft end of the component were splayed outward and deformed in the direction of engine rotation. The Turbine Splined Adapter showed evidence of smearing on the aft internal splines consistent with damage generated as the adapter began to splay outward and decouple from the splines on the Second Stage Turbine Wheel stub shaft. The component was bulged outward between the forward splines and flange as shown in Figure 7. The forward spline portion of the component was unremarkable, which is consistent with evidence on disassembly that the spline joint with the Turbine to Compressor Coupling remained intact.

Figure 6. Views showing the general condition of the Turbine Splined Adapter. The lower images are detailed views of the component, aft looking forward. The small arrows indicated locations of smearing in the direction of rotation during decoupling from the second stage turbine wheel.

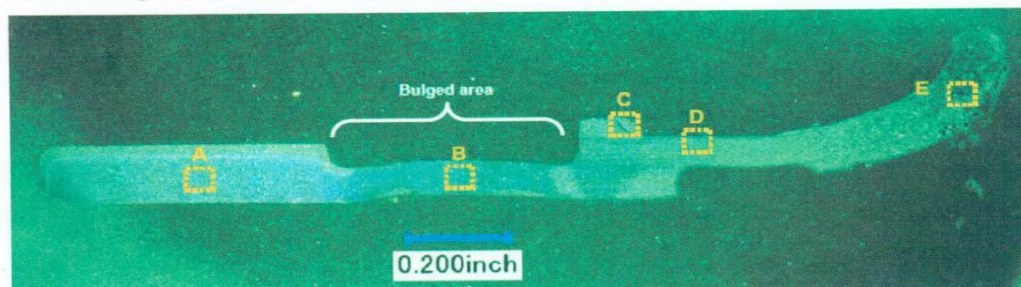
An axial cross-section was taken along the Turbine Splined Adapter at the location indicated in the upper image of Figure 6. This cross-section, shown in Figure 7, was polished and etched for metallurgical evaluation revealing thermal distress along the entire length of the component. The microstructure at locations B through E was consistent with thermal distress. Deposited material on the component at location C was analyzed using semi-quantitative XEDA and determined to contain elements found in AMS 6490 (M-50) which is consistent with the engineering requirement for the No. 6 Bearing. In cross-section, the Turbine Splined Adapter measured 2.1 inches long which is greater than the engineering drawing requirement of 1.9 inches, indicating a significant amount of plastic deformation. Semi-quantitative XEDA determined that the Turbine Splined Adapter was an AMS 6470 (135 Mod) type material as required by the engineering drawing.

Figure 7. View of metallurgical cross-section through the Turbine Splined Adapter showing microstructural condition.

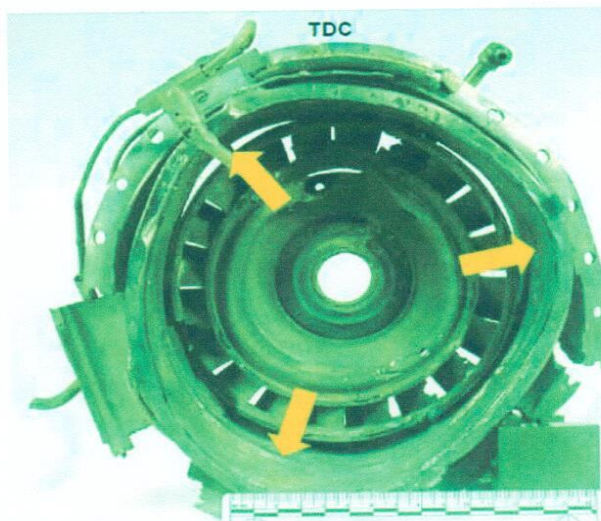
The general condition of the Gas Producer Turbine Support assembly and First Stage Turbine Nozzle is shown in Figure 8. The internal Energy Absorbing Ring was plastically deformed with three areas of significant deformation as shown by the arrows in Figure 8. The forward portion of the support assembly exhibited areas of metal which appeared to have peeled outward. This three-lobed damage is consistent with damage caused by a First Stage Turbine Wheel burst. Damage to the First Stage Turbine Nozzle Assembly was consistent with secondary damage generated by impact from First Stage Turbine Wheel fragments. The Second Stage Turbine Nozzle was not included with the engine when it was received at Rolls-Royce.

Figure 8. Forward looking aft view showing general condition of the Gas Producer Turbine Support assembly. Arrows indicate areas of the most deformation in a three-lobed pattern indicative of First Stage Turbine Wheel burst.

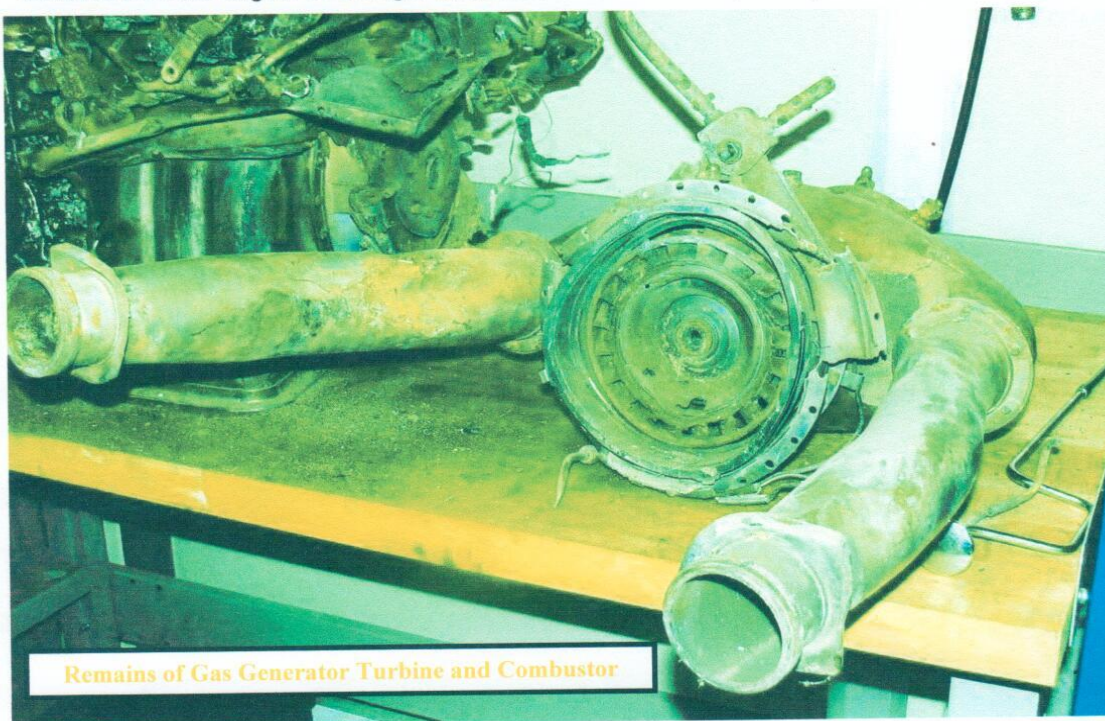
Remains of Gas Generator Turbine and Combustor

The combustor outer case and inner liner were removed and examined. Both were contaminated by sand and corrosion. The liner exhibited no evidence of streaking or abnormal combustion. All damage to the outer case is attributable to either the turbine disc burst or crash damage.

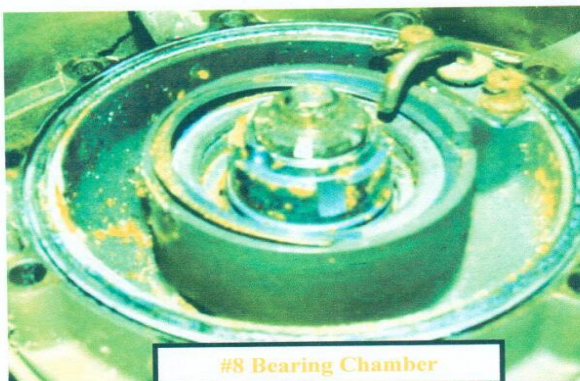
#8 Bearing Chamber

The #8 bearing chamber exhibited patches of corrosion throughout. The #8 bearing retainer snap ring had partially dislodged. No oil residue was present in the bearing chamber. The #8 bearing was removed and found to be dry, corroded and exhibiting operational damage. Although corroded, the #8 bearing oil jet was properly secured and was confirmed to flow a normal stream when flow checked with alcohol. The bearing and associated hardware was retained for detailed examination by the failure analysis laboratory.

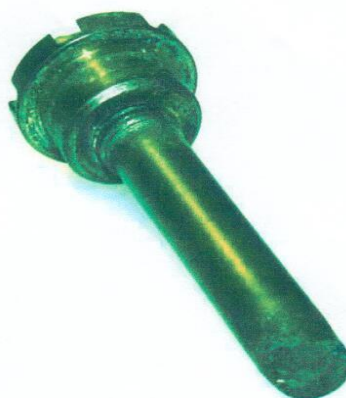
Aft End of Turbine Tie Bolt

The aft end of the fractured turbine tie bolt was located in its normal position, within the 1<sup>st</sup> stage turbine stub shaft. The tie bolt nut appeared to be in good condition, and examination of the threads revealed no evidence that the nut had loosened during operation. The fracture surface on the stub shaft was smeared, and the shaft itself was slightly deformed. The tie bolt section was retained for detailed examination by the failure analysis laboratory.

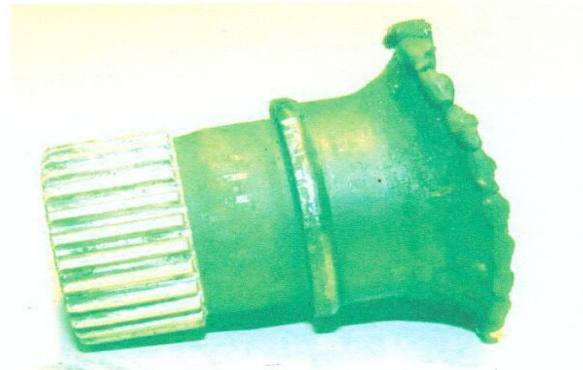
Turbine Splined Adapter

The turbine splined adapter was spread radially (bell-mouthed) on the aft end and bulged in the middle. Witness marks on the aft internal splines are consistent with turbine rotation as the splined adapter became excessively hot and subsequently opened up under centrifugal load. The opening up of the aft end of the splined adapter would allow the gas generator turbine to disengage from the compressor.

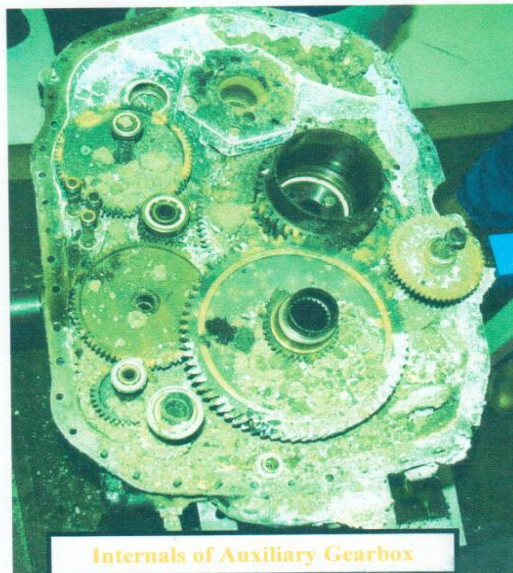
Internals of Auxiliary Gearbox

When the gearbox was opened, revealing the interior of the gearbox, all major components were found in the correct locations. There was no evidence of operational failure or malfunction of the gearbox. The gearbox was mostly dry, although small traces of oil trickled from several undetermined locations.

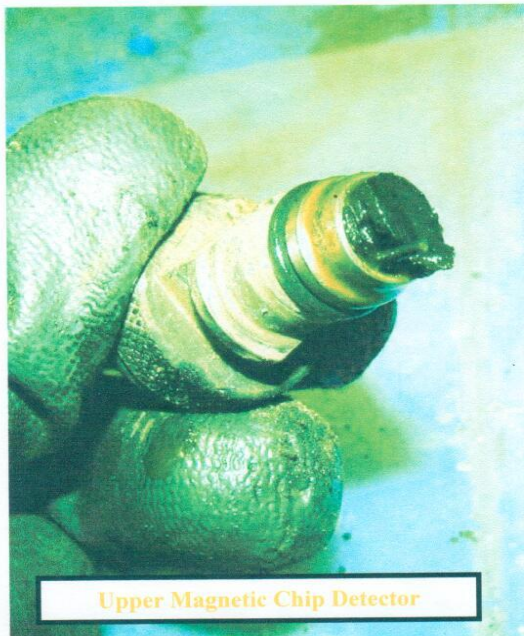
Upper Magnetic Chip Detector

The upper and lower magnetic chip detectors were removed and inspected. Both had captured a small amount of ferrous debris. The upper magnetic chip detector had captured what appeared to be a bearing roller pin. Both detectors and their debris were retained for examination by the failure analysis laboratory.

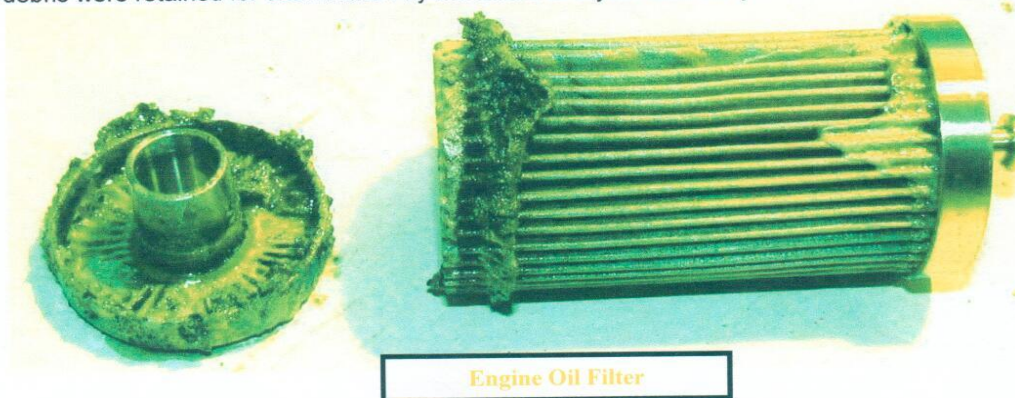
Engine Oil Filter

The engine's internal oil filter was removed and examined. The filter chamber contained both oil and water. The filter was contaminated with organic matter and metallic debris. The filter and its debris were retained for examination by the failure analysis laboratory.

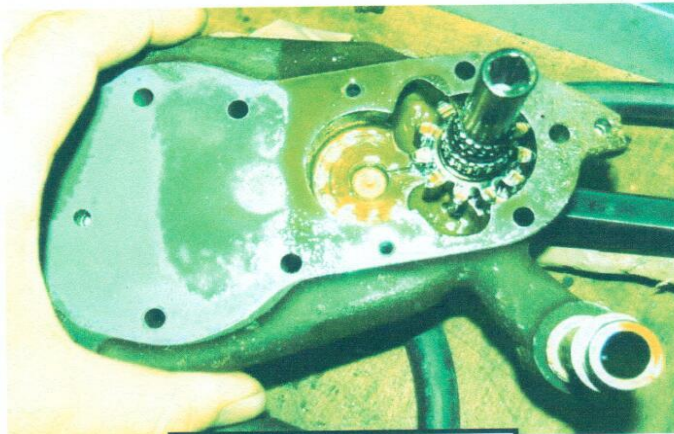
Engine Oil Pump

The engine oil pump was then disassembled. When opened, the interior of the pump was oil-wetted. All gear-rotors were intact and appeared undamaged. The oil pump drive shaft was intact and could be rotated easily by hand. A small amount of metallic debris was present within the pump, and the pump exhibited evidence of having operated with contaminated oil, with light gouging being noted along the rotational paths of the gear-rotors. There was no evidence of operational failure or malfunction of the pump.
