AIRCRAFT ACCIDENT REPORT

IAC/2014/08/18/F

Accident Investigation Bureau

**Report on the Serious Incident involving International
Aviation College (IAC) Diamond DA42 Aircraft with
registration 5N-BNH, on Runway 23 of Ilorin
International Airport, which occurred on 18th August,
2014**

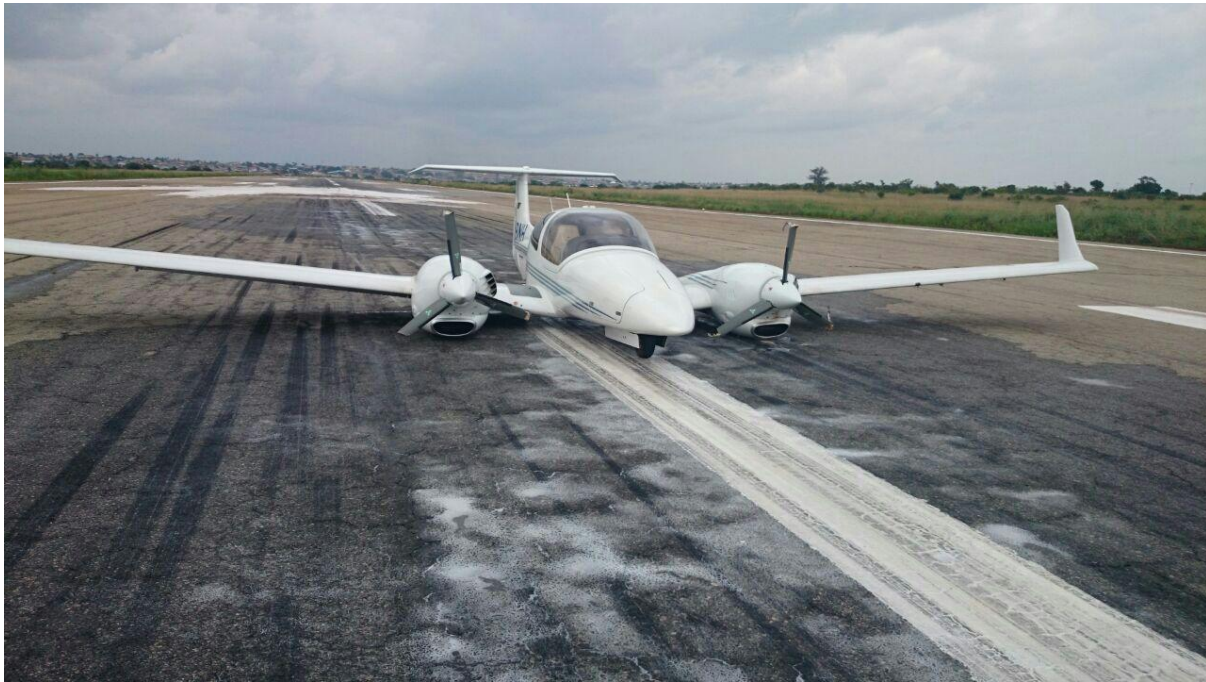
All the propeller blades on both engines were damaged, the left and right engine exhaust pipes were abraded, the left and right side steps were damaged, the left and

right engine nacelles were scratched and there were a few faint propeller strike marks on the runway but there was no fire outbreak.

Figure 1: Photograph showing the aircraft at its final resting point on Runway 23 after belly-landing

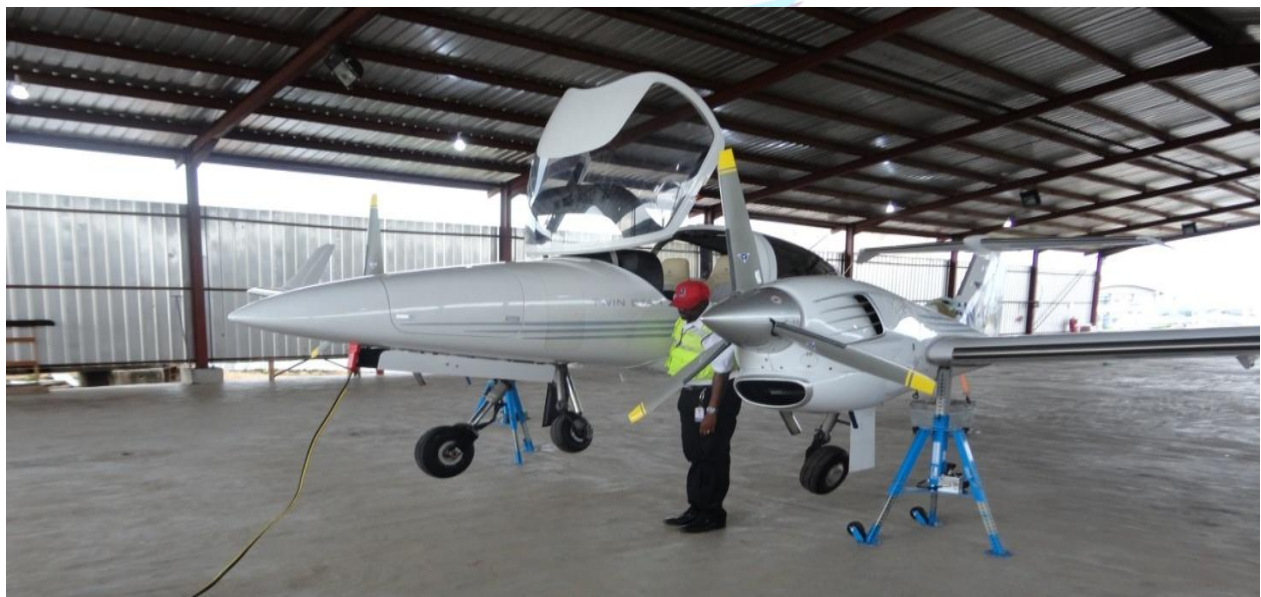
When the landing gear lever was put down, the Nose Landing Gear and Left Main Landing Gears extended but the Right Main Landing Gear did not. The left and nose landing gears fully extended and locked down, with their green lights ON, the unsafe light was still ON but the right hand main landing gear was still stuck UP.

Figure 2: Photograph showing extension and retraction test being conducted at IAC Hangar Facility

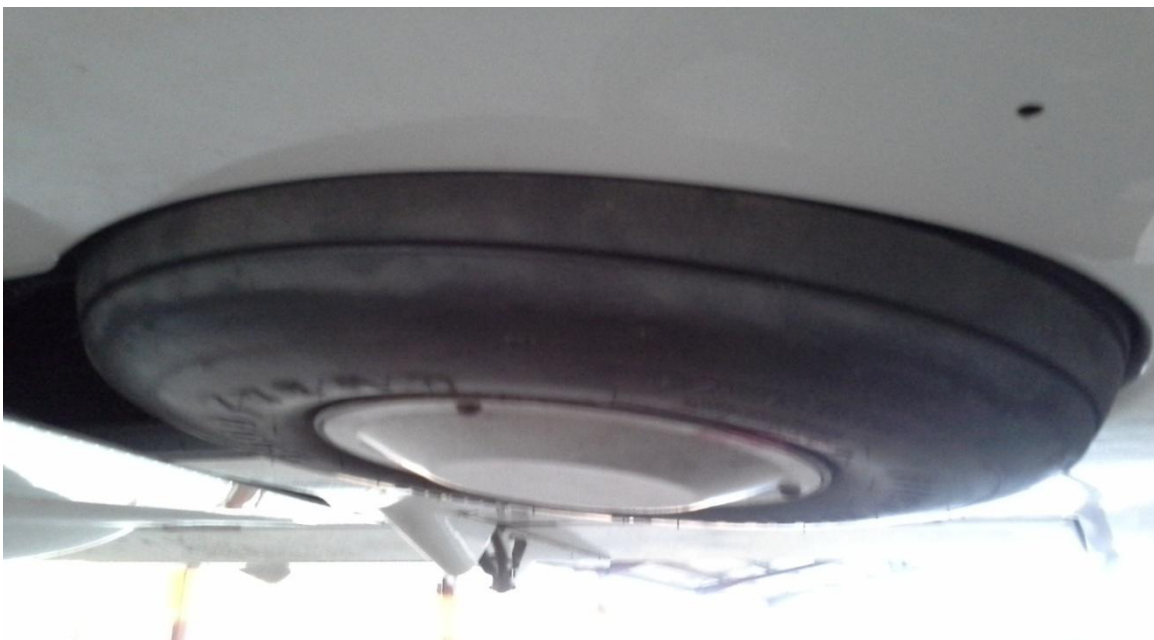
A minimum clearance of 4mm (0.16in.) between the MLG tyre and the lower wing shell/wheel bay cut-out is required for normal operations of the landing gear system, as contained in AMM Section 32-10.

Figure 3: Photograph showing the right main landing gear tyre stuck in the wheel well during extension and retraction test

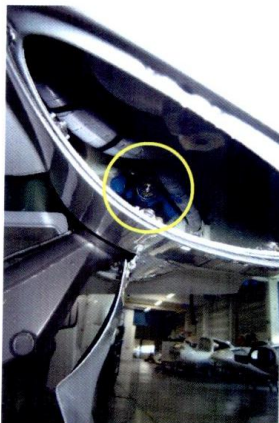
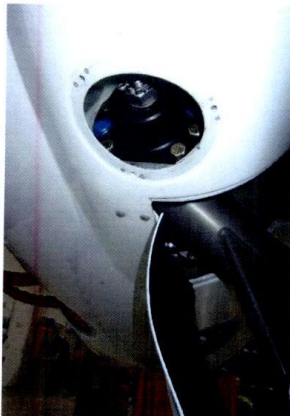
During standard maintenance on aircraft operated mainly in coastal areas several Main Landing Gear Bearing Housing have been found with cracks initiating from corrosion on the surface between the attachment bolts and the housing. This service bulletin is issued to draw the attention to that area and prescribes an inspection of the Main Landing Gear Bearing Housing. If there are cracks in the housings, the housings must be replaced by an improved design.

<div style="border: 1px solid black; padding: 2px; display: inline-block;">CRACK</div> </div>

5)	If cracks are found, replace the MLG bearing housing in accordance with Section III.2. If no cracks are found proceed with step 6.
6)	Install Maintenance Cap 2 LH and RH. Refer to AMM section 52-40.
7)	Install Fuel Filter Cap RH and LH. Refer to AMM section 52-40.
8)	If Replacement per section III.2 was carried out, perform operation test of the landing gear. Refer to AMM section 32-30.
9)	Lower the airplane and remove the wing and rear fuselage trestles.
10)	Set the GEAR, GEAR WRN / ELEV. LIMIT and STALL WRN circuit-breaker.
11)	Clean working areas, check for foreign objects.
12)	Check all altered, replaced, repaired parts for proper function.
13)	Test all systems in working area for function.
14)	Make all necessary entries in the airplane logs.
