AIRCRAFT ACCIDENT REPORT

IAC/2013/11/25/F

Accident Investigation Bureau

**Report on the Accident involving a Diamond DA40D
Aircraft operated by International Aviation College
(IAC) Ilorin with Nationality and Registration Marks
5N-BRD which occurred at Ilorin International Airport,
Ilorin, Kwara State, Nigeria
On 25th November, 2013**

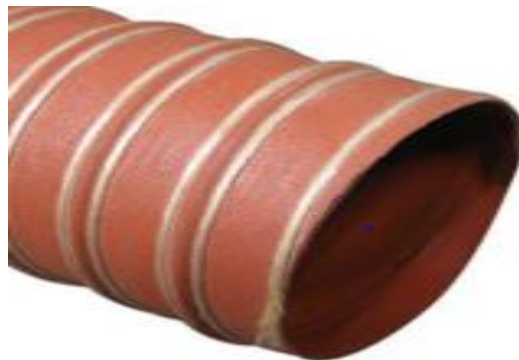
Figure 1: The suitable quality Turbocharger hose (MSB D4-088)

2 strings (one close to each side of the wire) and a maximum bonding area between each winding.

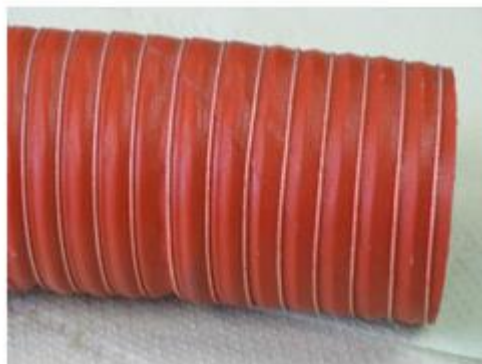
Figure 2: Other quality (NOT suitable according to MSB D4-088)

However, during the post-crash examination by the Bureau, it was found that the Turbocharger Inlet hose installed on the aircraft was not of the suitable quality as specified by the AD. **See Appendix A & Appendix D** and Figures 1 and 2.

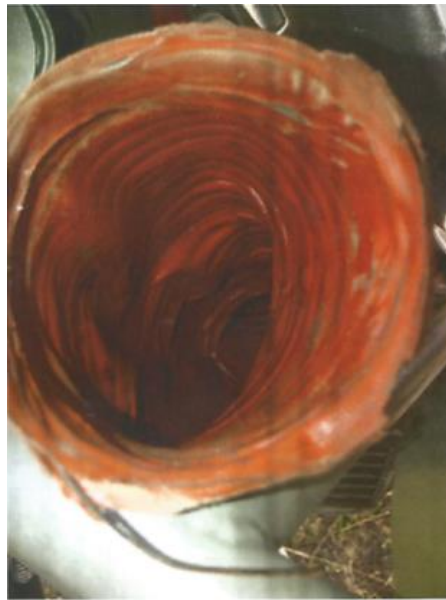
Figure 3: Delaminated turbocharger hose found installed on 5N-BRD

Also, the post-crash examination found that the inner layer of the Turbocharger Air Intake Hose had delaminated from the outer layer and collapsed, restricting air flow into the engine manifold.

In view of the above, the investigation revealed that the engine failure caused by the lack of adequate airflow through the delaminated Turbocharger Inlet Hose into the manifold resulted from the installation of an inappropriate hose. See Figures 1, 3 and 4.

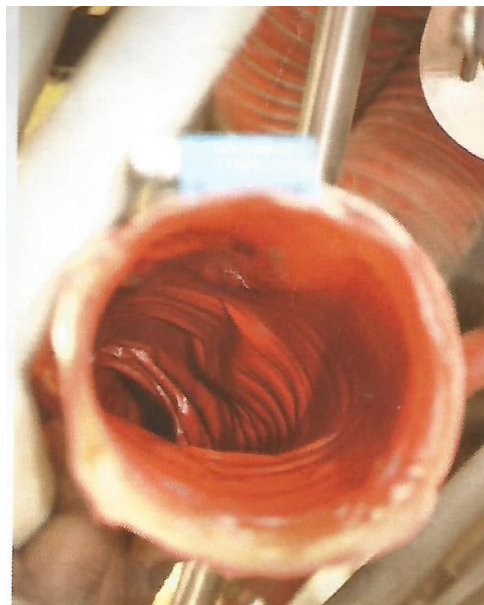
Figure 4: The turbocharger hose found installed on 5N-BRD

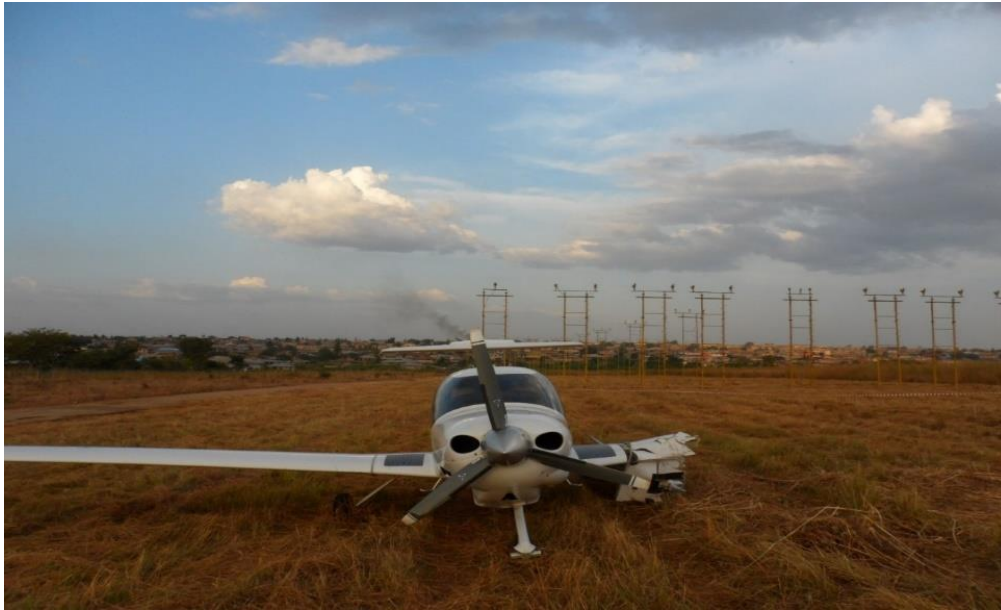
The accident occurred within the airfield's vicinity about 596 m to runway 23 threshold. When the aircraft was turning to land, the left wing impacted shrubs and got damaged. The right wing was intact. One of the propeller blades bent rearward at the tip. The distance between the approach light and the final resting point of the aircraft was 40 m.

Figure 5: Final resting position of the 5N-BRD

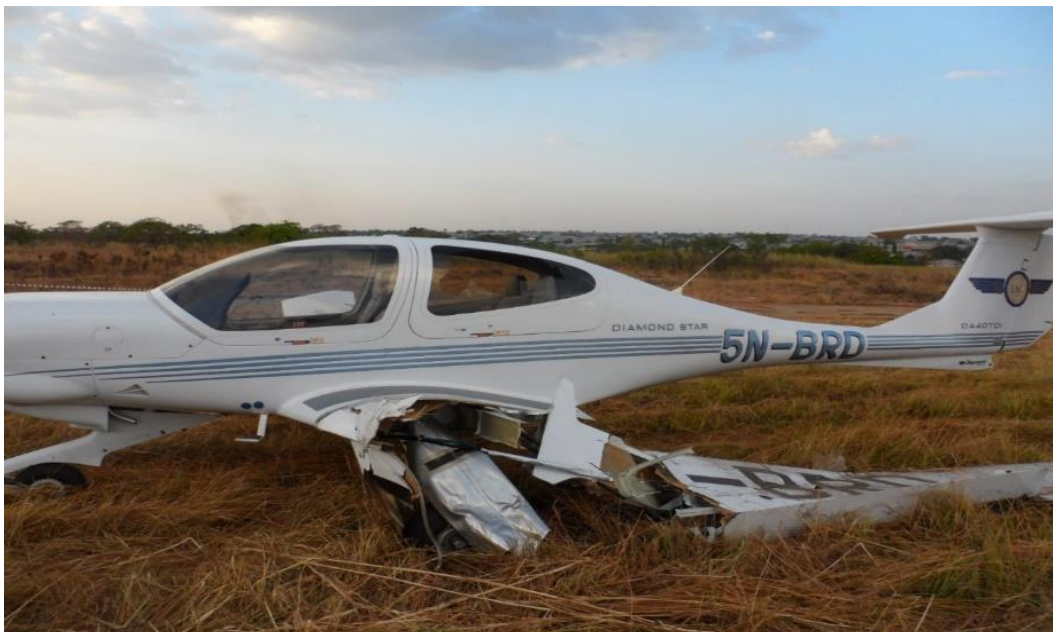
Figure 6: A damaged left wing

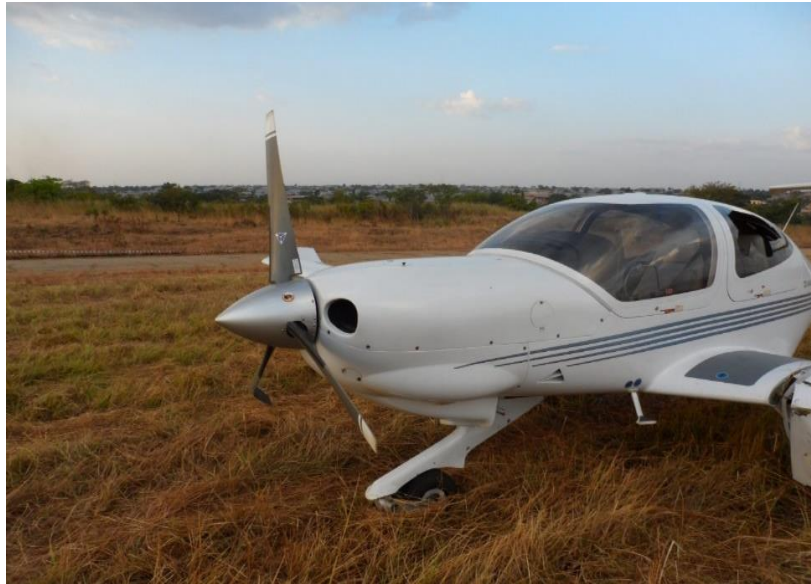
Figure 7: Propeller blade bent rearward
