# AIRCRAFT ACCIDENT REPORT

MWTTSG/2012/10/25/F

**Report on the Accident involving a Cessna 208B  
Caravan with Nationality and Registration Marks  
5N-BMJ belonging to Ministry of Works and  
Transport, Taraba State Government which occurred  
at Kwanan-Waya Village, Yola South Local  
Government Area, Adamawa State  
On 25th October 2012**

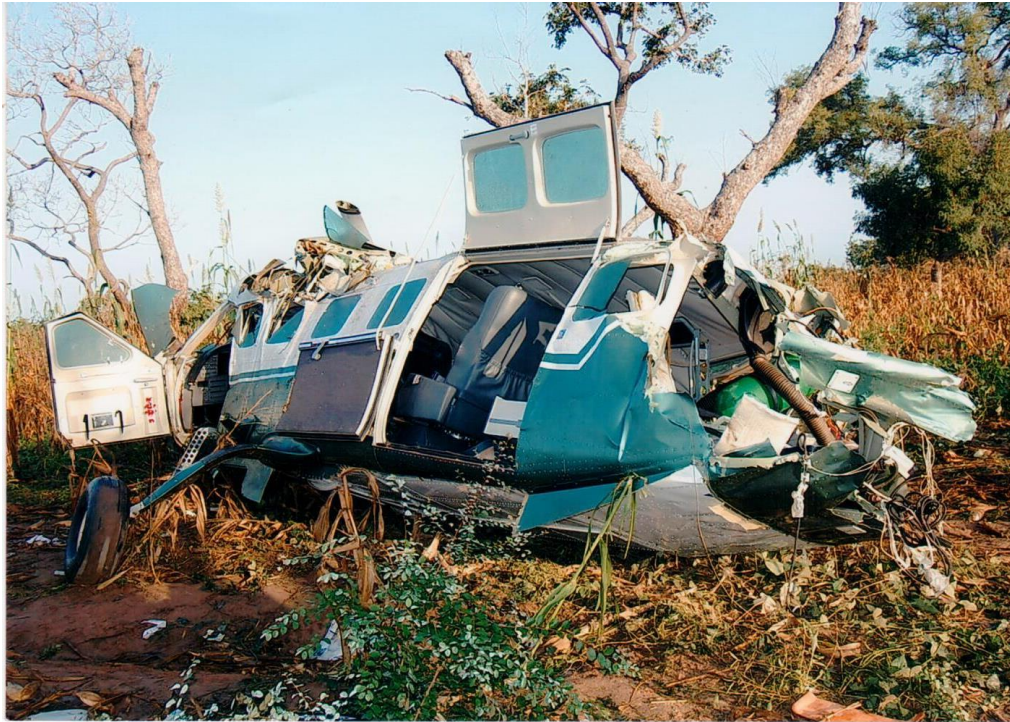
The accident occurred on a farm land about 100 meters from the NNPC Depot, Yola. The first point of contact was on a tall dry tree where the empennage section of the aircraft was detached, the aircraft battery was found 30 meters away from the main wreckage. The Engine and Propeller units were found 10 and 15 meters away respectively from the main wreckage; the fuselage section and the cockpit areas were substantially damaged but found largely in one piece.

**Figure 1:** Photo showing the left side view of the aircraft main wreckage

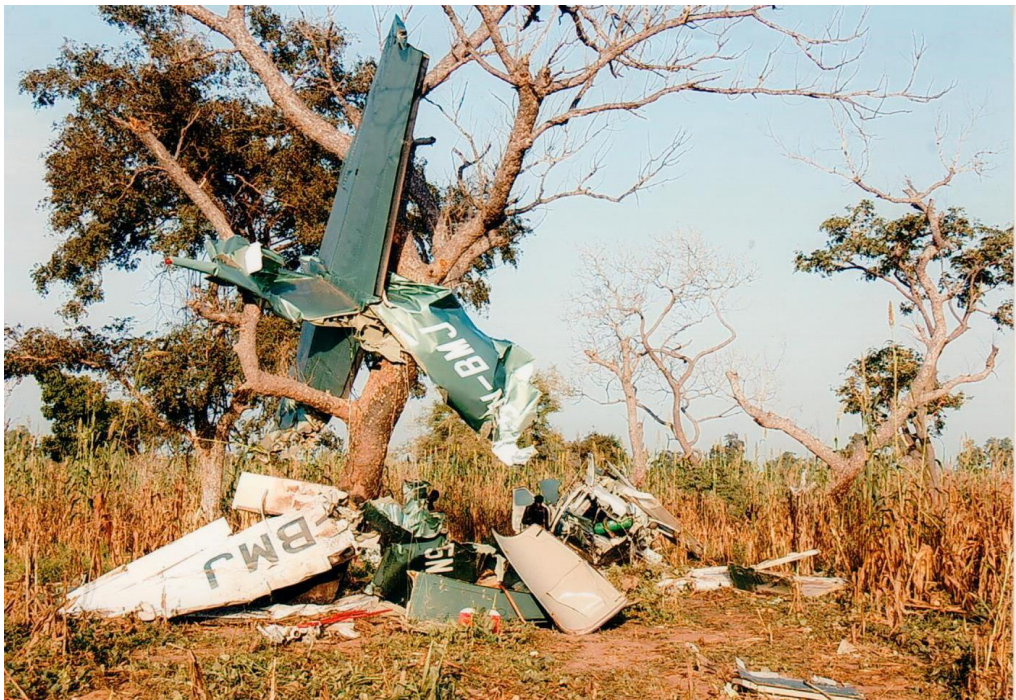
**Figure 2:** Photo showing detached empennage section of the aircraft and destroyed farmland

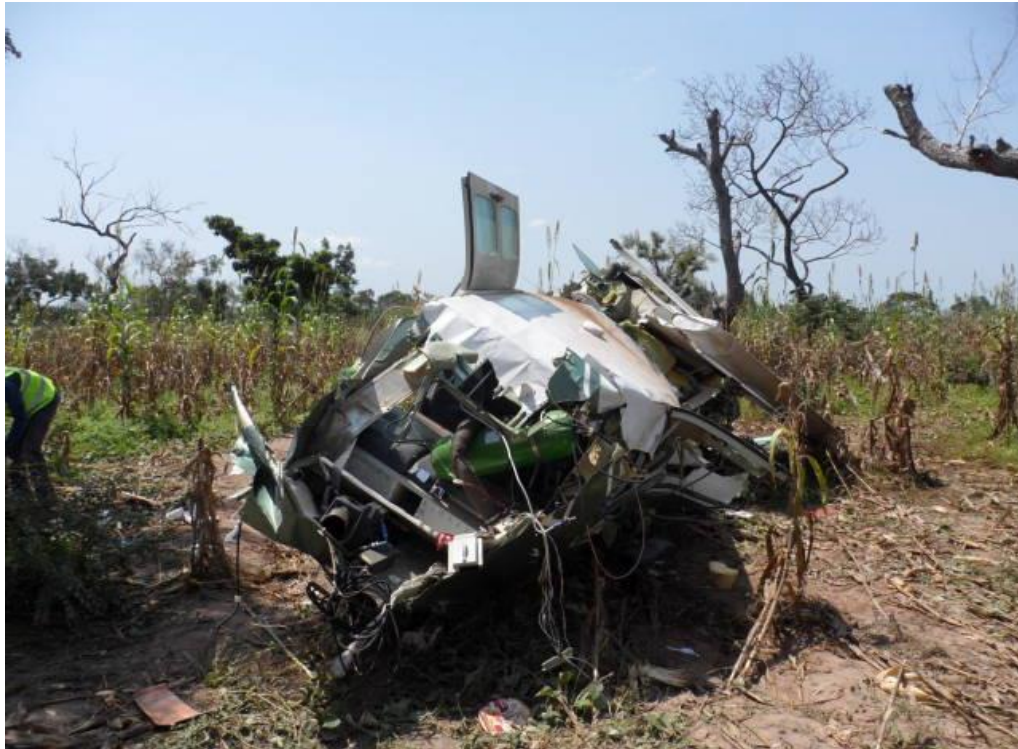
**Figure 3:** Photo showing the front view of the main wreckage

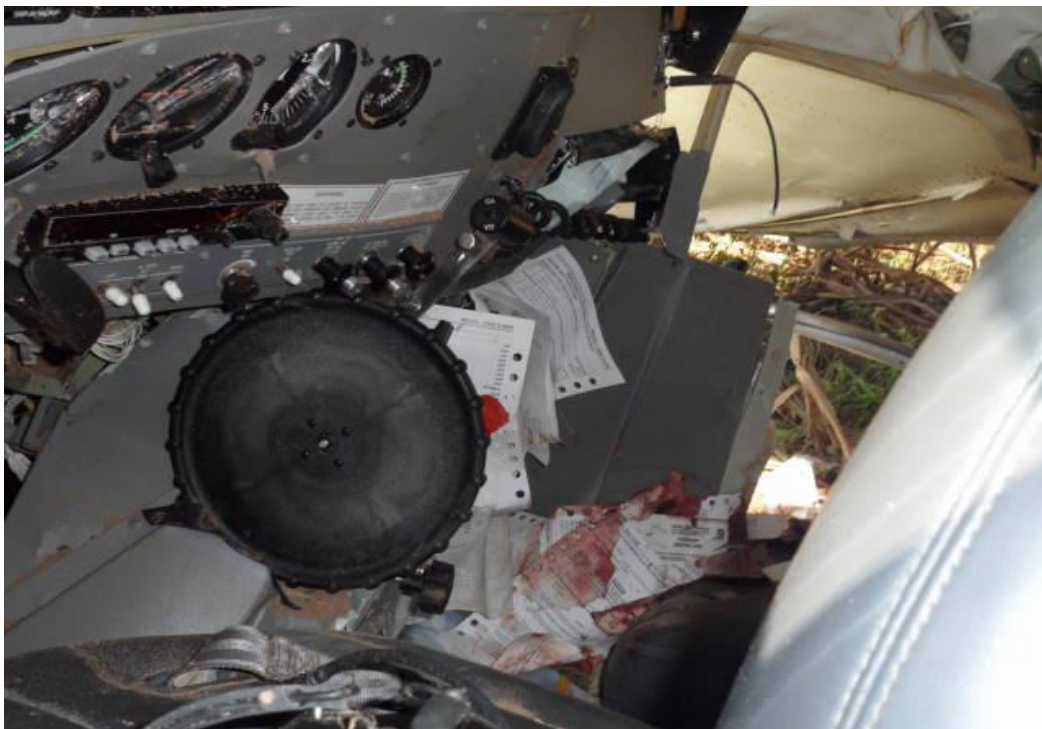
Throttle control position was found at below-idle beta position. The left tank fuel selector was found in ON position while the right tank selector was found in OFF position.

**Figure 4:** Photo showing the cockpit area

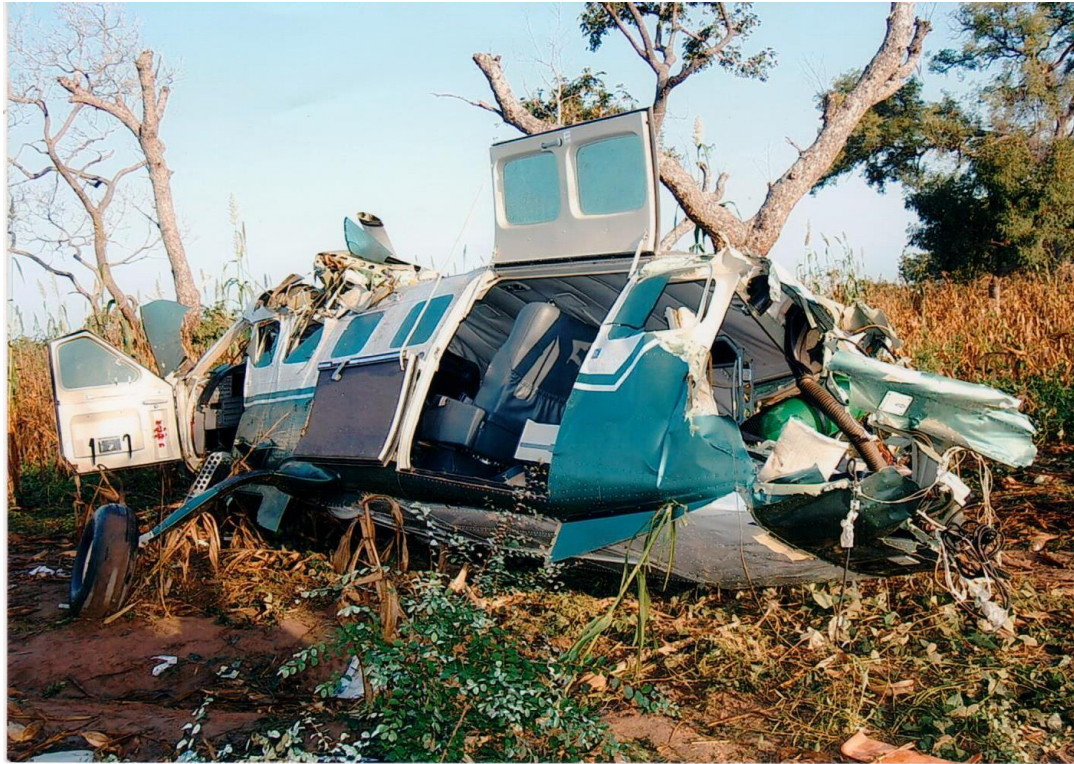
The damage to the cabin area was minimal such that a liveable volume of space existed where the occupants were.

**Figure 5:** Photo showing the condition of aircraft fuselage with a liveable volume of space existing in the cabin

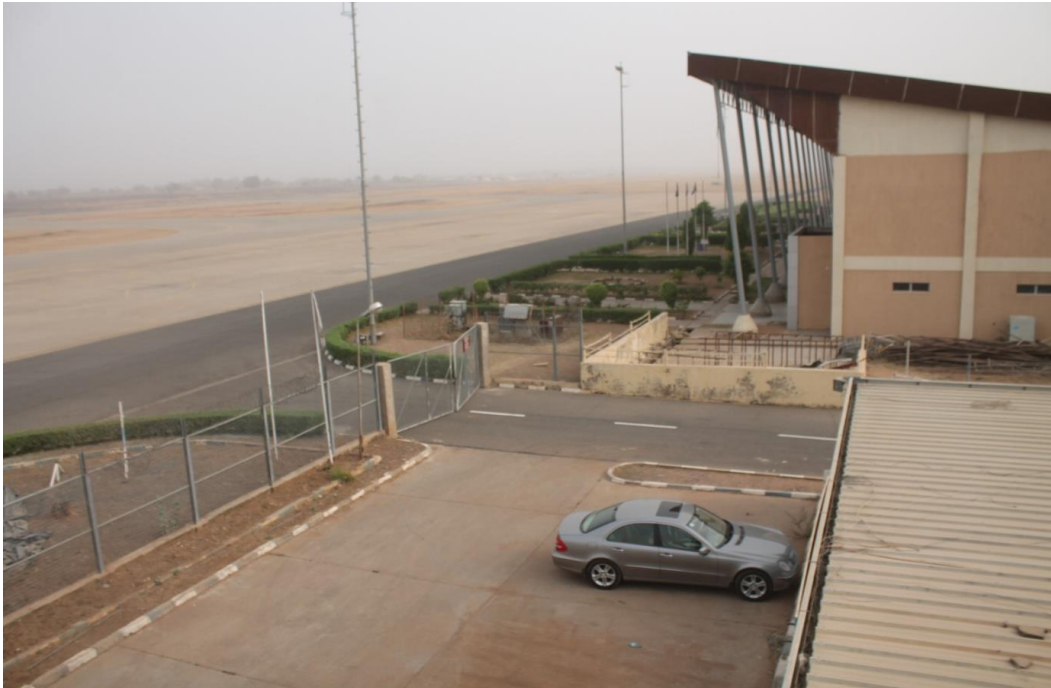
The siting of the new terminal building at the Yola Airport should not have been approved, as the building is adversely affecting safety and also obstructing the view of the approach path of runway 35 from the Tower. See Figure 6.

**Figure 6:** Photo showing the current ATC CT view of the runway

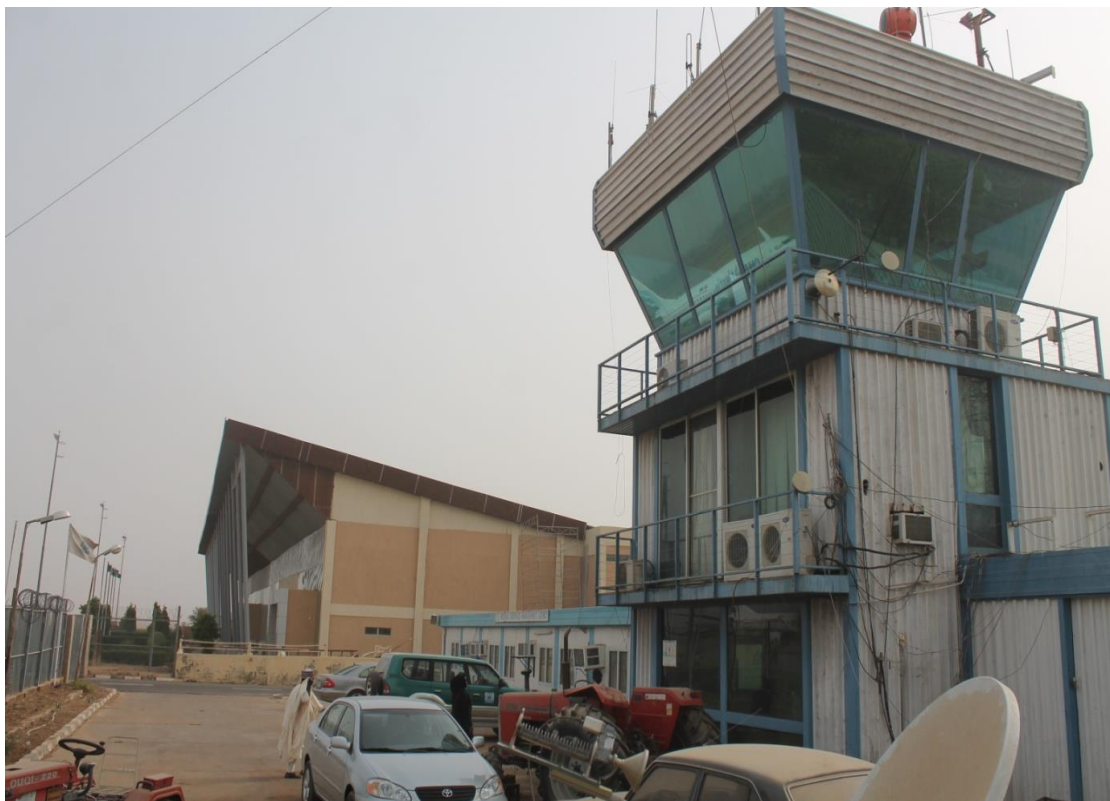
It was also observed that the terminal building under renovation constitutes an obstruction to the view of the approach path of runway 35 from the Control Tower. FAAN, being the custodian of the airport could have advised relevant agencies of the safety implication of siting the building at that location.

**Figure 7:** Photo showing the view from the CT with the renovated terminal building obstructing the view of the approach path of runway 35

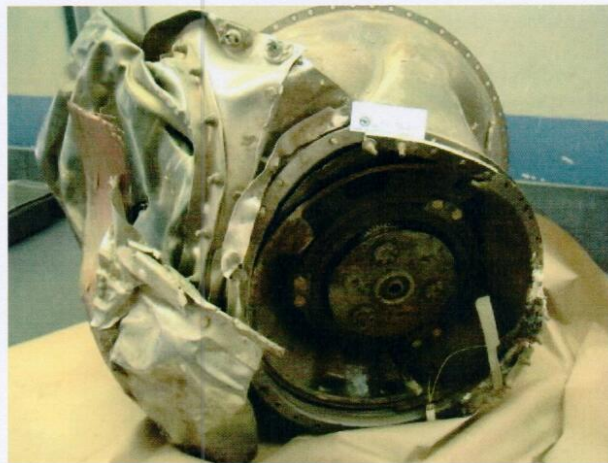
Photo No. 6  
Exhaust case showing rear RGB housing

**Exhaust Duct:** The exhaust duct was crumpled due to impact with the ground and had also separated at the “C” and “D” flanges (Photo Nos. 3, 6 and 7).

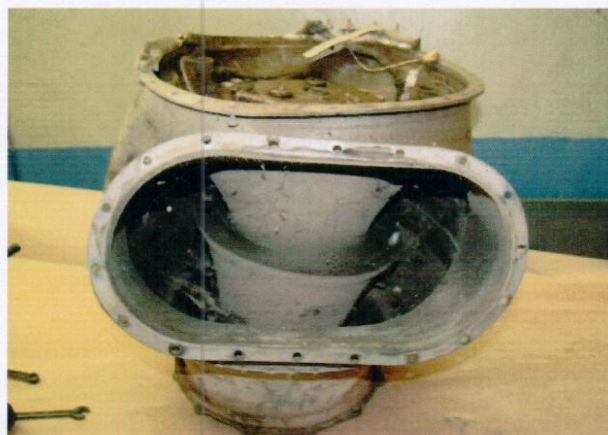
Photo No. 7  
Exhaust duct

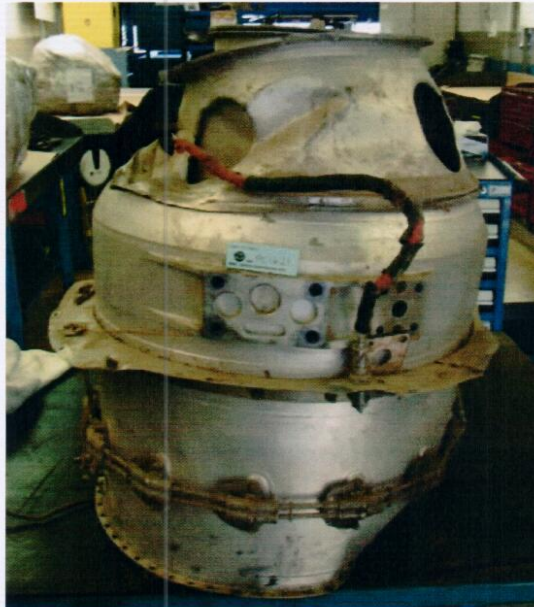
**Gas Generator Case:** The gas generator case showed mechanical damages from impact with the terrain (Photo No. 8). Torsional deformation and mechanical deformation was also observed in the inner support housing (arrows, Photo No. 9).

Photo No. 8  
Gas generator case

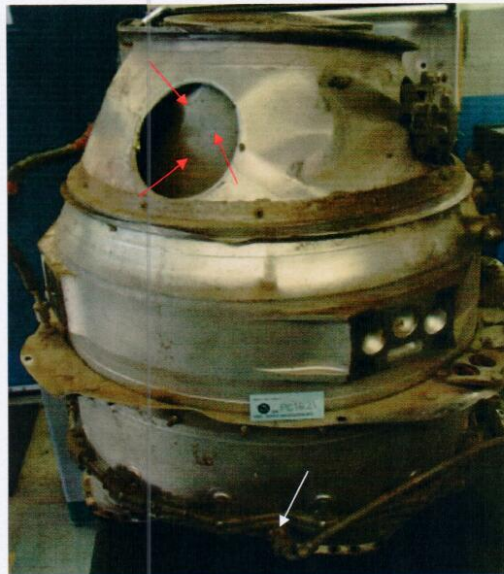
Photo No. 9  
Rotated view of gas generator case

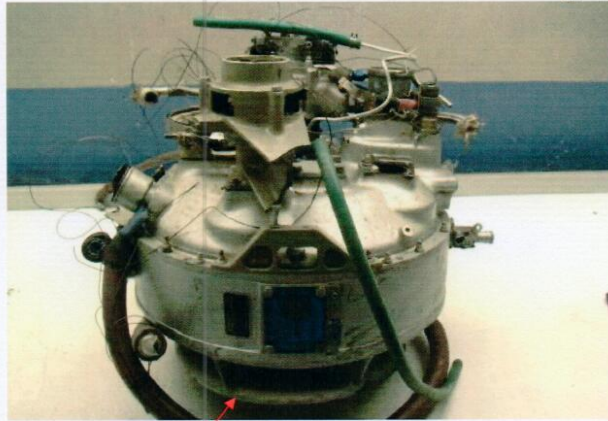
**Accessory Gearbox:** The accessory gearbox was intact and was still attached at flange "G" to the inlet case, which had fractured from the gas generator case at flange "F" (Photo No. 10).

Photo No. 10  
View showing AGB attached to front inlet case which was  
separated from gas generator case at flange "F" (arrow)

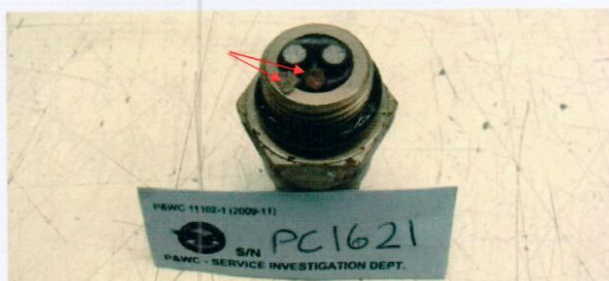
Photo No. 12

**Accessories Gearbox Chip Detector:** Showed no metal debris accumulation, however, mold deposits were observed on the detector surface (arrows, Photo No. 12).

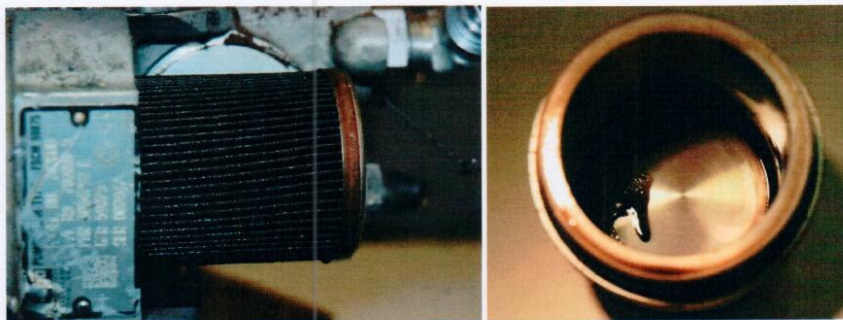
**Fuel Filter:** The outlet filter was dark and there was dark residue in the outlet filter bowl (Photo Nos. 13 and 14). The residue was analyzed by the P&WC Chemical Laboratory and was identified as low-decomposition temperature material such as solvent or fuel, organic material and silicon with traces of aluminum, sodium, iron-oxide and carbon.

Photo No. 13  
Fuel pump outlet filter and filter bowl

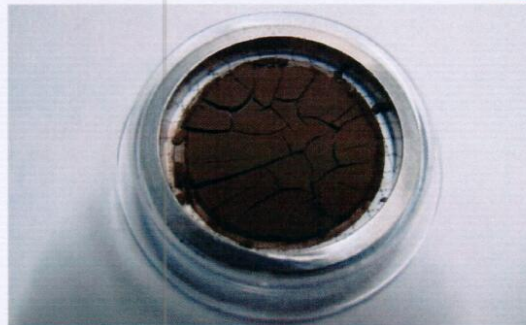
Photo No. 14  
Fuel pump outlet filter residue

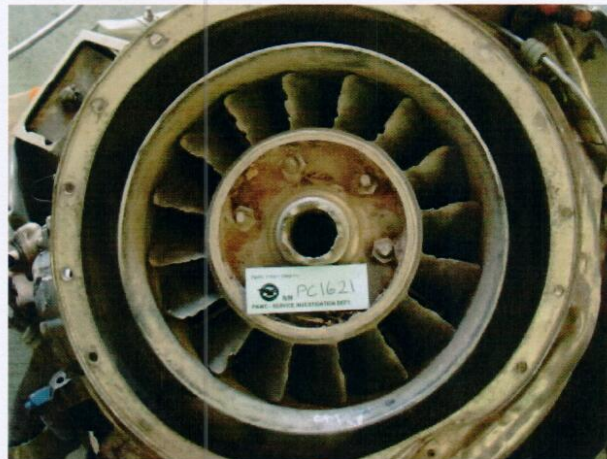
The compressor showed dirt ingestion. The compressor could not be rotated. The first stage compressor rotor blades showed foreign object impact damages and bending of blade tips in the direction opposite the rotation (Photo No. 15). The compressor rear coupling hub was fractured off due to impact. The compressor was not accessed further for the purpose of this investigation.

Photo No. 15  
First stage compressor rotor

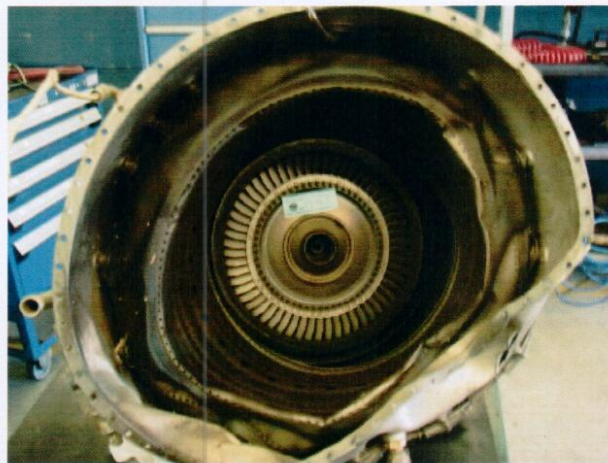
**Combustion Chamber Liner:** The combustion liner was mechanically damaged and as a result could not be removed. No pre-event anomaly was observed with the combustion chamber (Photo No. 16).

Photo No. 16  
Combustion chamber

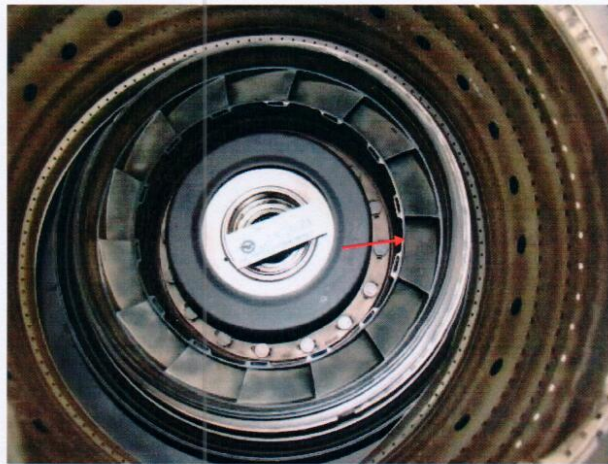
**Compressor Turbine Guide Vane Ring:** The compressor turbine vane ring appeared in good condition with no distress of the vanes (arrow, Photo No. 17). Circumferential rubbing wear was observed on the inner shroud wall from contact with the platform region of the compressor turbine blades.

Photo No. 17  
Compressor turbine vane ring

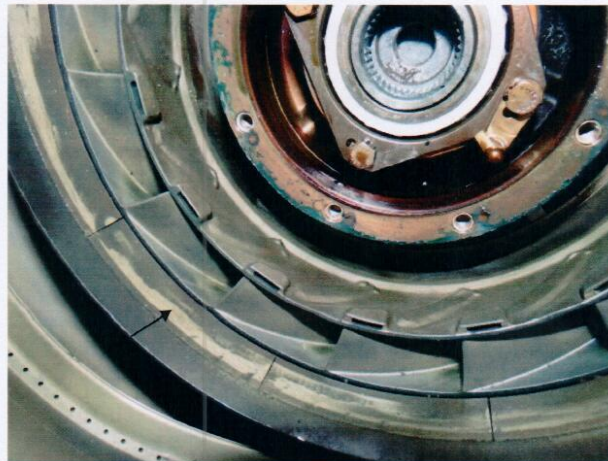
**Compressor Turbine Shroud:** The compressor turbine shroud segments showed circumferential rubbing (arrow, Photo No. 18).

Photo No. 18  
Compressor turbine shroud segments

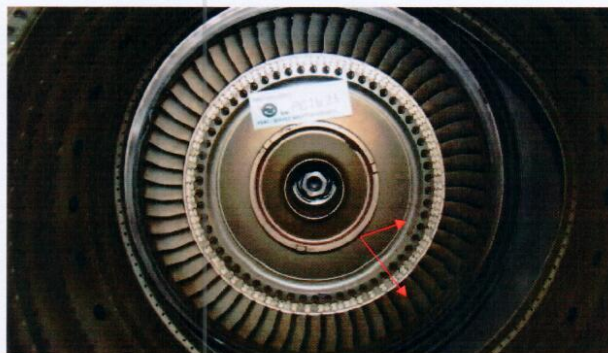
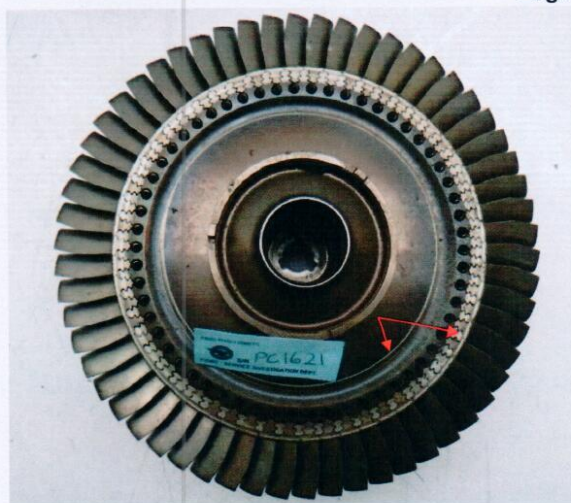
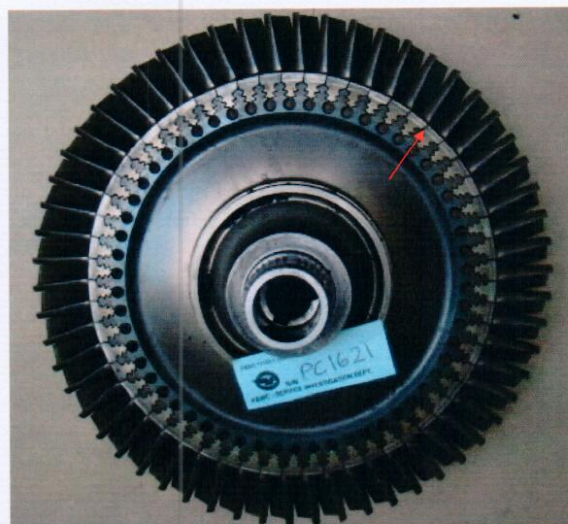
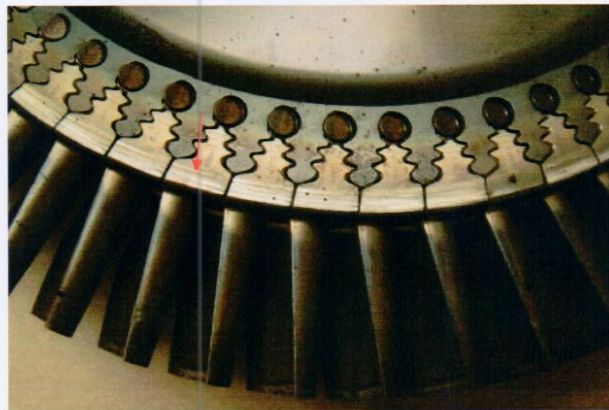
**Compressor Turbine:** The compressor turbine blades showed no distress (Photo No. 19). The downstream side showed circumferential rubbing on the blades and disc firtree region and on the disc face (arrows, Photo No. 19 and 20). The upstream surface of the compressor turbine showed some rubbing in the platform region of the compressor turbine blades from contact with the compressor turbine vane ring inner shroud wall (arrows, Photo Nos. 21 and 22).

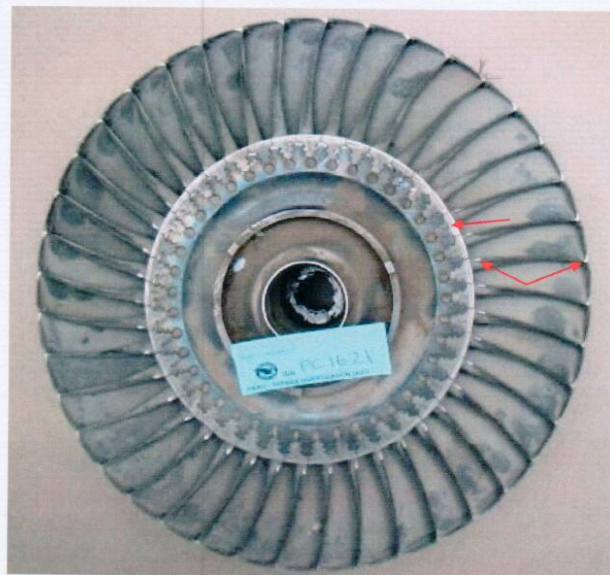
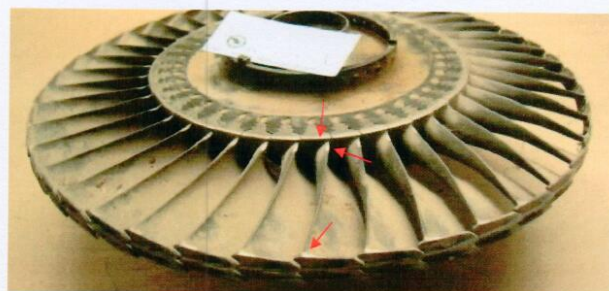
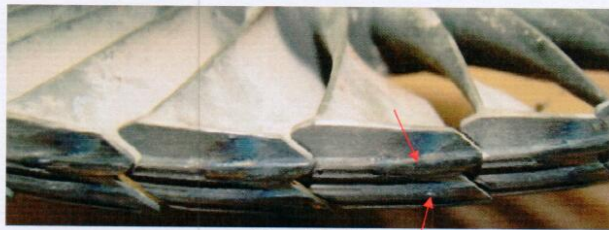
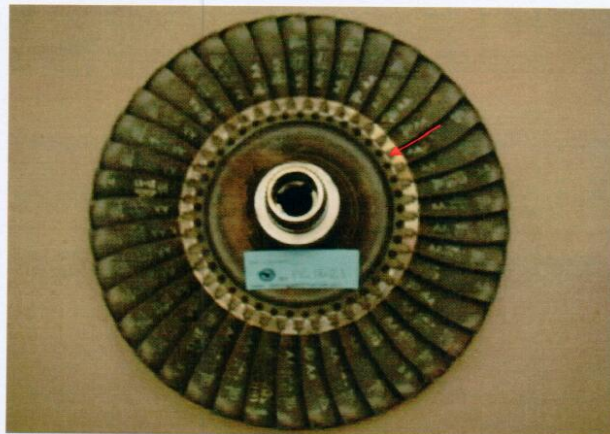
**Power Turbine:** The power turbine blades showed no distress (Photo No. 3). The upstream side showed circumferential rubbing on the blades leading edge platform, near the base of the blades and on the leading edge of the blade shroud tips (arrows, Photo Nos. 25 and 26). The shroud tips showed significant rubbing wear and heat discoloration from contact with the power turbine shroud (arrows, Photo No. 27). The downstream surface of the power turbine showed some rubbing in the firtree region of the power turbine disc (arrow, Photo No. 28).

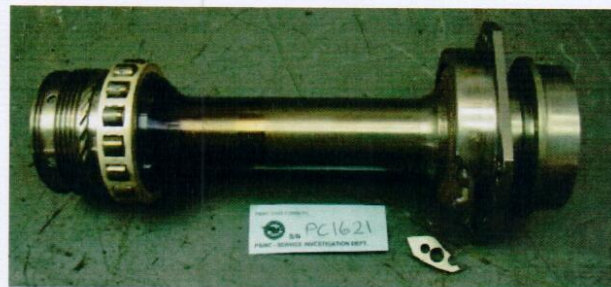
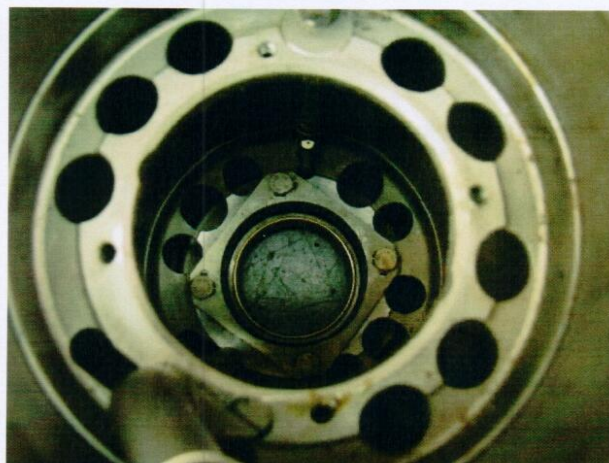
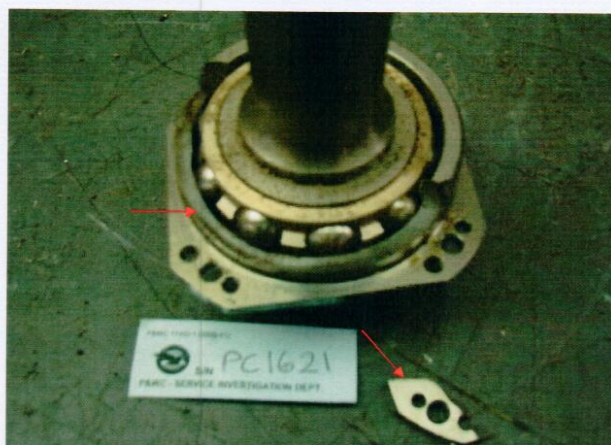
**Power Turbine Shaft and Shaft Housing:** The power turbine shaft and shaft housing was intact (Photo Nos. 29 and 30 respectively). The No. 4 bearing showed environmental debris deposit on its surface (Photo No. 31). One flange of the No. 4 bearing and part of the outer ring raceway was found fractured (arrows, Photo No. 31).

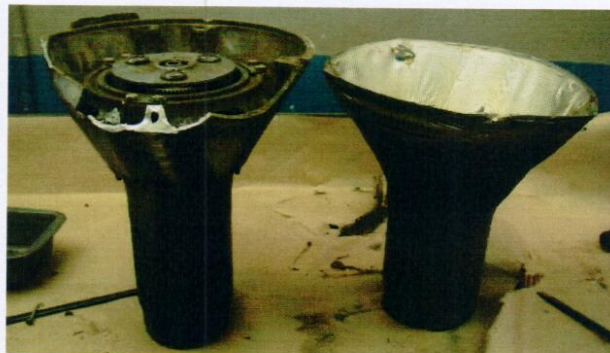
**Rear Housing:** The rear housing was fractured (Photo No. 32).

Photo No. 32  
Reduction gearbox rear housing and thermal blanket

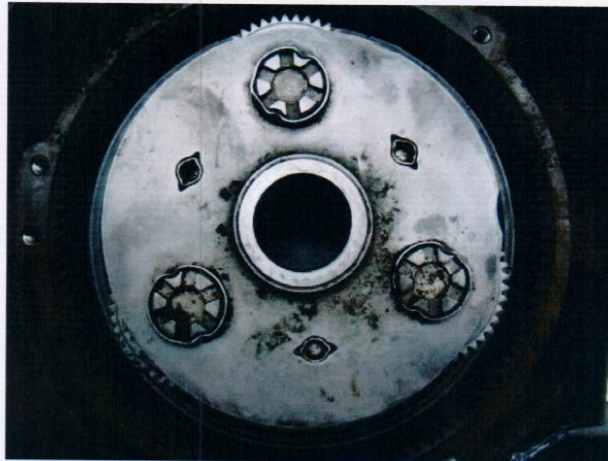
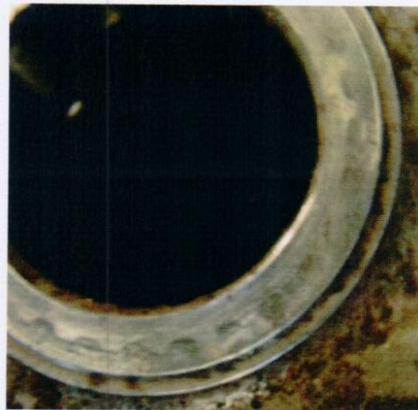
**1<sup>st</sup> Stage Planet Gear Carrier:** The 1<sup>st</sup> stage planet gear carrier, which showed discoloration due to environmental exposure and debris deposit, showed no prior distress; however the second stage sungear coupling assembly mounting boss was fractured off (arrow, Photo 34). The fracture surface morphology after some cleaning appeared indicative of torsional shear (Photo Nos. 35 and 36).

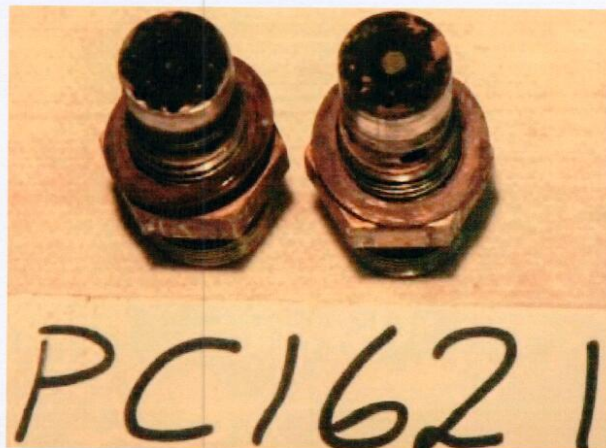
**Ignition Plugs:** The ignition plugs showed exposure to environmental elements but no prior distress (Photo No. 44).

Photo No. 44  
Ignitor plugs

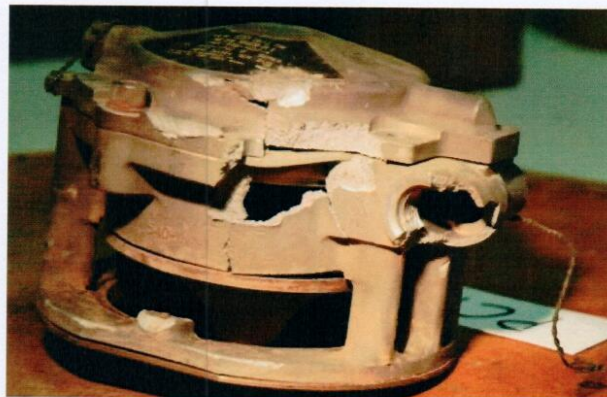
**Compressor Bleed Valve:** The compressor bleed valve showed impact damage resulting in the fracture of the bleed valve retaining cover (red arrow, Photo No. 49). The compressor bleed valve was removed and investigated by the External Controls Nacelle Technical Support Investigator. The exterior of the compressor bleed valve (BOV) was soiled. The housing was incomplete, a piece of the housing and cover were fractured and missing (Photo No. 53). Lockwire was present at all locations. The diaphragm was torn at the fracture location (arrow impact damage, Photo No. 54). The piston moved freely in the housing. The inside of the BOV housing was clean, but there was a fracture across the housing (Photo No. 55).

Photo No. 53  
Compressor bleed off valve

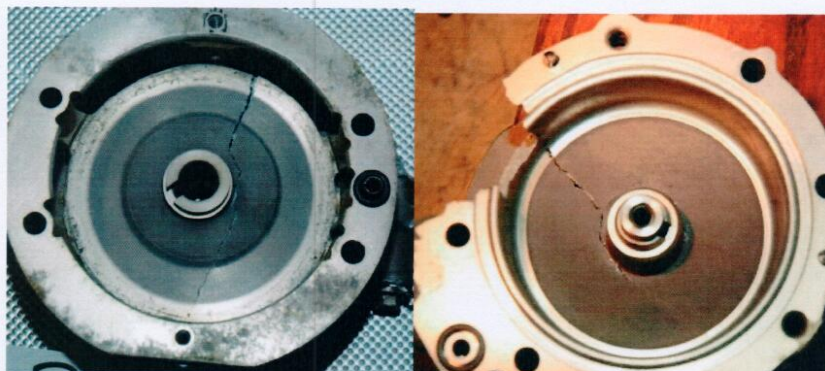
Photo No. 55  
Bleed off valve housing
