AIRCRAFT ACCIDENT REPORT

NCAT/2013/05/21/F

**Report on the Serious Incident involving Nigerian
College of Aviation Technology (NCAT) TBM 850
Aircraft with Registration 5N-BZA, Near Kaduna
Airport, Kaduna, Nigeria on 21st May, 2013**

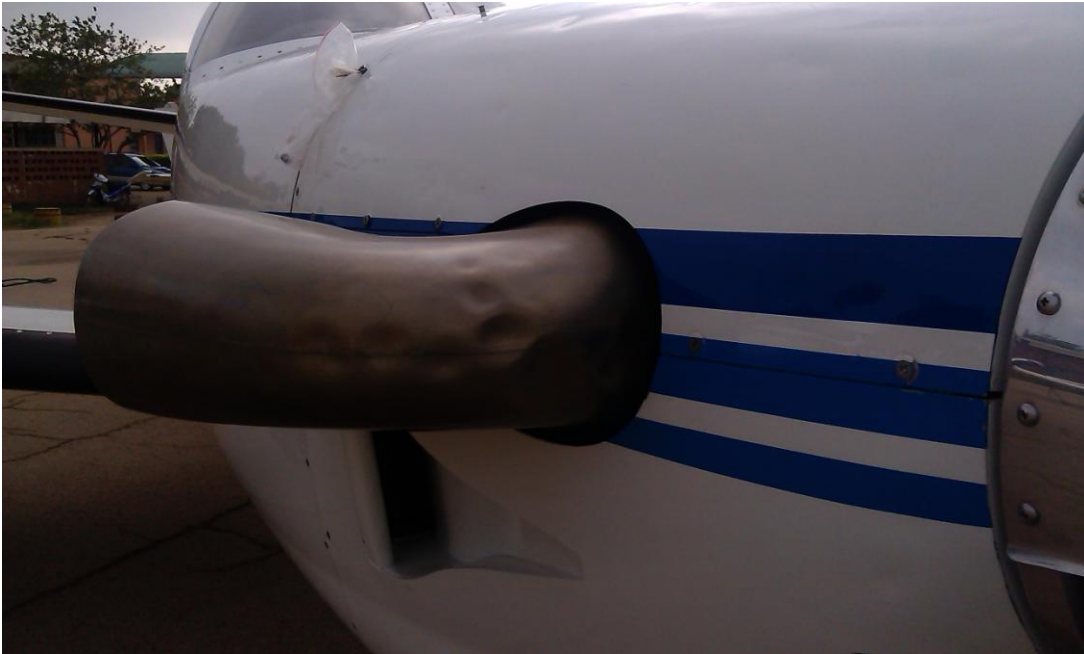
Figure 1: Picture showing dented Left Exhaust stack

The aircraft had an encounter with hailstorm in-flight while descending through FL130, resulting in damage to parts of the aircraft: dents on engine upper cowlings, engine lower cowlings, left and right exhaust stacks, complete damage on left and right landing lamp housings and left and right VOR antenna gaskets, abrasion and dents on radome/weather radar structure cover plates.

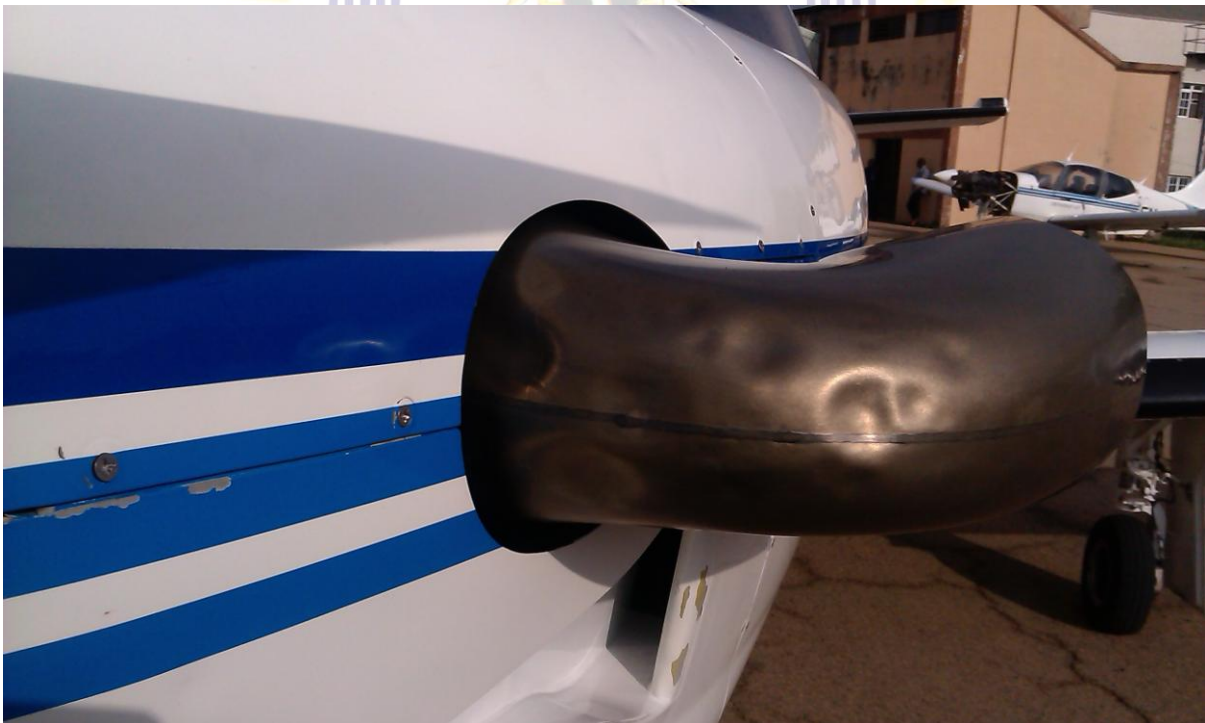
Figure 2: Picture showing dented Right Exhaust stack

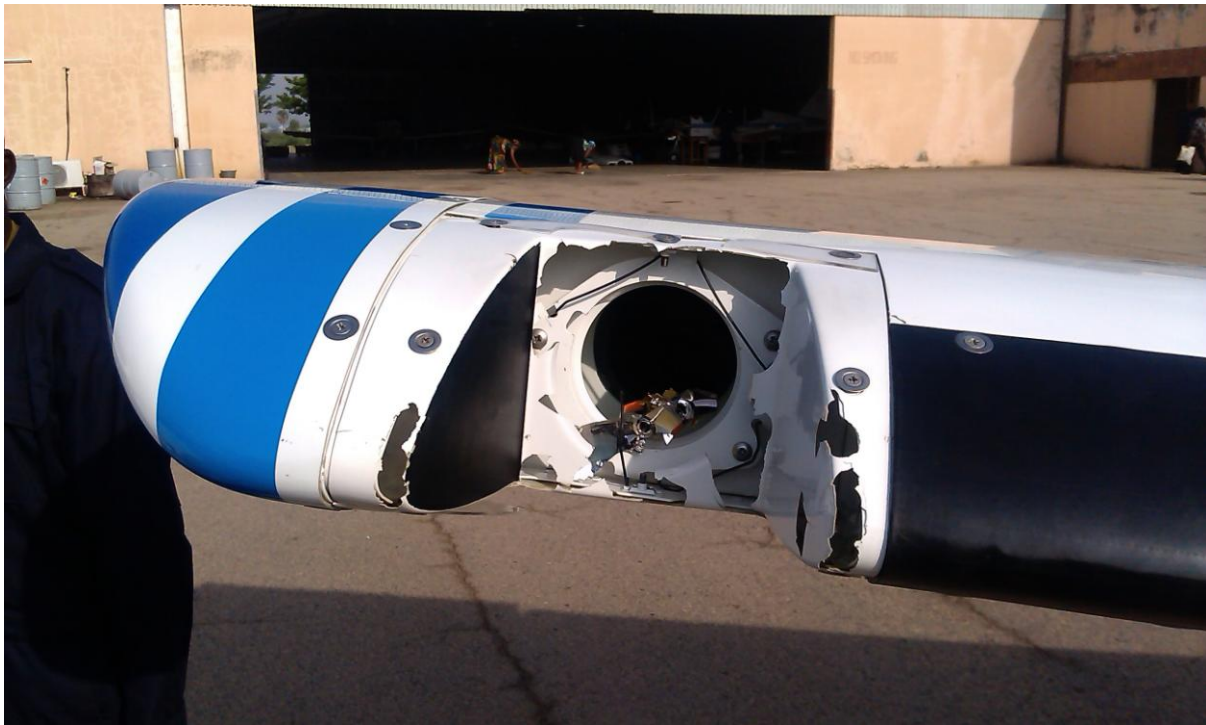
Figure 3: Picture showing damaged Right Landing Lamp housing

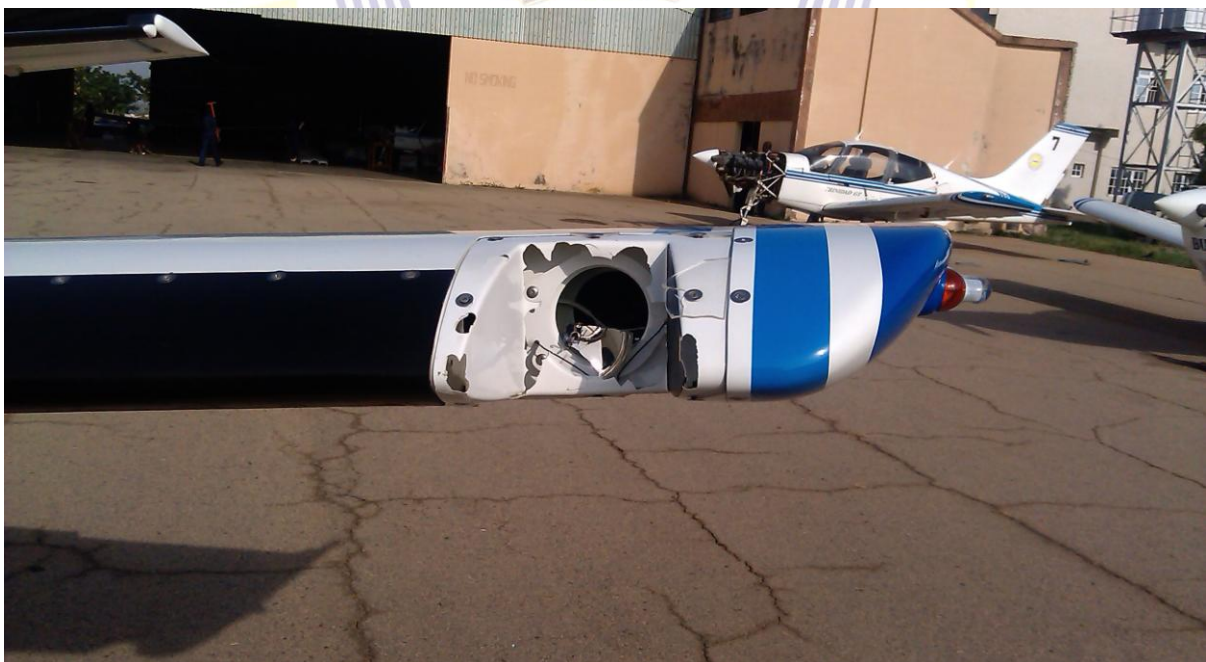
Figure 4: Picture showing damaged Left Landing Lamp housing

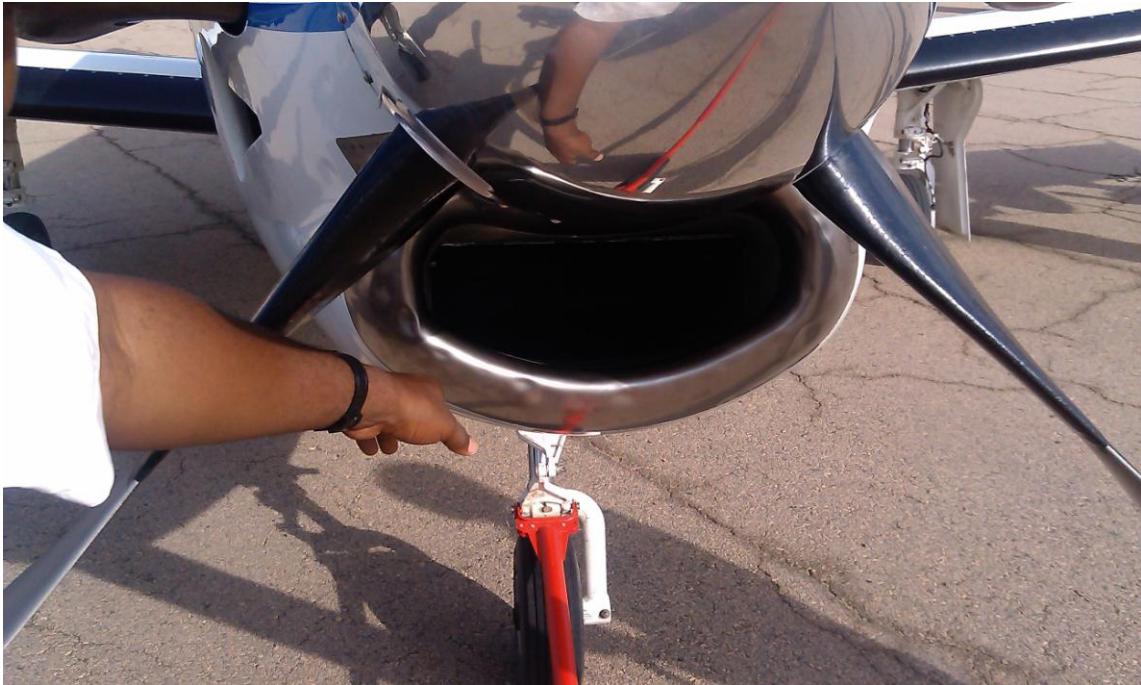
Figure 5: Picture showing dented Lower Engine Cowl assembly

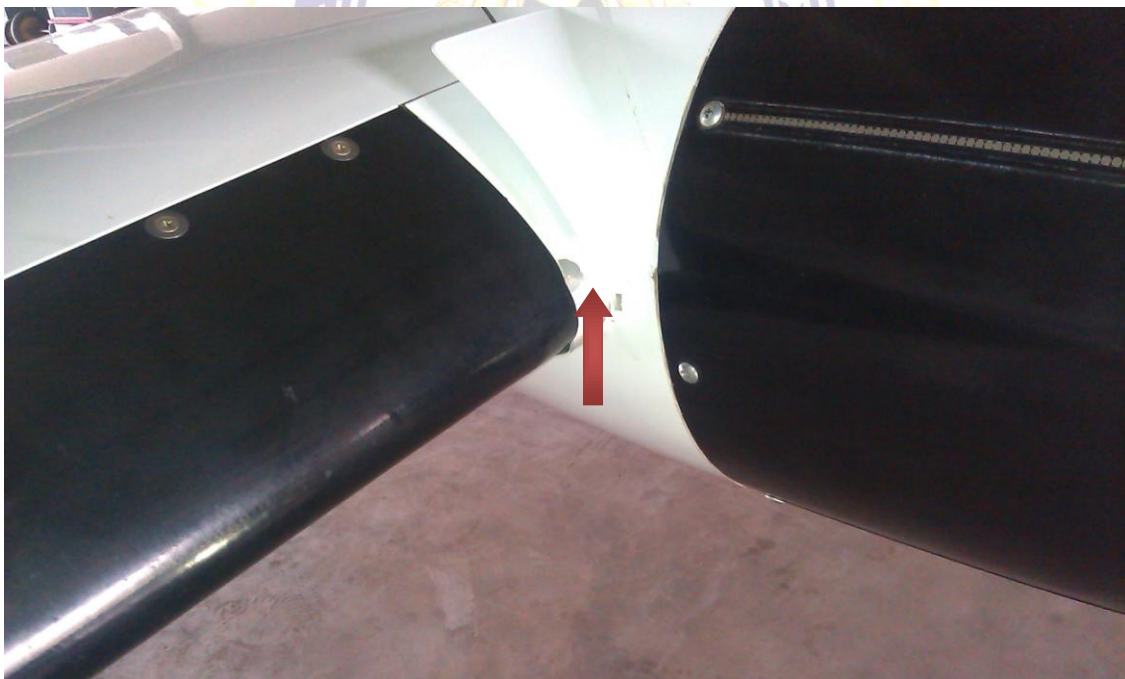
Figure 6: Picture showing dented Right Wing root Leading Edge section (red arrow)

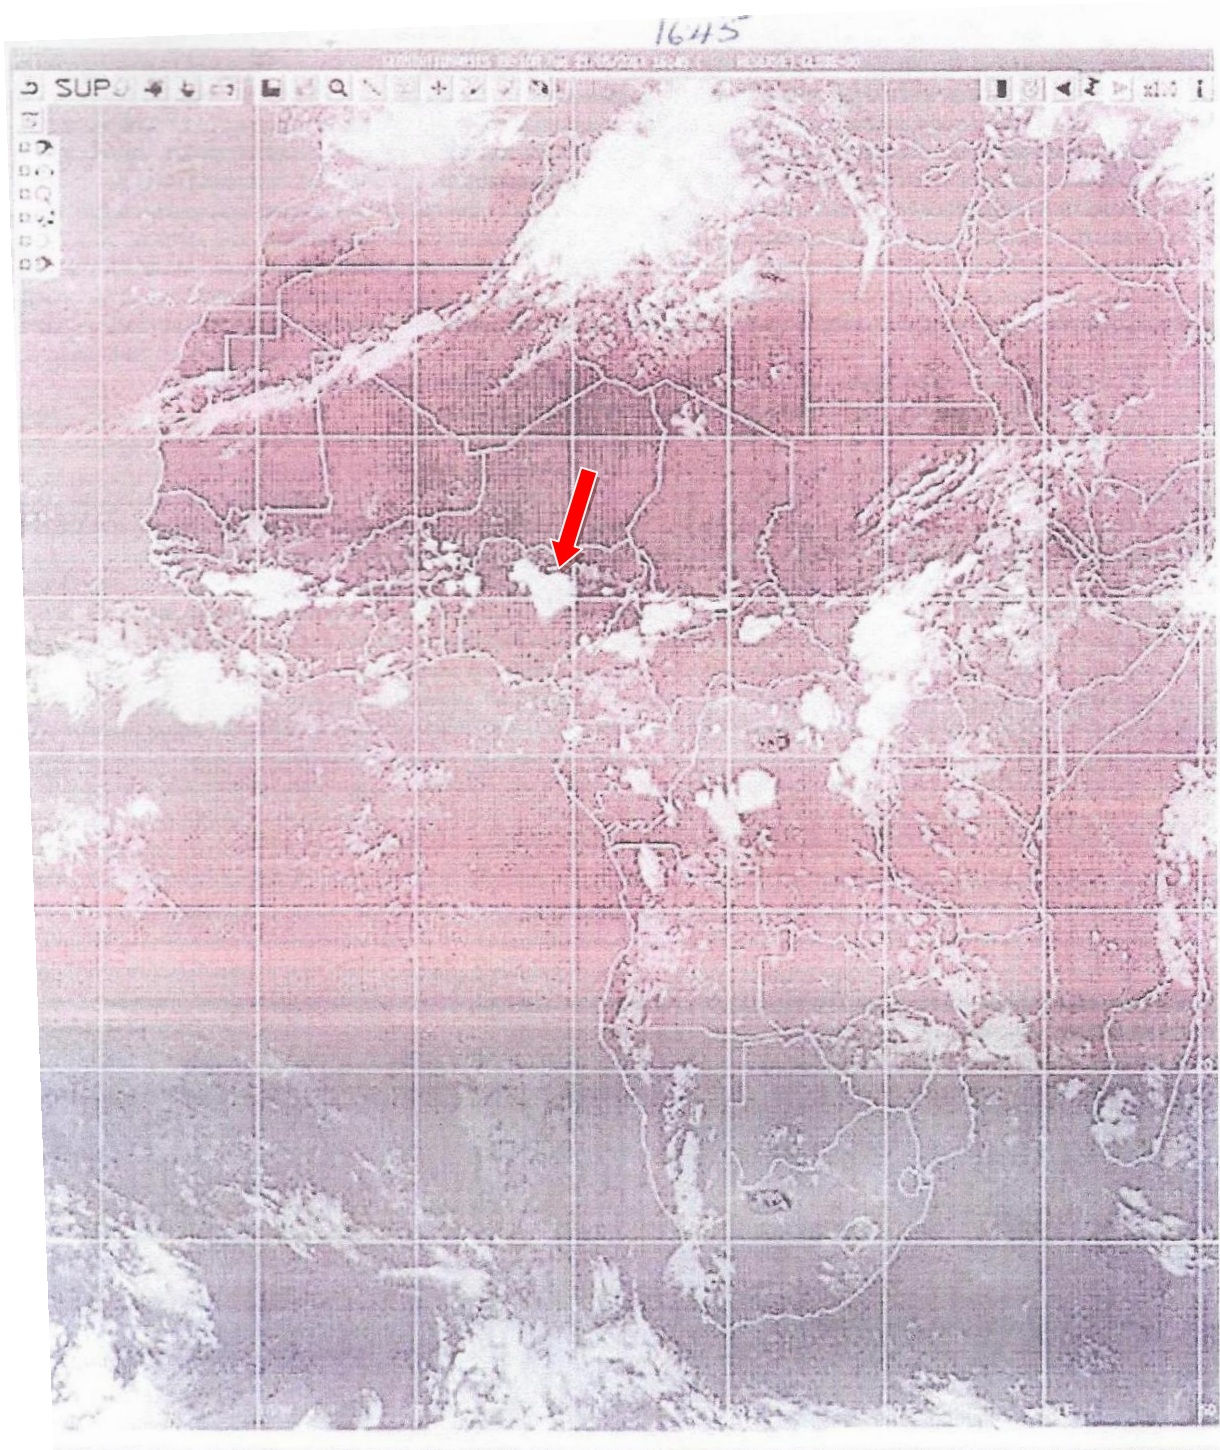
Figure 8: Satellite Weather Imagery for 1645Z

The satellite weather imagery received from NiMET showed cloud development on 21st May, 2013 at 30-minute intervals beginning from 1645Z to 1745Z. It was apparent that the isolated convective cell developed sometime around 1500Z and grew rapidly. Given the intensity, vertical development and the movement of the cell over Kaduna, it produced hailstorm, rain and lightning activities.

This satellite weather imagery indicated the pictorial weather (thunderstorm) as passed to the pilot. The information was obtained by phone, which is not in accordance with the regulation (Nig.CARs 8.6.1.1). The crew had sufficient time and opportunity to avoid the severe storms by delaying the departure time, since avoidance is the best option in this situation. The pilot was not prepared when he flew into the clouds containing hailstorm and scattered or embedded CBs characterised by gusty winds, thunder hails, rain, etc., as shown in Figures 8, 9 and 10 below.

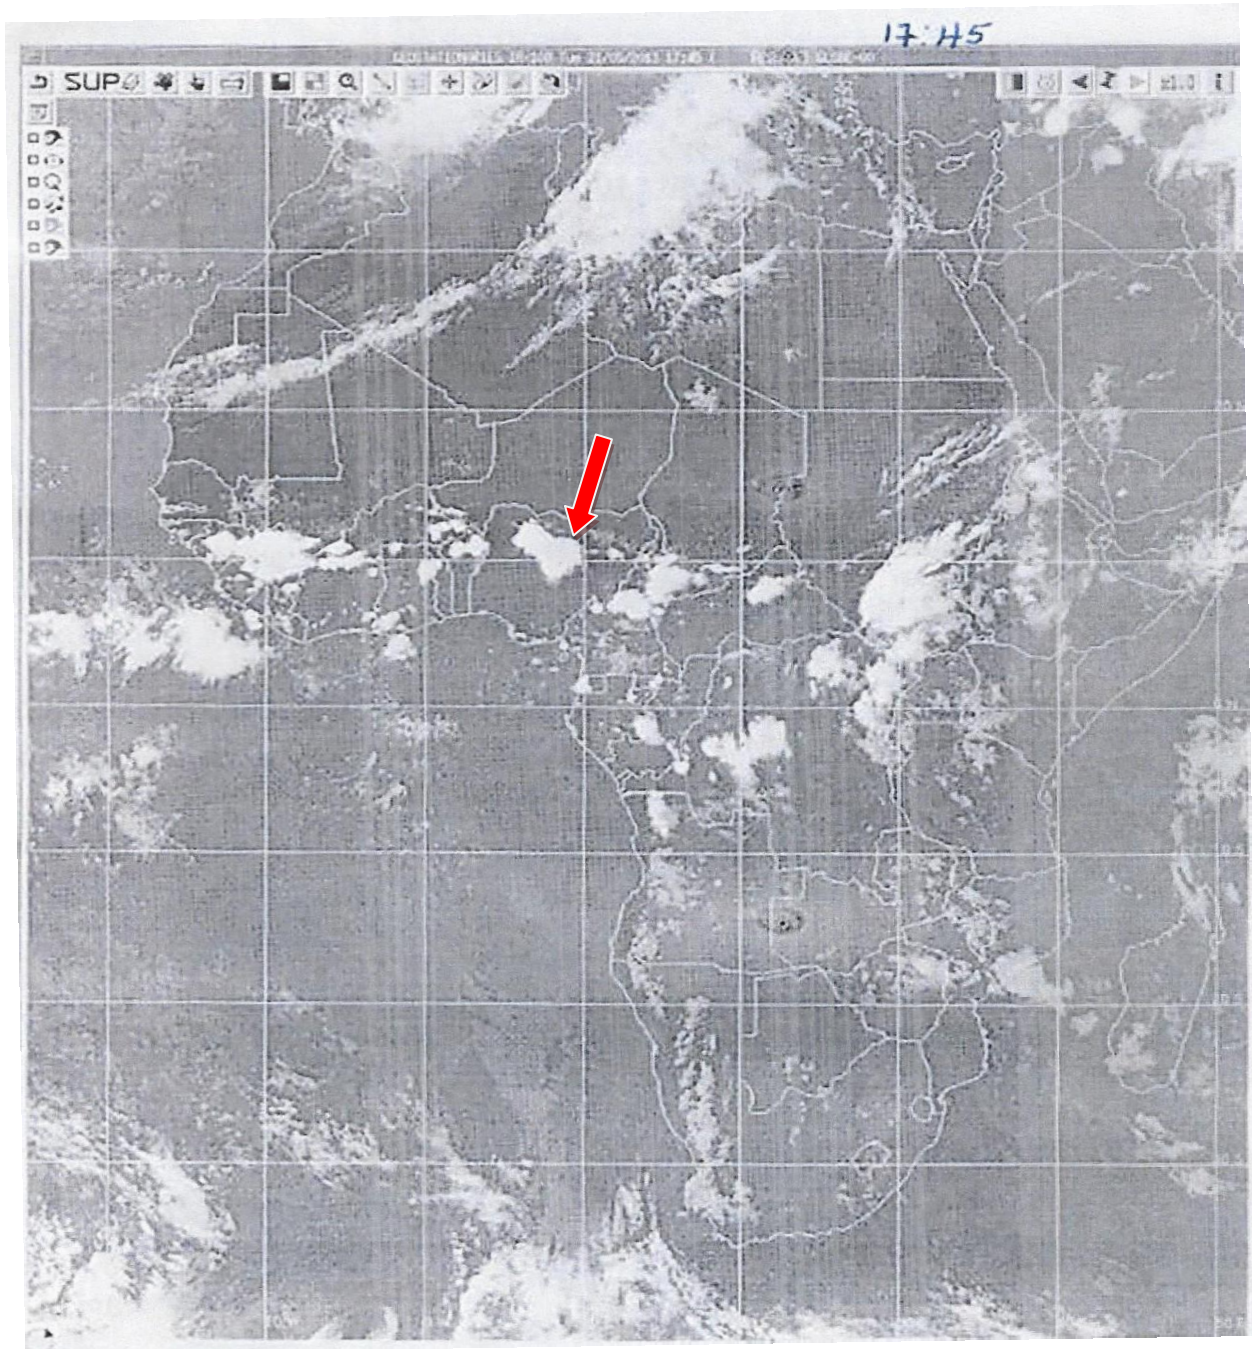
Figure 10: Satellite Weather Imagery for 1745Z

The Infrared Satellite Imagery of 1645Z to 1745Z of 21st May, 2013 also indicated that there was a massive active thunderstorm cell over the region. The serious incident occurred at about 1740Z.
