# AIRCRAFT ACCIDENT REPORT

OAS/2011/07/29/F

**Report on the Accident involving OAS Helicopters  
(Nig.) Limited Ecuruiel A 350 B2 Helicopter with  
Registration 5N-BKA at Oke-Oba Hill,  
Ikonifin, Osun State, Nigeria  
On 29<sup>th</sup> July, 2011**

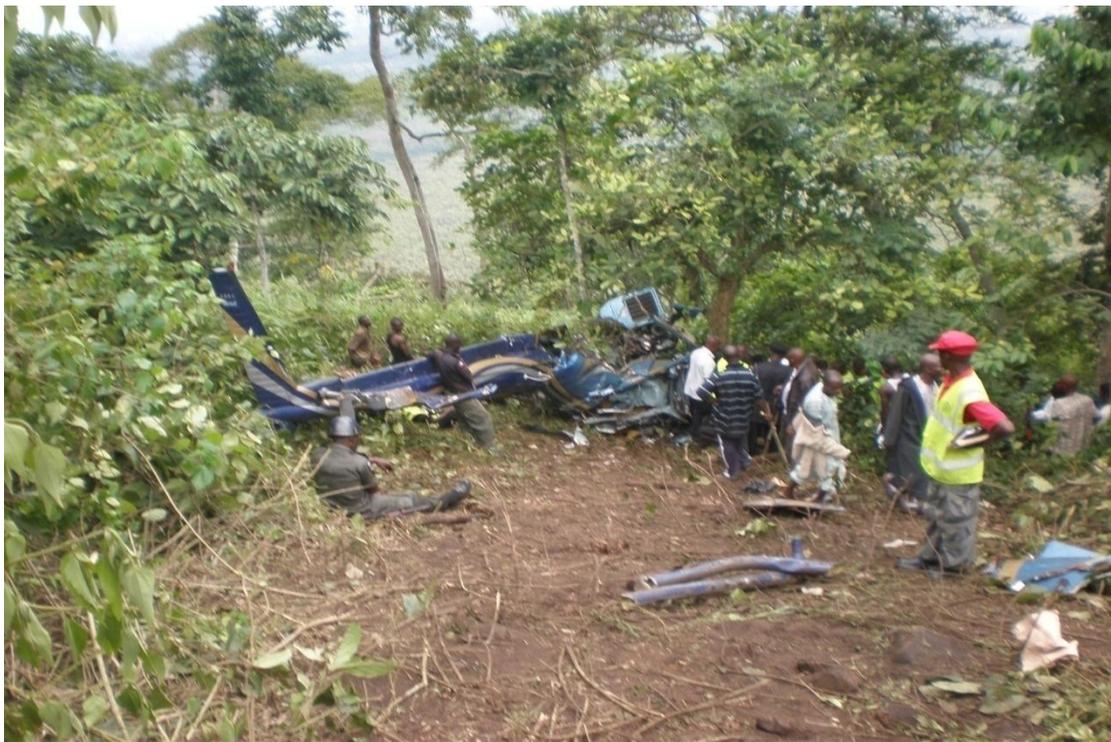
Figure 1.12a Main Wreckage

The aircraft crashed into a wooded un-inhabited forest in Oba-nla hill. Its first point of impact was with a very tall tree in the wooded forest. The wreckage of the Helicopter was concentrated in a small area, apart from the main rotor assembly and the Landing skid that detached during the accident. These items were found within the immediate vicinity of the main wreckage. See figures 1.12a-c.

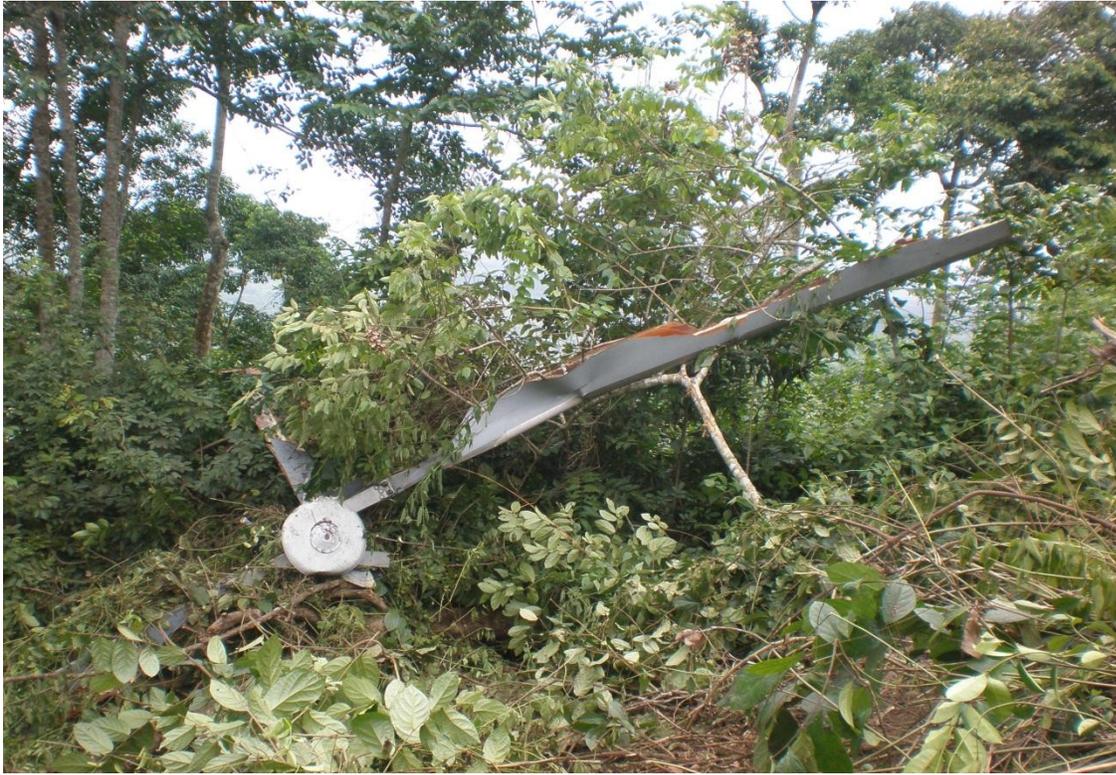
Figure 1.12b Main Rotor

The wreckage was later sighted at about 2250hrs same day at Ikonifin near Ife-Odan in a hilly terrain between Iwo and Ogbomoso. The accident occurred at about 1000hrs in daylight with 3 fatalities. The damage on both the main and the tail Rotor blades was consistent with engine on power.

- 3.1.5** The last major check on the aircraft was carried out in April 2011.
- 3.1.6** There was no fire outbreak at the crash site.
- 3.1.7** The main rotor assembly detached from the aircraft and was found at a point 25 meters away from the main wreckage. The damage on the rotor blades showed that they were on power at the time of crash.

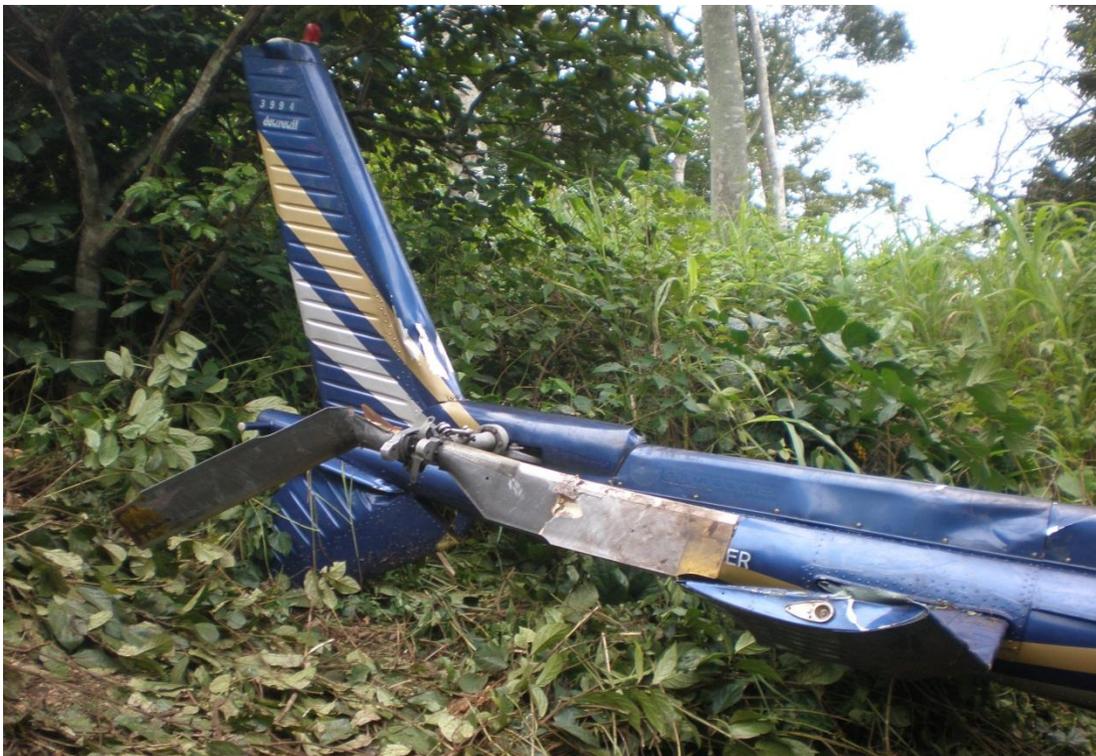
Figure 1.12c Tail Rotor Assembly

The Nig. CARs and OAS manuals made the Visual Flight Rule very clear. The non-adherence to these rules led the pilot to fly into the foggy area which obscured the terrain. The damage to the blades, that is, both the main and tail rotor blades was consistent with engine on power.

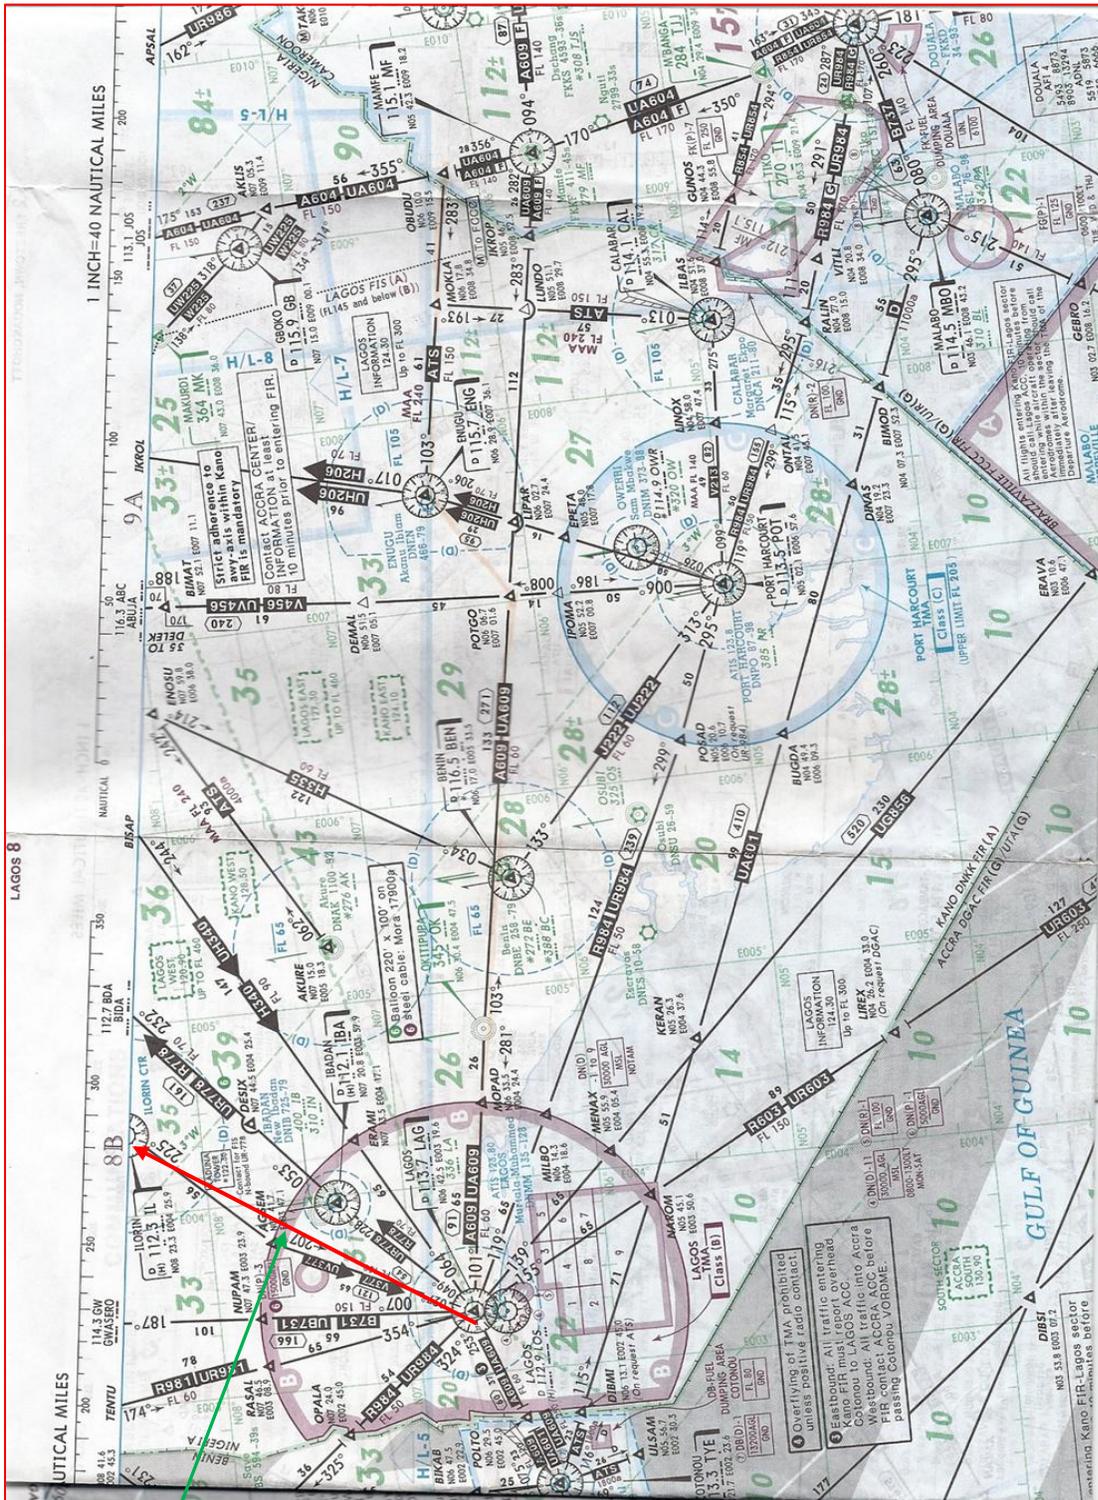
**Figure 1.18 JEPPESEN CHART**

The chart shows a safe altitude of between 3,100 ft to 3500 ft from Lagos to Ilorin

While abeam Ibadan, the pilot requested to climb to 1500ft, when the highest point en-route was higher than 1500ft. The reasons the pilot chose to fly that low was due to the company policies of maintaining visual contact with the ground and remain clear of clouds. Unfortunately, the prevailing weather condition at the time of the crash was foggy around the hill. From records available to AIB, it was observed that the required route familiarisation flight was not performed by the accident pilot. Eye-witness account "Baale of Ikonifin" who stated that during this time of the year the hill-top is usually foggy in the morning, until the sun rises when the fog clears.
