## **AIRCRAFT ACCIDENT REPORT**

**PAAN/2012/10/27/F**

**Report on the Accident Involving  
Pan African Airlines Nigeria Limited (PAAN), Bell 206  
L4 Helicopter with Registration 5N - BFF, At Chevron  
Okan Production Platform, Escravos Offshore, Delta  
State which occurred on 27<sup>th</sup> October, 2012.**

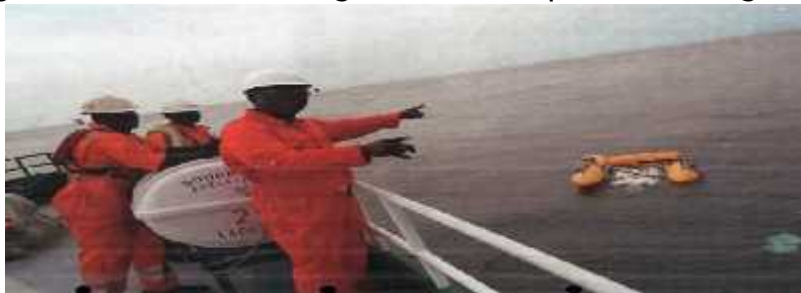
Fig.1.15b: picture showing the crew of the supply boat (Rescuers) and the capsized helicopter.

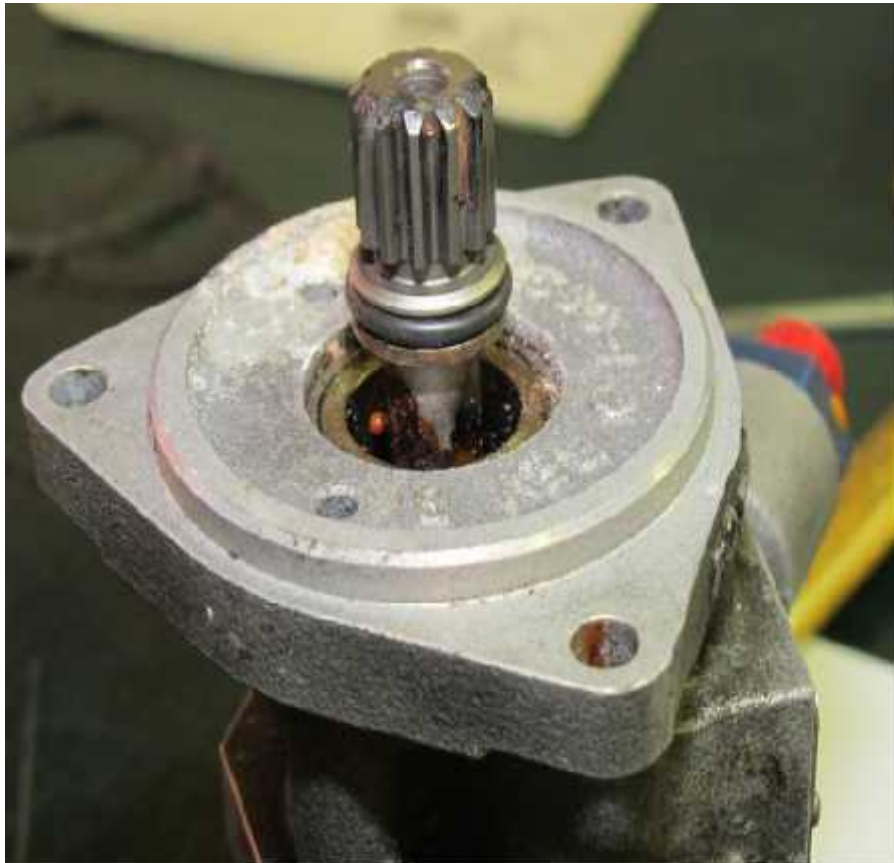
The fuel pump main drive shaft external splines, which mate to the internal splines of the pump driver gear, were severely worn. The wear was significant enough to decouple the fuel pump main drive shaft from

Fig.1.16b: Picture showing Fuel Pump Main Drive Shaft prior to removal from Fuel Pump.

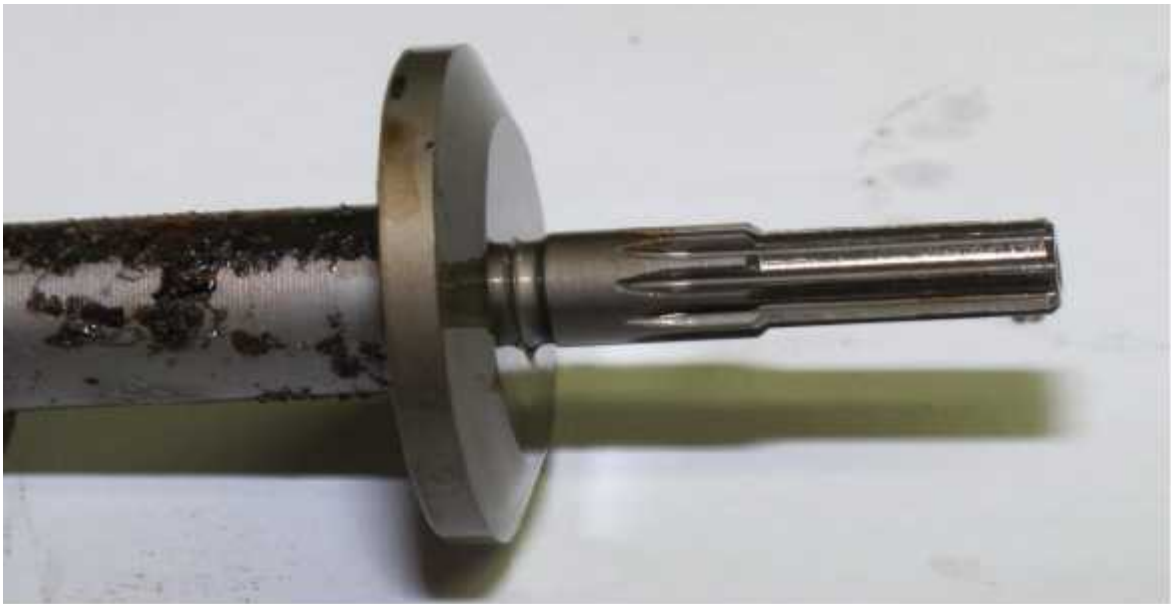
Fig.1.16d: Picture Showing Fuel Pump Main Drive Shaft after removal

*The fuel pump driveshaft “ratcheted” when turned by hand. Normally, it is not possible to turn the fuel pump driveshaft due to the pump configuration. The corresponding output splines, which turn the FCU input shaft, were not coupled with the drive shaft as designed. The fuel pump driveshaft was then removed and severe spline wear was noted.*

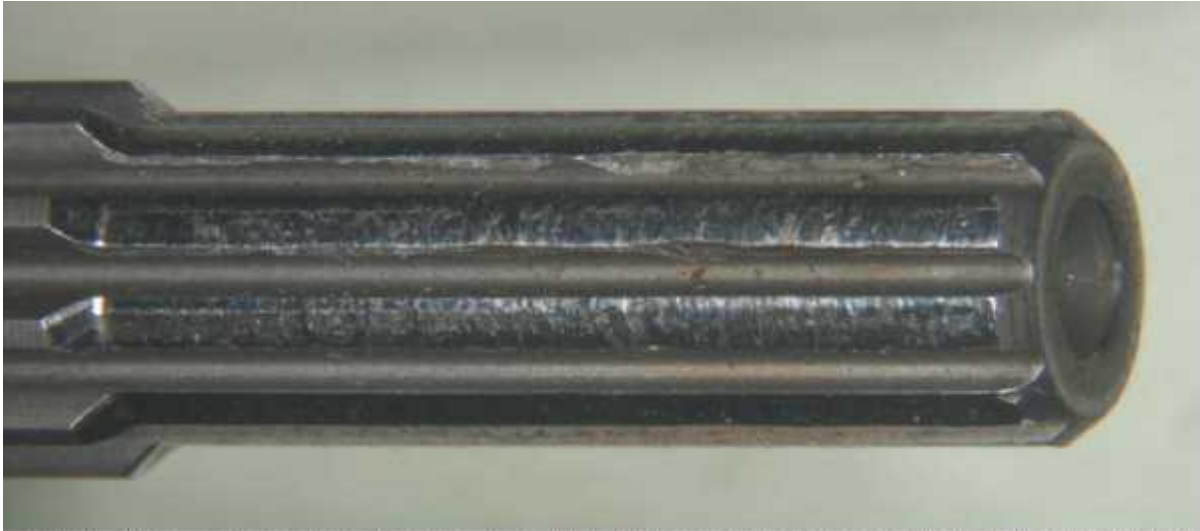
Fig.1.16e: picture showing the Magnified View of Fuel Pump Main Drive Shaft Splines Wear

*Investigation of the main fuel pump conducted at the Triumph Engine and Control Systems facility revealed that all teeth of the male spline on the main drive shaft which mates with the female spline of the pump driver gear were completely worn away over approximately two thirds of their length. However, the mating spline of the pump driver gear showed little to no wear, and appeared in near pristine condition. A measurement under wires of this spline yielded a value of 0.1902 in., only slightly below the new part print limit of 0.1926 in.*

According to the metallurgical evaluations of the main drive shaft, this is part of the pump assembly and the driver gear and also part of the gear assembly, the former is made from H-11 tool steel while the latter is made from CPM -10V. Whereas all teeth of the male spline on the main drive shaft, which mates with the female spline of the pump driver gear were completely worn out over approximately two thirds of their length, the mating spline of the pump driver gear showed little or no wear, and appeared in near pristine condition.

FAA should ensure that TECS review the material compositions of the assemblies of its MFP 264 - 1 main fuel pump to prevent excessive differential wear between the parts.

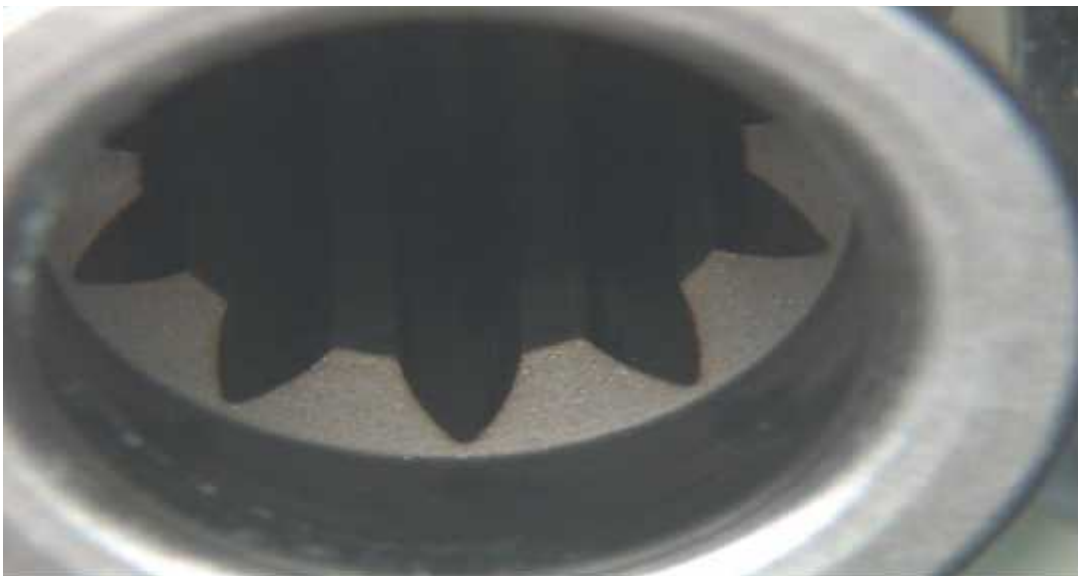
Fig 1.16f: Picture showing the Magnified View of Fuel Pump Driver Gear internal splines

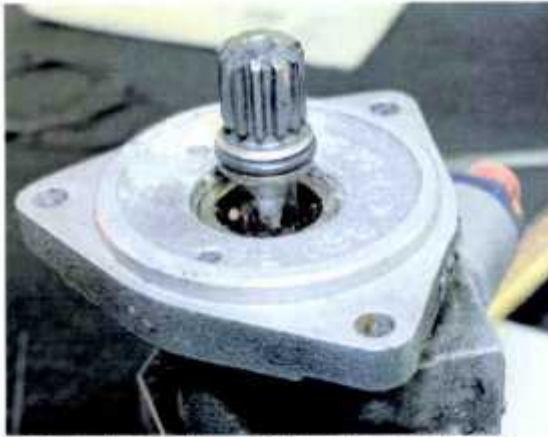
Photo 10 Fuel Pump Main Drive Shaft prior to removal from Fuel Pump

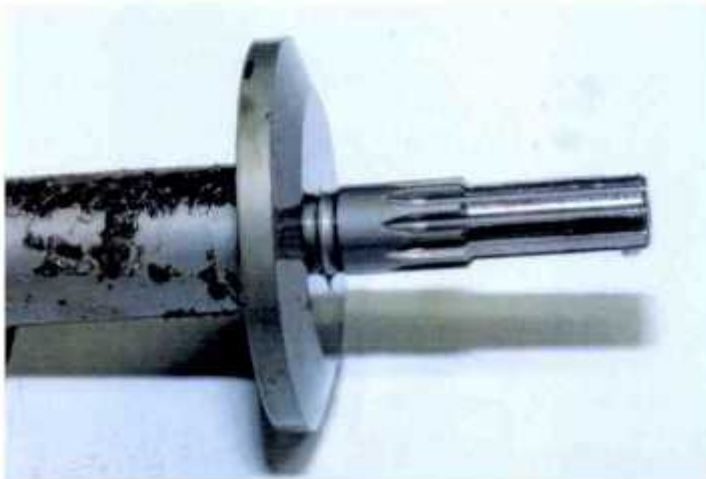
Photo 12 Fuel Pump Main Drive Shaft upon removal

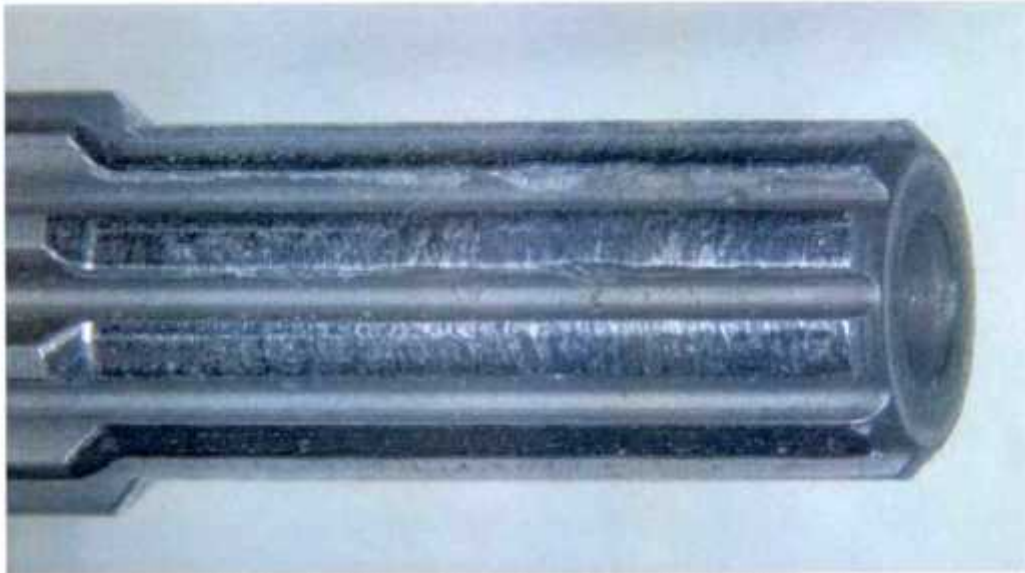
Photo 13 Magnified View of Fuel Pump Main Drive Shaft Spline Wear

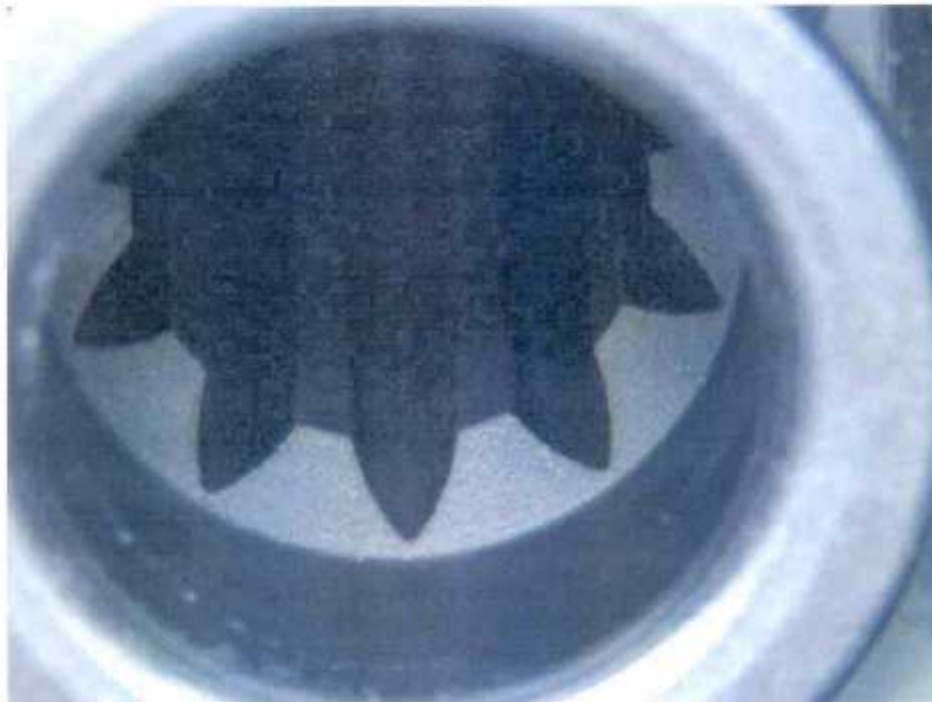
Photo 14 Magnified View of Fuel Pump Driver Gear internal splines

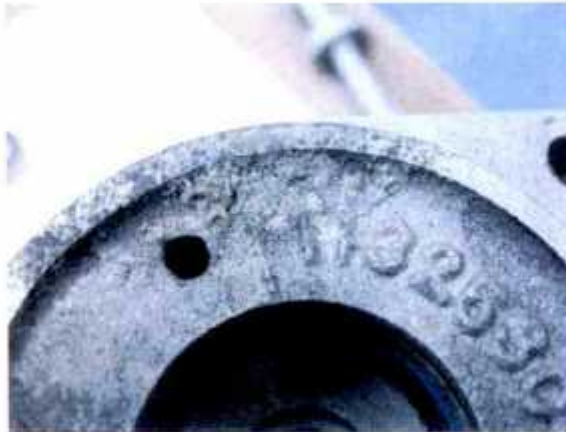
Figure AI-13: Pump mounting face (corrosion product)

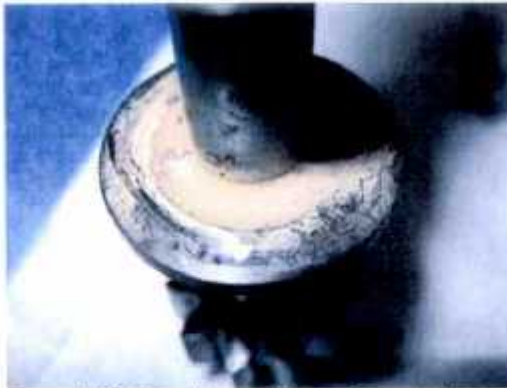
Figure AI-25: Main drive shaft (corrosion product)

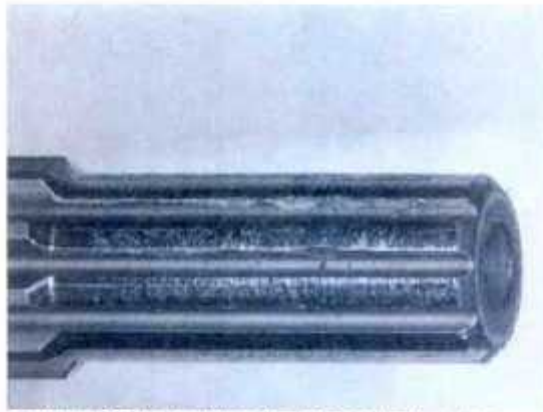
Figure AI-39: Main drive shaft inboard end – worn Splines, 7X

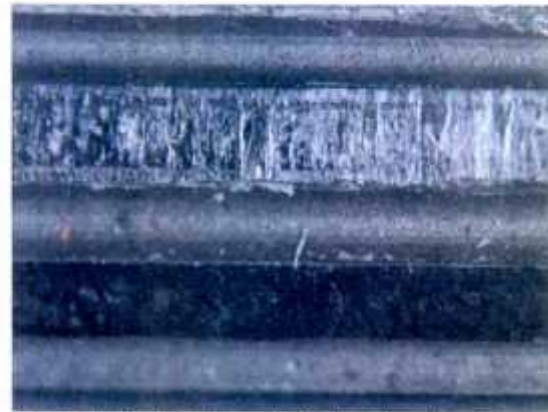
Figure AI-40: Main drive shaft inboard end – worn splines, 20X
