AIRCRAFT ACCIDENT REPORT
PAAN/2010/04/16/F

Accident Investigation Bureau

**Report on the Serious Incident involving
Pan African Airlines Nigeria Limited
Bell 412-EP Helicopter Registration 5N-BFU at NNPC
Housing Complex, Warri, Delta state, Nigeria
On 16th April, 2010.**

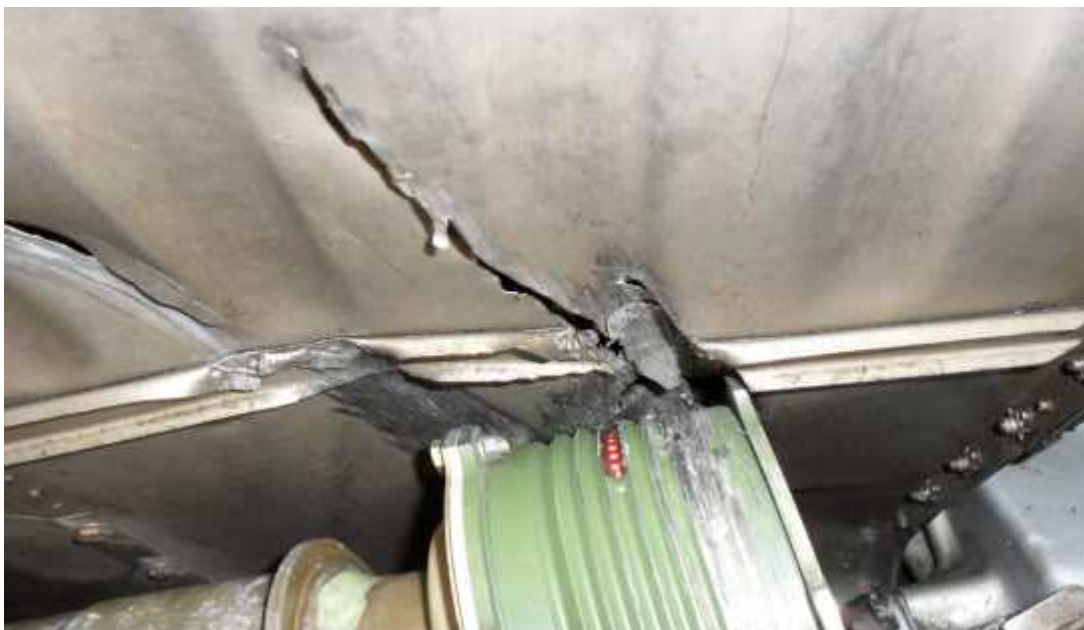
The aircraft was substantially damaged around the engine tunnel and bulkhead. See fig 1.3 below.

Fig 1.3 showing damage to tunnel area housing the Main Drive Shaft (MDS)

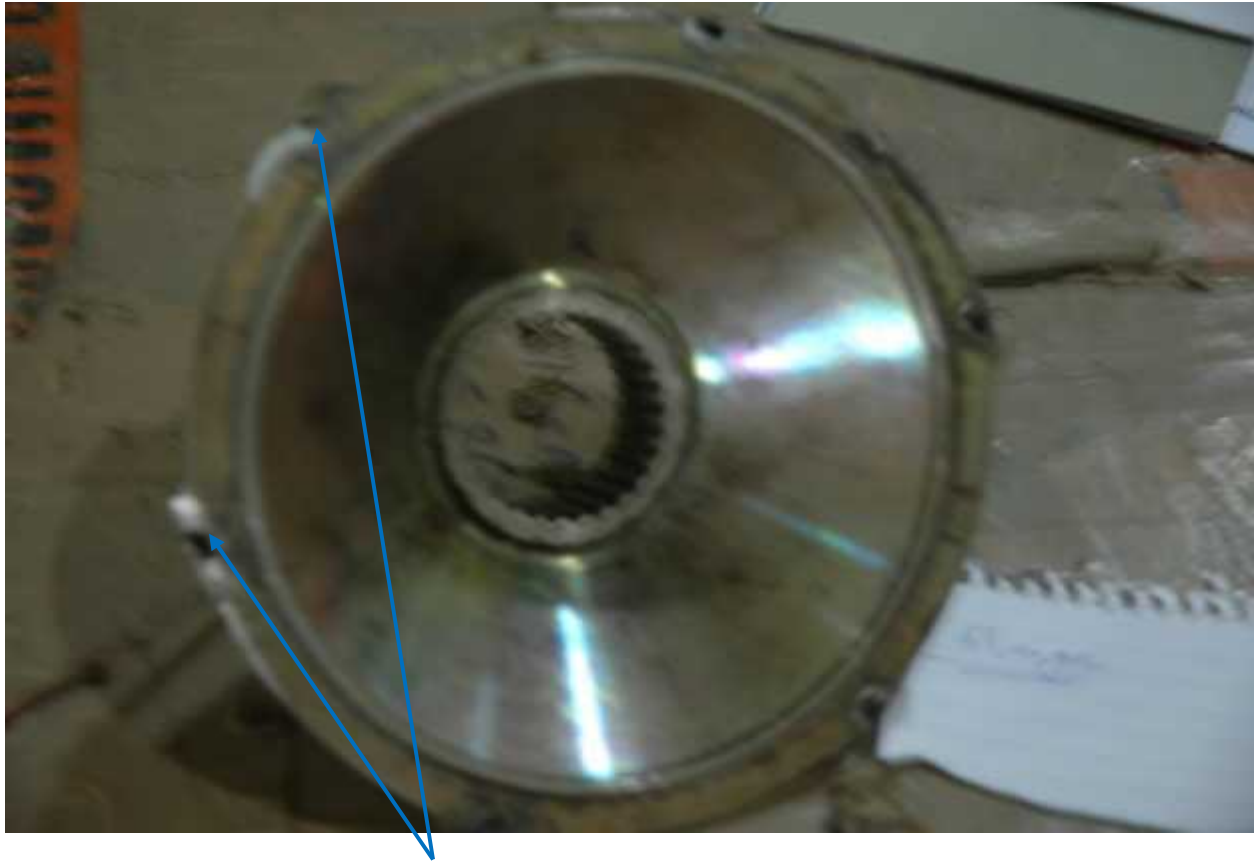
The four (4) missing bolts work loosed over time, shedding the load bearing capability of the assembly by 67% and transferring the load to the two bolts that were found. Fig 1.12a below shows the

indentation marks made by the fractured bolts. The lock washers on the C-box end were not found.

Fig1.12a Indentation marks

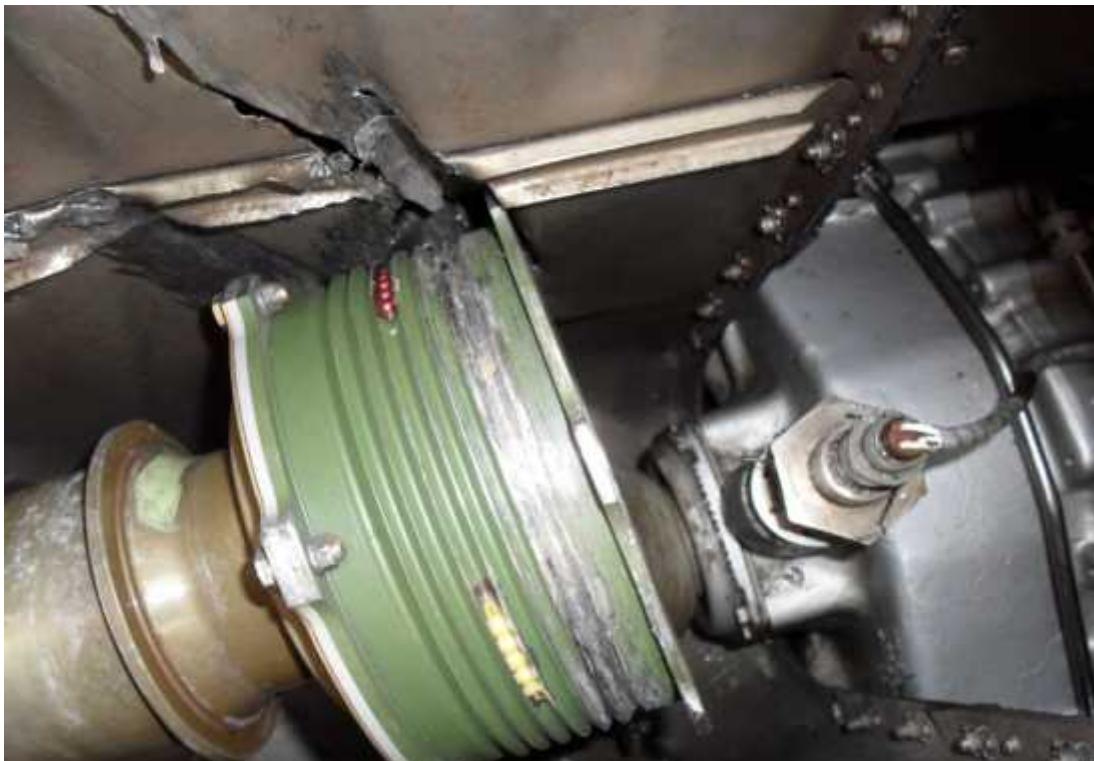
The aircraft came to rest at the NNPC housing complex and was found intact. The Main Drive Shaft coupling sheared off from its attachment point at the combining gear box end. The tunnel area housing the Main Drive Shaft and the combining gear box was also damaged.

Fig 1.12c: Picture showing the damaged part of a coupling joint of the drive shaft

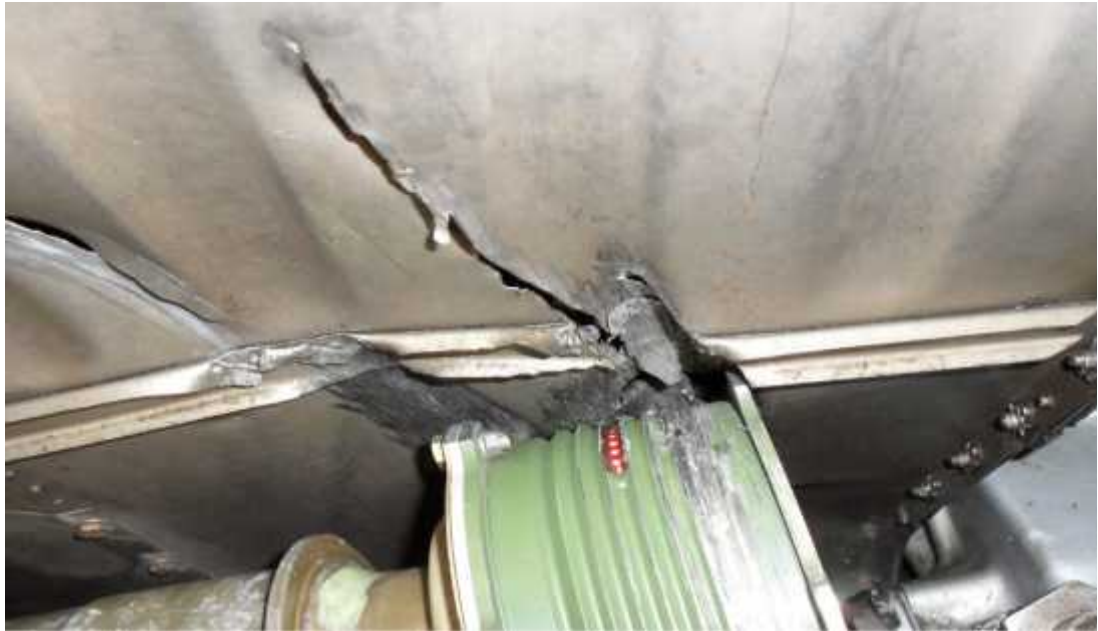
Fig 1.12d showing damage to tunnel area housing the Main Drive Shaft (MDS)

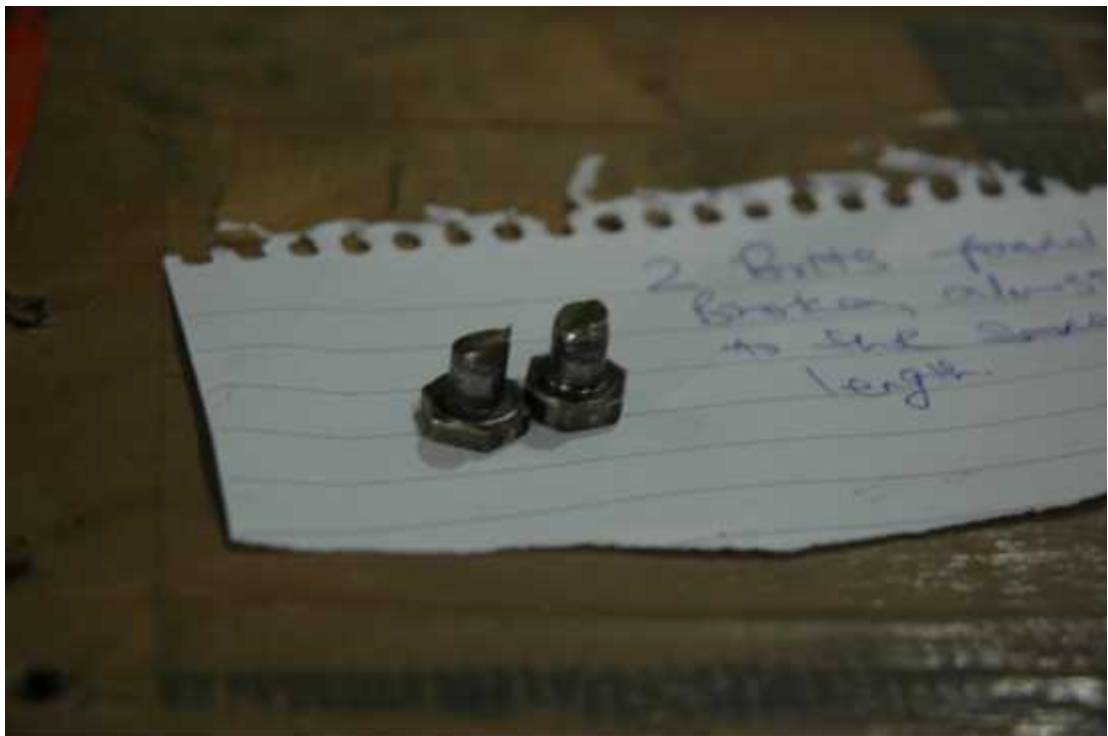
The six bolts and nuts/lock washers on the transmission end of the drive shaft coupling were found intact. However, on the C-box end of the drive shaft coupling, four bolts were found missing while the remaining two bolts were found broken and detached from the attachment point. See. Fig.1.12 b, c, d, e and f.

Fig1.12e showing two bolts found on the C-box end inside the aircraft.

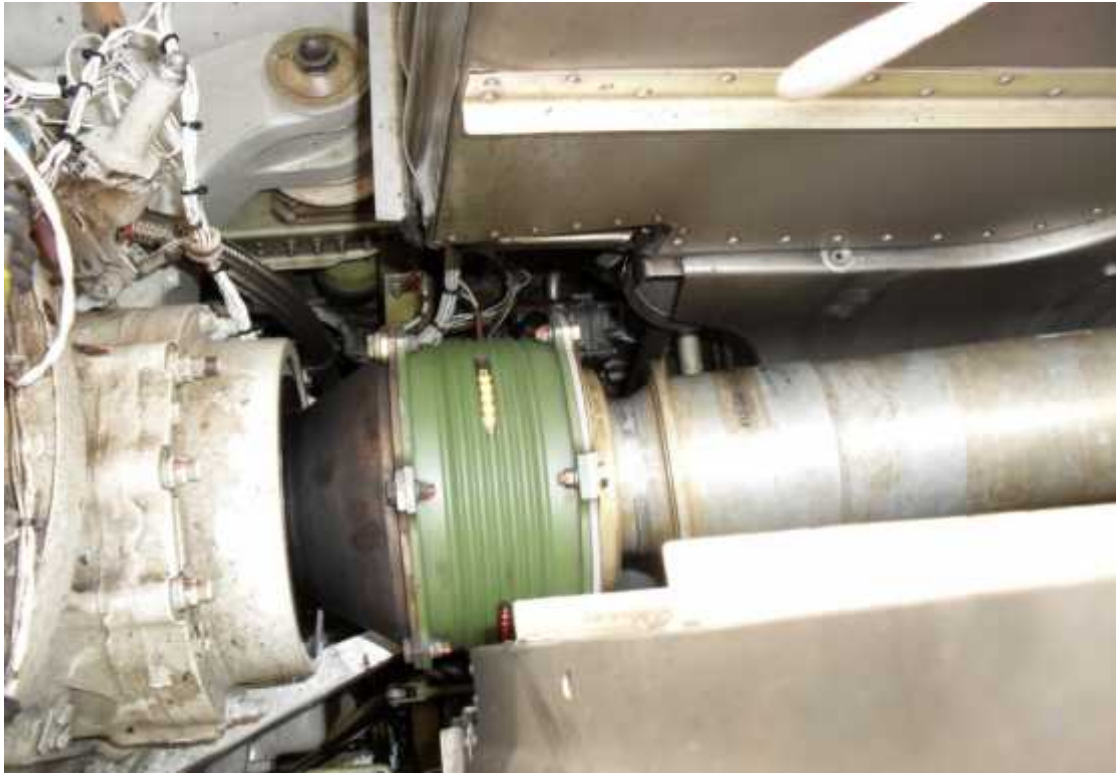
Fig. 1.12f showing bolts intact at the transmission end.

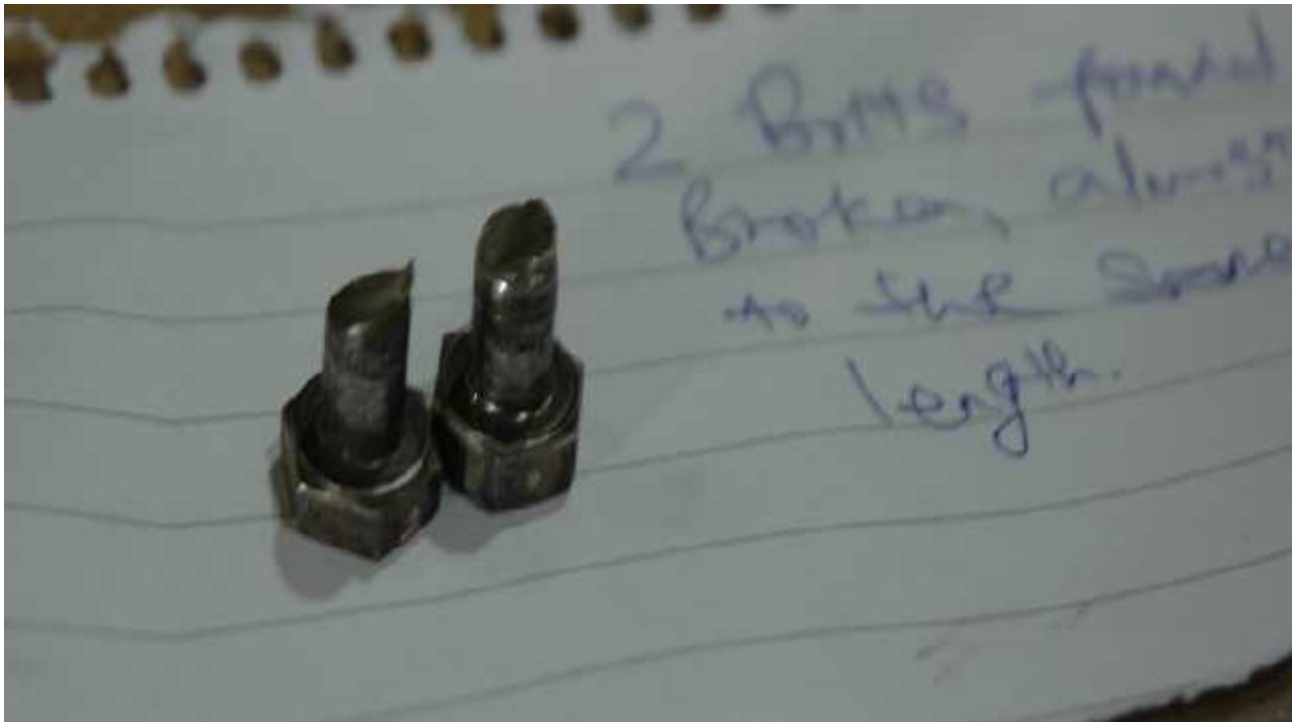
Physical inspection of the damage, showed that the MDS coupling sheared off from its attachment point at the C-box end; damaging the tunnel area. The MDS is held in place at this end by six retention bolts, two of the retention bolts were found though damaged.

Fig 2.1a showing two bolts found on the C-box end inside

“In order to prevent bolts from loosening over time, various locking mechanisms are employed, they include lock washers. If this locking mechanism is not applied during installation or replacement, a catastrophic event may result. They are required when vibration or joint movement will cause loss of clamp load and joint failure”- (Charles C. Roberts, Jr.). This was the case in this event.

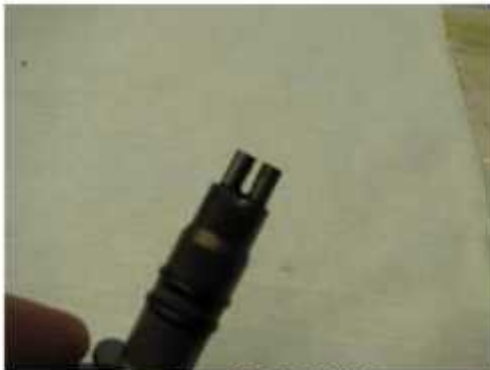
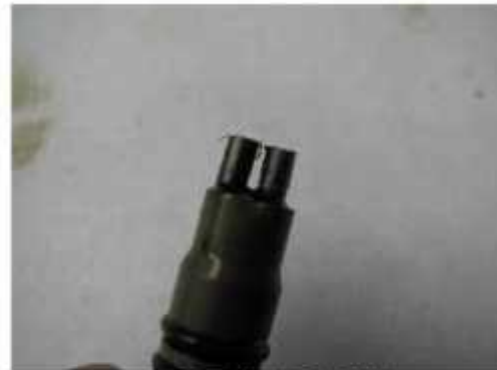
- 3.2 The RGB chip detectors and oil filter elements were received separately. There were a few metallic particles on the chip detectors (Photo No. 3 and 4). An oil sample from the RGB center oil system was also received. The oil filter elements, chip detectors and oil sample were submitted to P&WC Chemical analysis laboratory for analysis. Refer to section 7.0 of this report for the results.

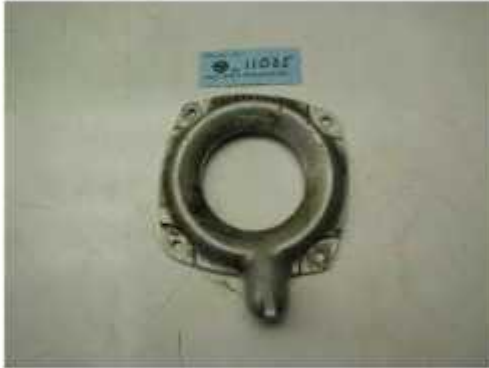
Photo No. 5

- 3.3 Examination of the RGB output gearshaft area did not show apparent damage except for the output shaft drain cover (Photo No. 5) that was rubbed on the inner diameter mainly at the 6 o'clock position (Photo No. 6). The RGB rotated freely and both clutch assemblies were showing normal engagement.

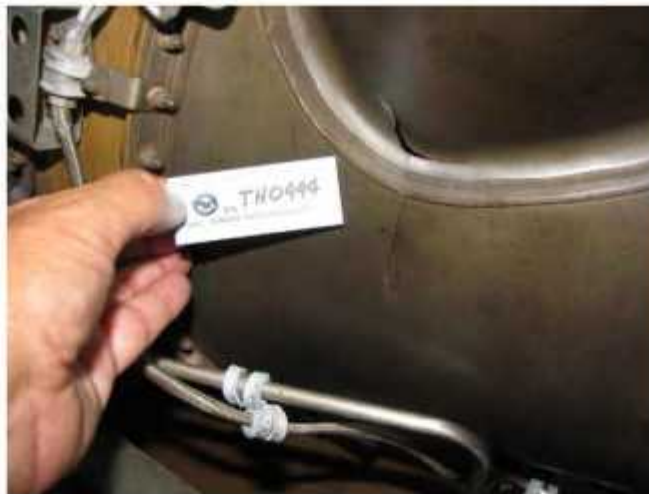
Photo No. 27

- 4.2 The crack on the exhaust case wall ran radially for approximately 1.750 inch from the exhaust port weld, and 0.630 inch through the weld and exhaust port, then branched axially 1.225 and 1.075 inch. into the exhaust port (Photo No. 27).

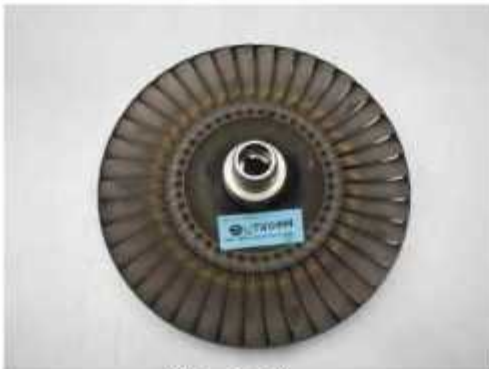
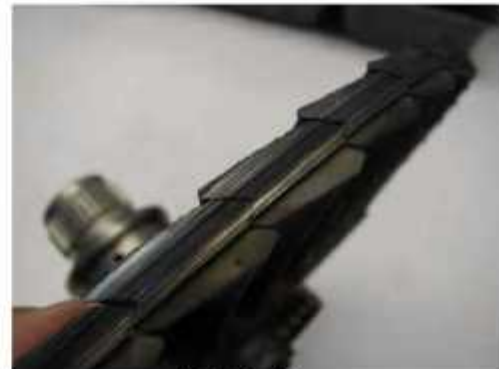
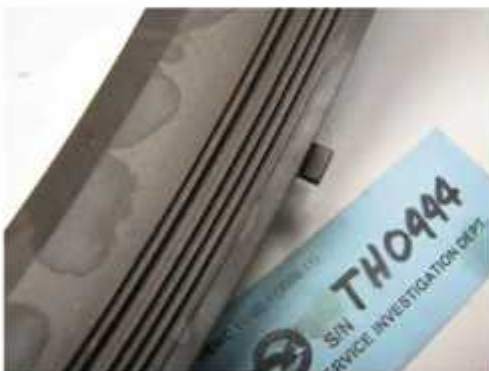
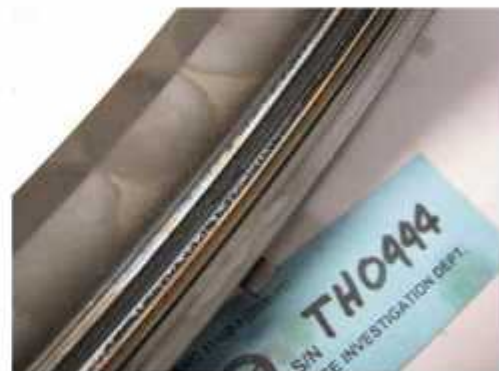
- 4.4 The power turbine disc was removed (Photo No. 30) and there was evidence of rubbing on the shrouded tips (Photo No. 31). The PT stator showed rubbing between the 10 to 2 o'clock position and 5 to 6 o'clock position (Photo No. 32 and 33).

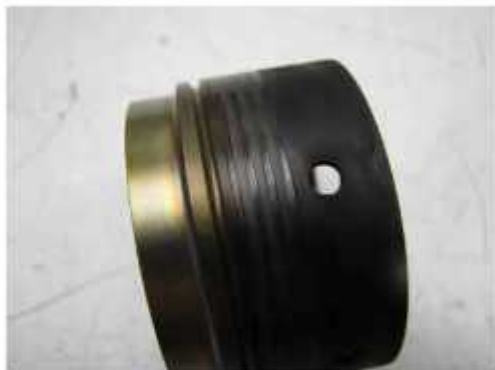
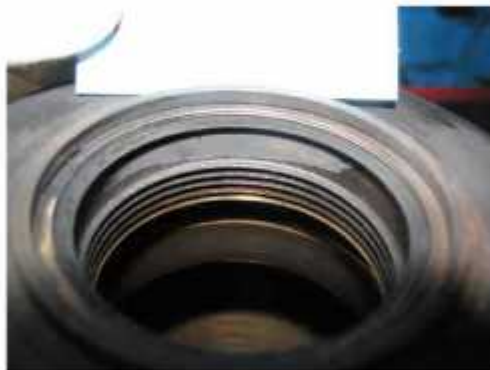
Analysis of the debris found in the oil filter elements identified as low alloy steel that is usually associated with gear material. The debris found on the chip detectors that caused the reported chip lights to come on was consistent with the material composition of the No. 3 bearing air seal.

- 4.5 The No. 3 bearing air seal rotor showed rubbing over the complete circumference (Photo No. 34) from contact with air seal stator (Photo No. 35).

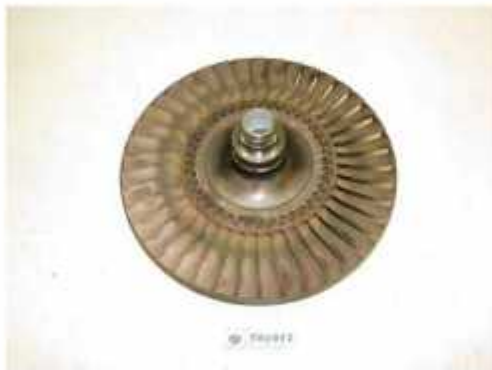
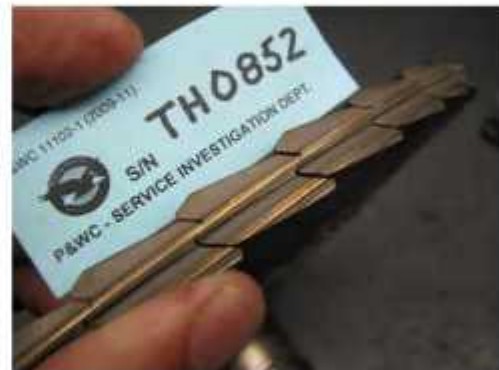
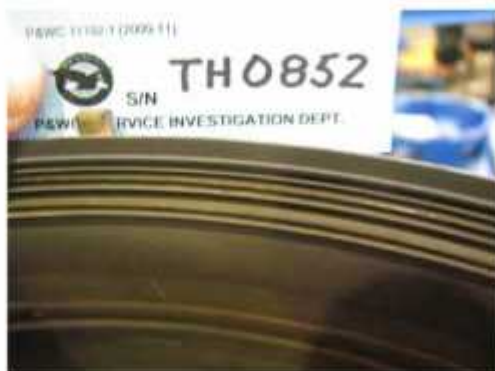
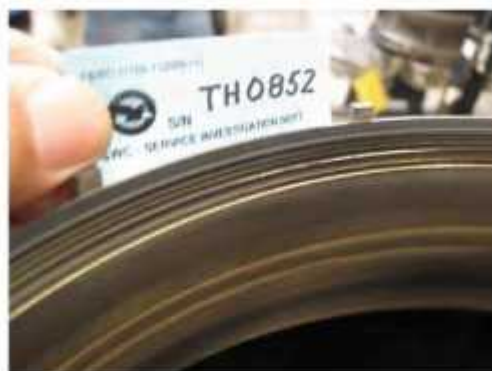
- 5.3 The power turbine disc was removed (Photo No. 40) and there was evidence of rubbing on the shrouded tips (Photo No. 41). The PT stator showed rubbing between the 10 to 1 o'clock position and 5 to 7 o'clock position (Photo No. 42 and 43).

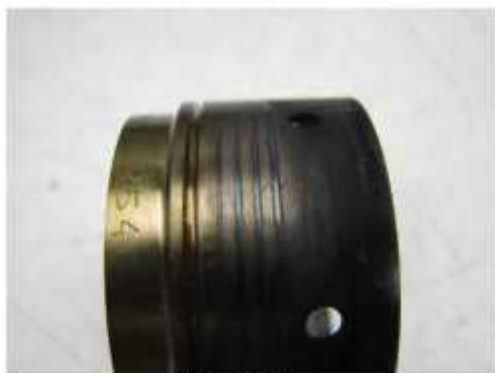
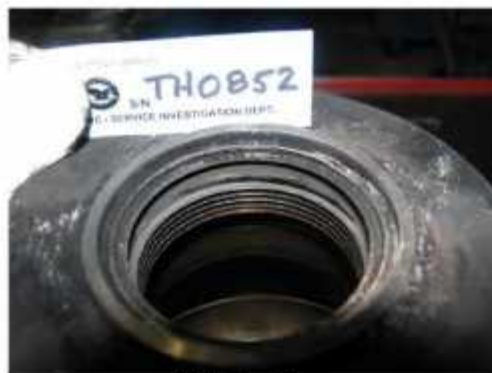
- 5.4 The No. 3 bearing air seal rotor showed rubbing over the complete circumference (Photo No. 44) from contact with air seal stator (Photo No. 45).

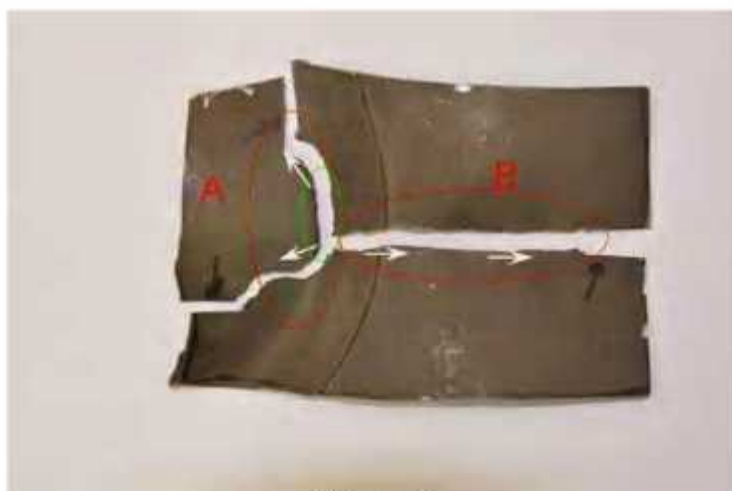
Photo No. 48

- 6.3 The cracks were opened in the laboratory to evaluate the fracture surfaces "A" and "B" (Photo No.48). The green dotted oval indicates the location of the main origin. The crack extended parallel to the resistance weld and at a distance of approximately 3/16 inches from the edge of the weld. The white arrows show the direction of the secondary cracks propagation.

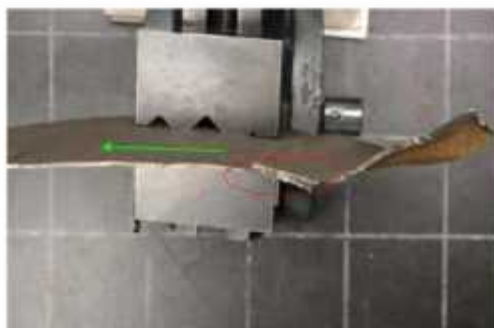
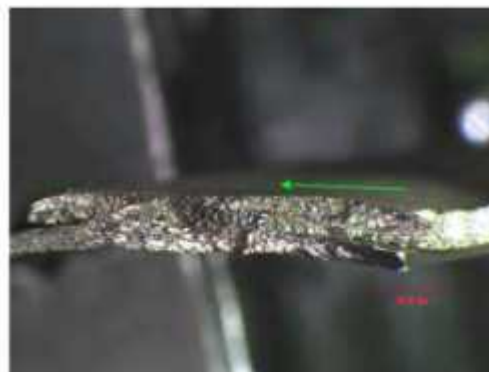
- 6.5 The fracture surface "B" in the area of the resistance weld (red dotted oval Photo No. 51) exhibited a granular and dull gray coloration suggesting that the fracture surface was older. The left hand side of the fracture occurred by shear overload and exhibited a yellowish fracture surface. The green arrow indicates the crack propagation direction (Photo No. 52).

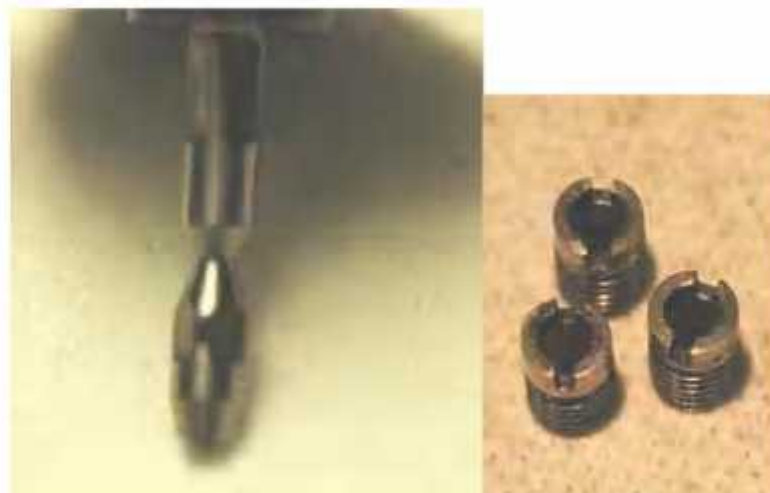
Figure 2
TH0852 AFCU bypass valve and bleeds

Partial disassembly of the AFCU revealed the bypass valve diaphragm was stiffening. The bypass valve and sleeve were worn. There were lateral grooves worn into the Pr regulator sleeve.
