**PRELIMINARY REPORT ON ACCIDENT INVOLVING SIKORSKY S-76C++ HELICOPTER BELONGING TO BRISTOW HELICOPTERS NIGERIA LIMITED WITH REGISTRATION 5N-BQJ WHICH OCCURED AT ABOUT 75 NM TO LAGOS IN THE ATLANTIC OCEAN ON THE 3<sup>RD</sup> OF FEBRUARY, 2016.**

**REGISTERED OWNER AND OPERATOR:** Bristow Helicopters Nig. Ltd.

**PLACE OF ACCIDENT:** 75 NM off Lagos in the Atlantic Ocean.

**DATE AND TIME:** 3<sup>th</sup> of February, 2016 at about 1025hrs.

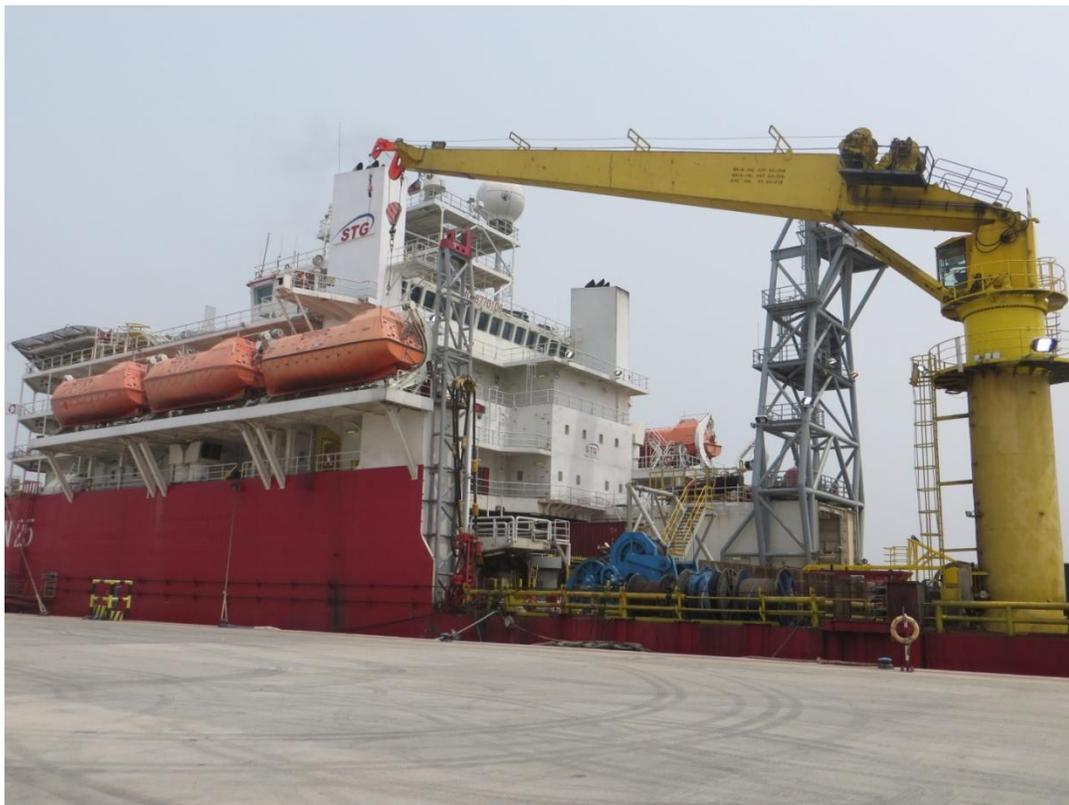
A speed boat was dispatched from the Sea Truck Group (STG) Jacson 25 ship to rescue crew and passengers (See fig 1). Several other boats from CHEVRON, AGIP and SHELL were involved in the rescue effort. Passengers and crew were all taken to the ship which subsequently berthed at the Eko Support Quay. They were later taken to the Lagoon Hospital where toxicology tests were performed only on the crew. The tests were negative to any substance of abuse. The first interviews were also conducted at the Lagoon Hospital.

Fig. 1. The Sea Truck Group (STG) rescue ship with a Heli-deck on board

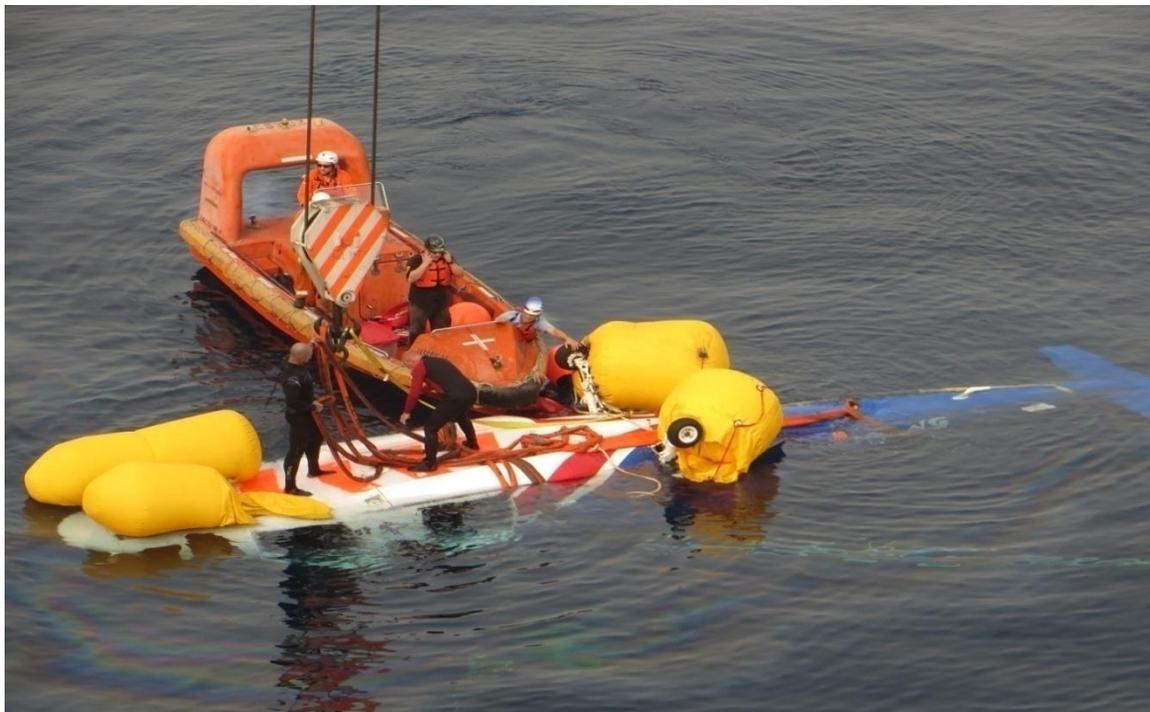
However, the aircraft ditched safely at about 10:25:00hrs into the Atlantic Ocean at about 75NM to Lagos, the two life rafts were deployed, although the left raft was slightly damaged during jettisoning of the left side door. The passengers and crew safely evacuated into the life raft and were rescued one and half hours later. More passengers transferred to the right life raft, thus creating a tilt of the aircraft to the right. The aircraft later capsized with the Emergency floating devices holding the aircraft afloat upside down, fully submerged in the salty waters of the Atlantic Ocean at about 75NM to Lagos (See fig. 2).

The helicopter was destroyed by submerging into the salty waters of the ocean (See Figs. 2-5).

Fig. 2. The Helicopter submerged in the salty ocean water

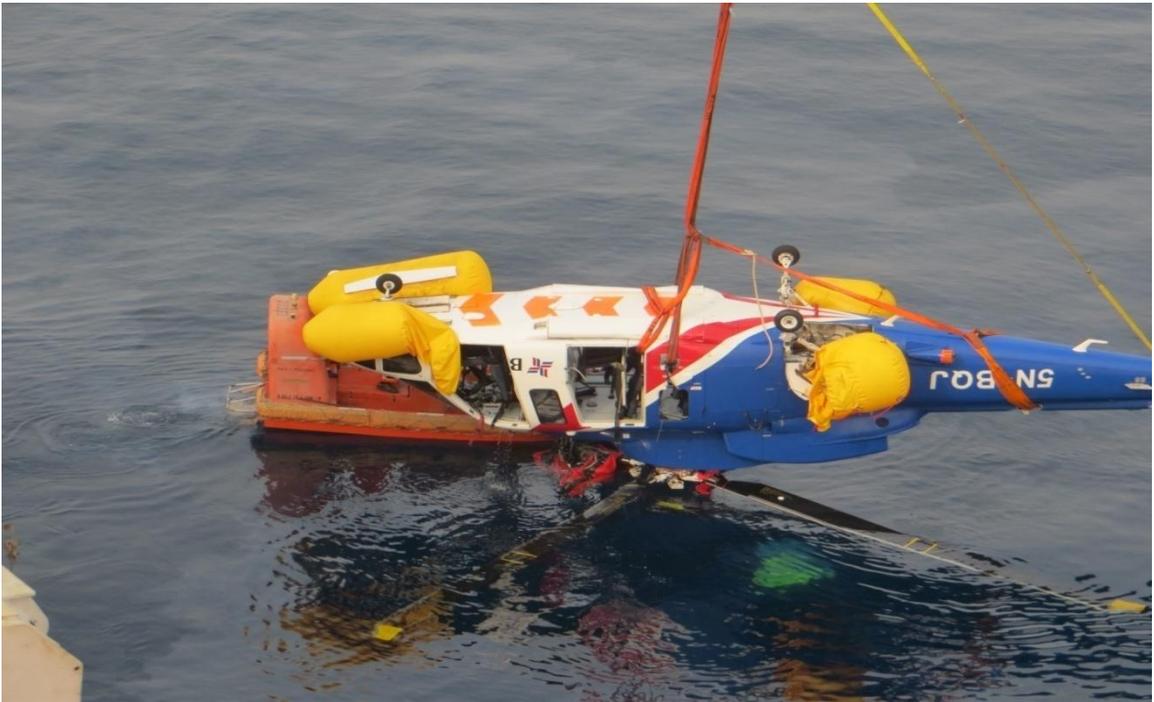
Fig. 3. Helicopter recovery from the ocean

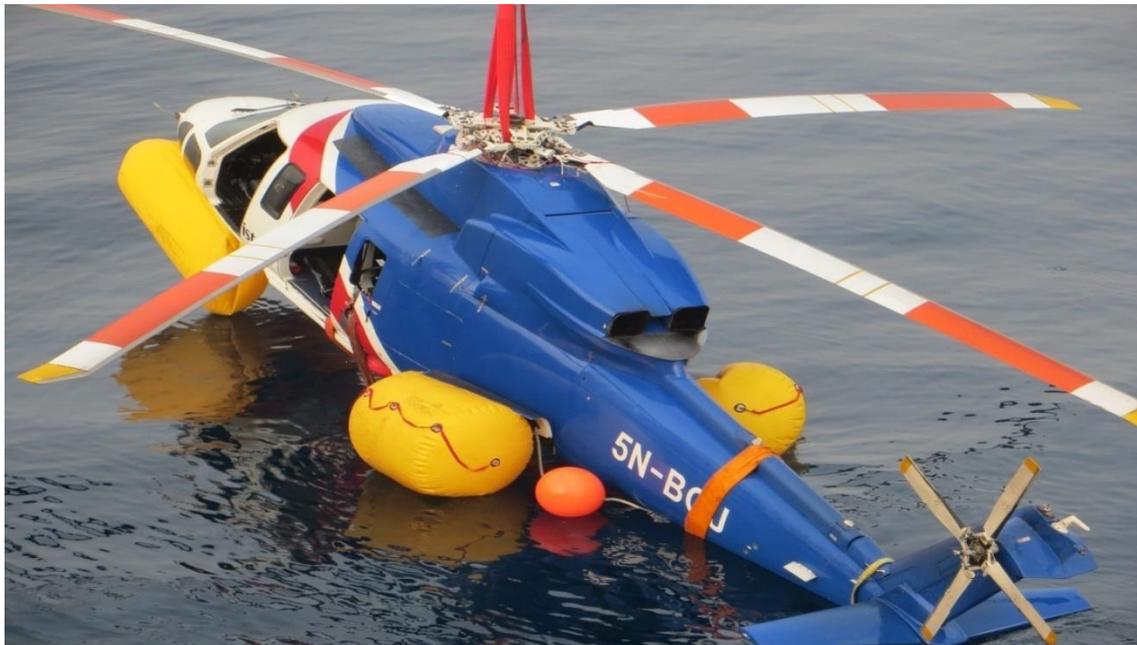
Fig. 4. Helicopter turned in readiness to be loaded on the rescue ship

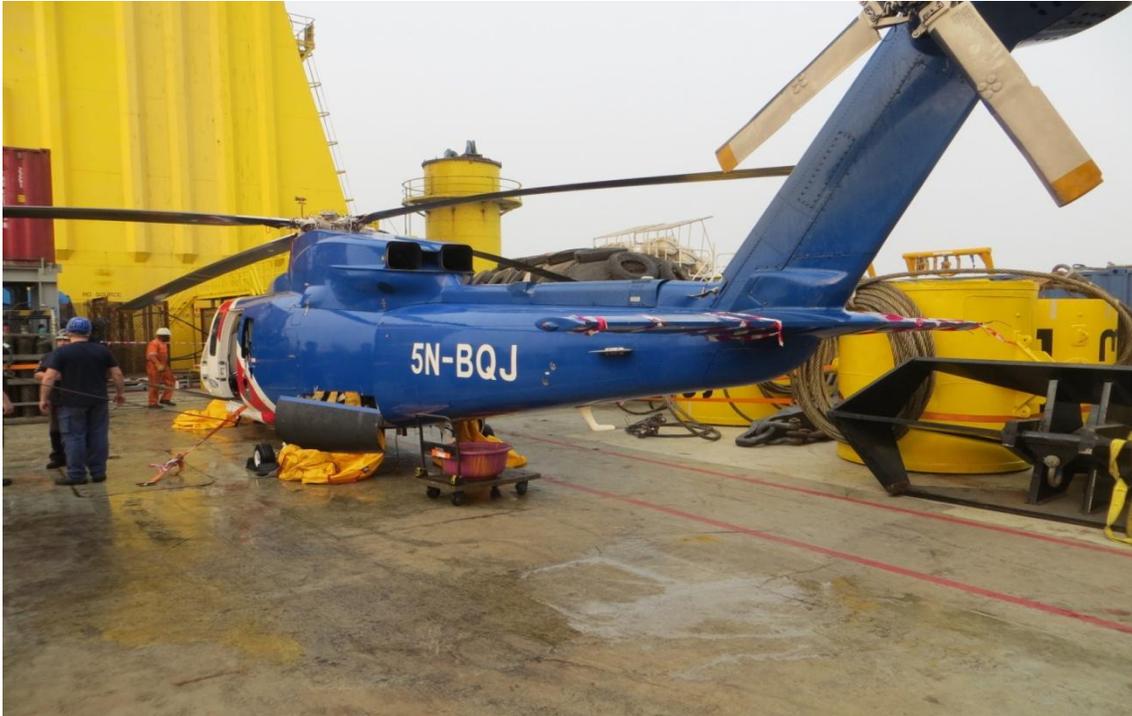
Fig. 5 Helicopter safely on board the rescue ship

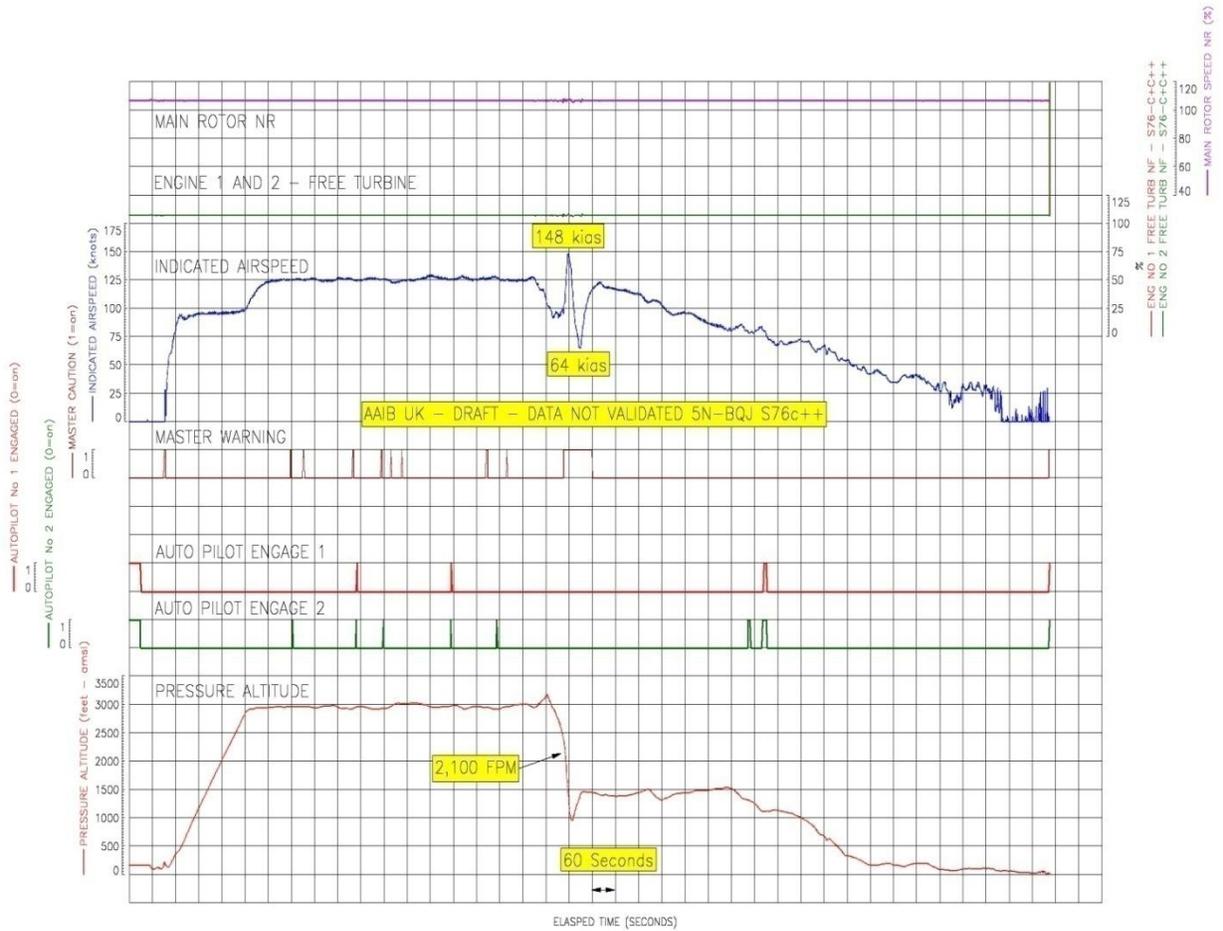
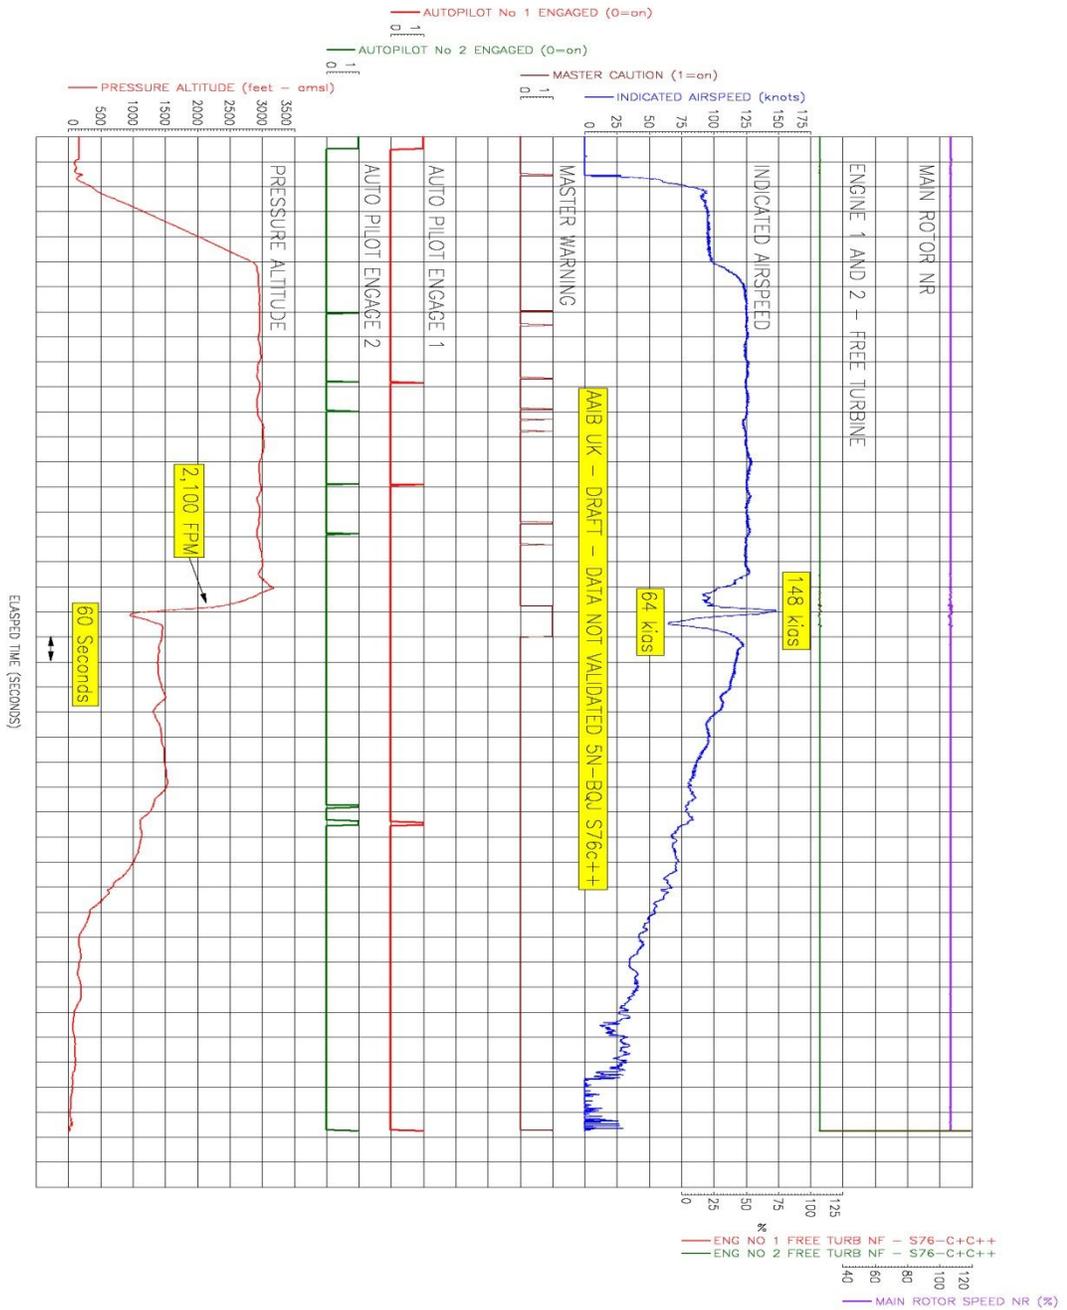
Investigation so far discovered some defects with both the Cockpit Image Recording and the Flight Data Recording Systems. The Flight Data Acquisition Unit (FDAU) also indicated internal FAULT. A significant number of the parameters on the FDR data such as heading, cyclic, collective and yaw control inputs were not retrieved. Other Non-volatile Memory Devices are being downloaded to obtain the necessary parameters.

Fig.6a FDR Recorder Download Plot

Fig. 6b FDR Recorder Download Plot

The cause of the accident has not been determined, as the investigation is still ongoing. Meanwhile, the initial FDR download confirmed some of the crew assertions like an uncommand rapid rate of descent and speed reduction. The aircraft descended within 60 seconds from 3000ft to 1000ft approximately at the rate of 2,100 Feet Per Minute (FPM) also losing speed from 148 KIAS to 64 KIAS over the same period (60 seconds) before stabilizing at 1,500ft (See figs 6a and 6b).

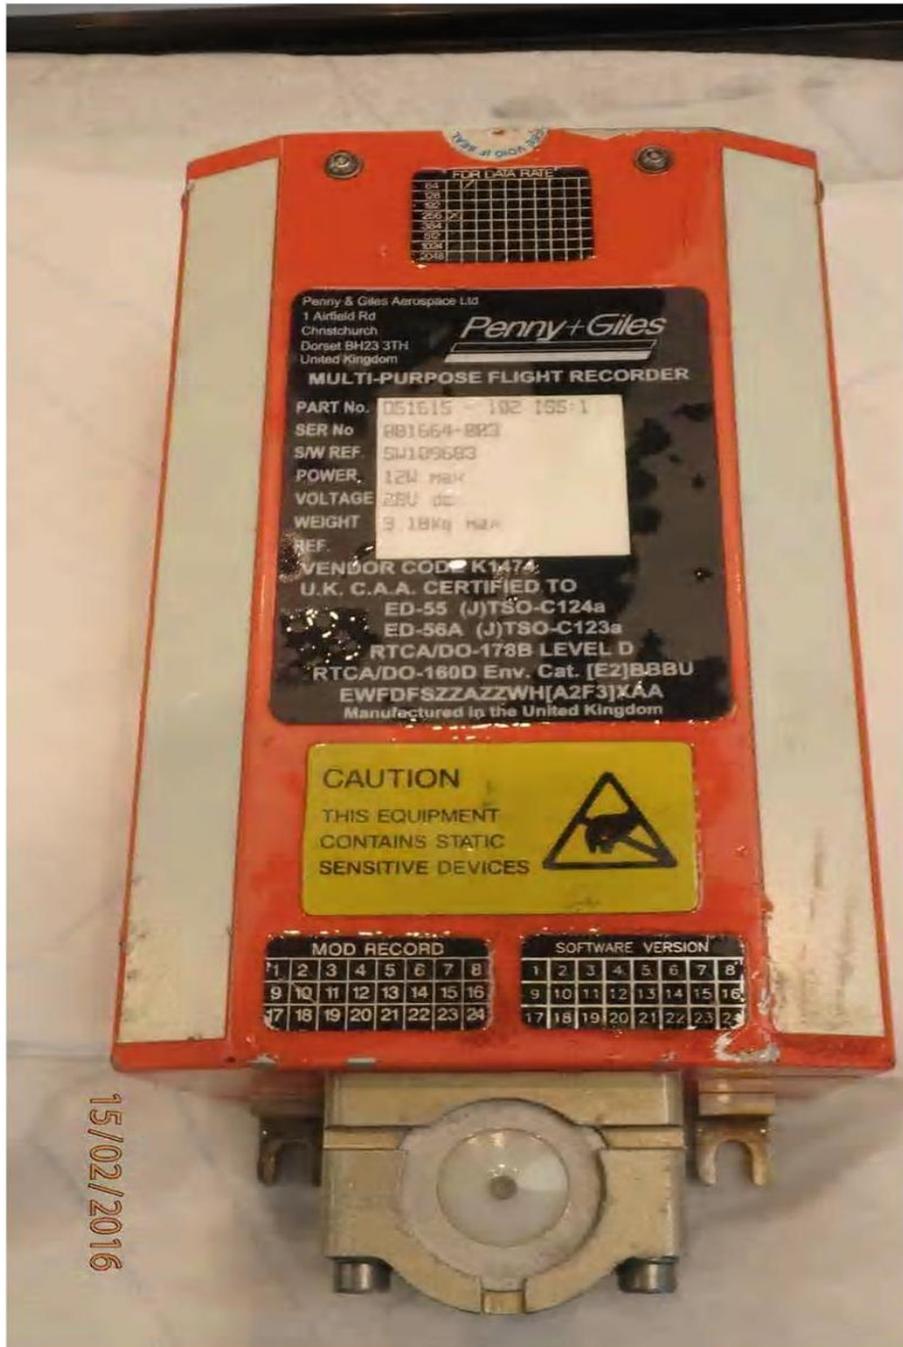
The Helicopter was fitted with a Multi Purpose Flight Recorder (MPFR) which represents the Cockpit Voice Recorder/Flight Data Recorder (CVR/FDR) (See fig.7), with a common part and serial number. However, a separate **Faerito Avionics Recorder** (Cockpit Image Recorder (CIR)) (See fig. 8) was also installed in the helicopter to augment the CVR and FDR. The recorders were retrieved when the aircraft was recovered from the ocean in good condition. The recorders were sent to Air Accident Investigation Branch (AAIB), UK and were successfully downloaded and are now being analyzed.

Fig.7 Multi-Purpose Flight Recorder

- a.) That annual flight recording readout is carried out for every aircraft in accordance with NCAA (Order 001) 2014 paragraph 4 and ICAO Annex 6 Part III.
- b.) The records obtained shall be preserved with the appropriate current data frame layout and presented on demand to the investigative authority in case of serious incidents/accidents.

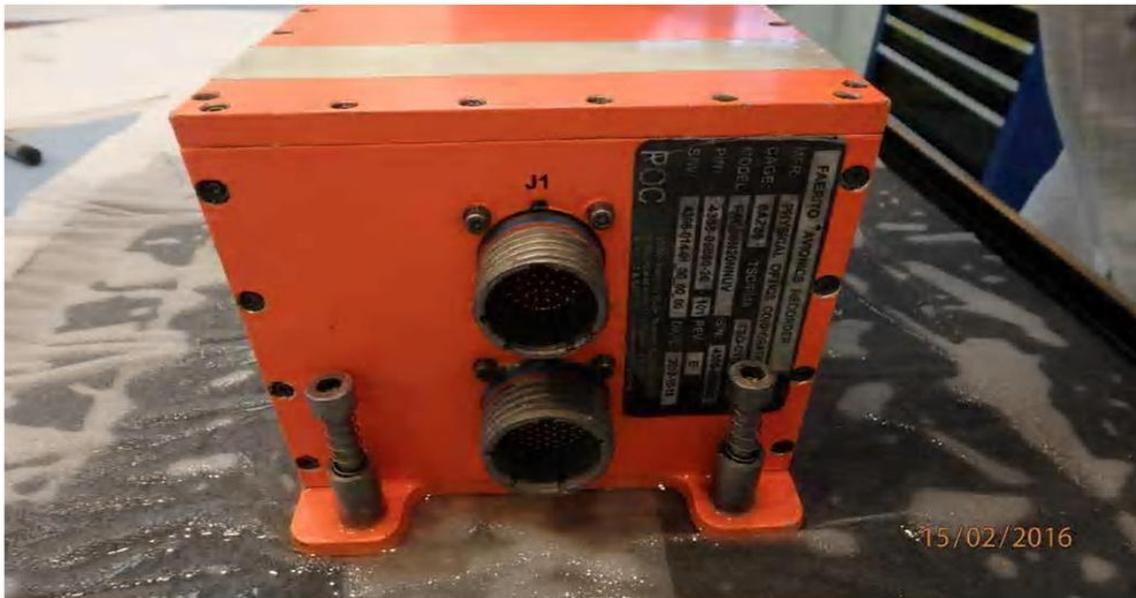
The recorder removed from 5N-BQJ is understood to be the first accident damaged recorder of this type. The download of data and display of images were made using replay software provided by the manufacturer, Physical Optics Corporation (POC).

Fig. 8. Faerito Avionics Recorder (Cockpit Image Recorder)
