## **PRELIMINARY REPORT ON SERIOUS INCIDENT INVOLVING BOEING 737-300 AIRCRAFT BELONGING TO AIR PEACE LIMITED WITH NATIONALITY AND REGISTRATION MARKS 5N-BUO WHICH OCCURRED AT FL 310 ENROUTE ENUGU FROM LAGOS ON 14<sup>TH</sup> DECEMBER, 2018**

<b>Registered Owner and Operator:</b>	Air Peace Limited
<b>Aircraft Type and Model:</b>	Boeing 737-36Q
<b>Manufacturer:</b>	Boeing Aircraft Company
<b>Date of Manufacture:</b>	1997
<b>Nationality and Registration Marks:</b>	5N-BUO
<b>Serial Number:</b>	28660
<b>Location:</b>	FL 310 Enroute Akanu Ibiam International Airport Enugu
<b>Date and Time:</b>	14 <sup>th</sup> December, 2018 at about 10:44 h <i>(All times in this report are local time (UTC +1) unless otherwise stated)</i>

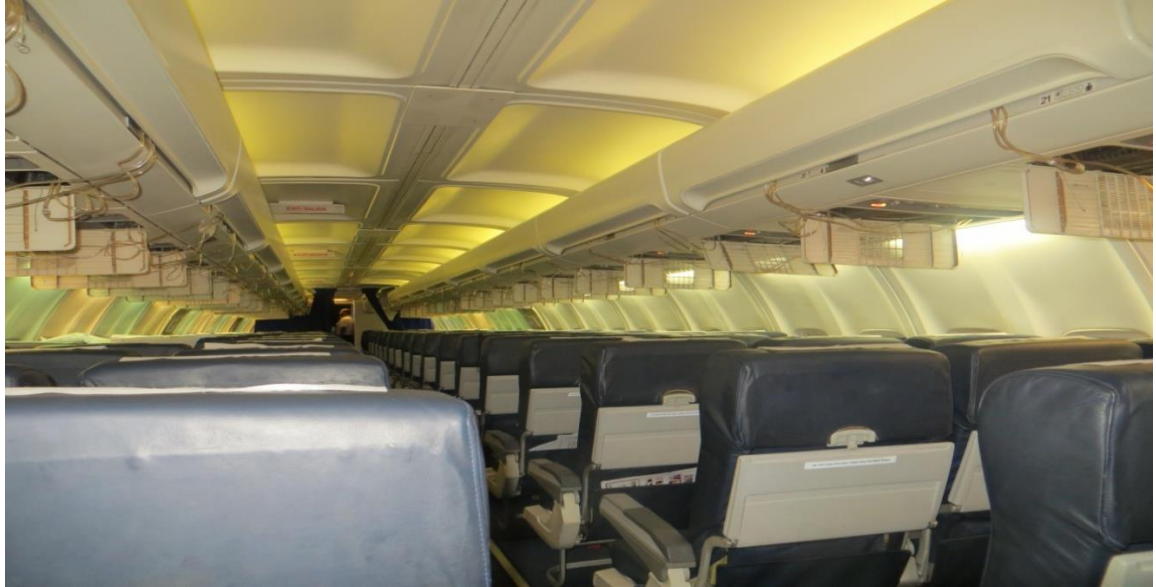
14. At FL 120, the cabin crew and passenger's oxygen masks automatically deployed and the cabin altitude remained at 14,000 ft.
15. During post incident inspection, the passenger oxygen switch in the cockpit was found wire-locked in 'Normal' position though the oxygen masks have dropped; hence the rapid depressurisation/emergency descent checklist was not completed.

**Figure 2:** Photo showing cabin with dropped oxygen masks from overhead panels

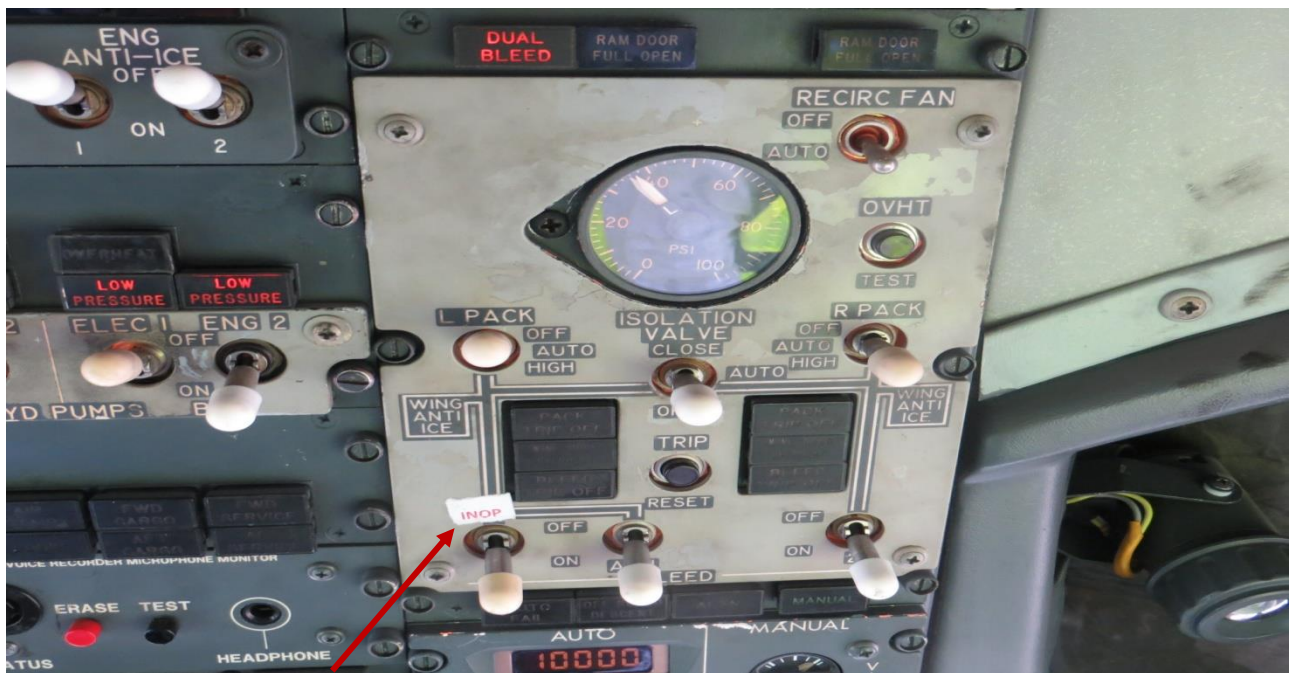
Engine No.1 bleed switch on the air-conditioning panel was placarded 'INOP'. Pressure on the left duct was 18 psi and this was entered in the Deferred Defect Log book on 12<sup>th</sup> December, 2018 with a limit of 22<sup>nd</sup> December, 2018. Action on the low bleed on engine no.1 was raised in accordance with MEL (36-05 CAT C).

8. The left engine bleed valve switch on the air-conditioning panel of 5N-BUO was placarded 'INOP'.
9. The take-off/climb out phase was normal.
10. The crew climbed to FL 310 with one air-conditioning pack inoperative as against the maximum FL 250 stipulated in the MEL.

**Figure 3:** Photo showing the left engine bleed switch on air-conditioning control panel with 'INOP' placard as indicated by the Red arrow

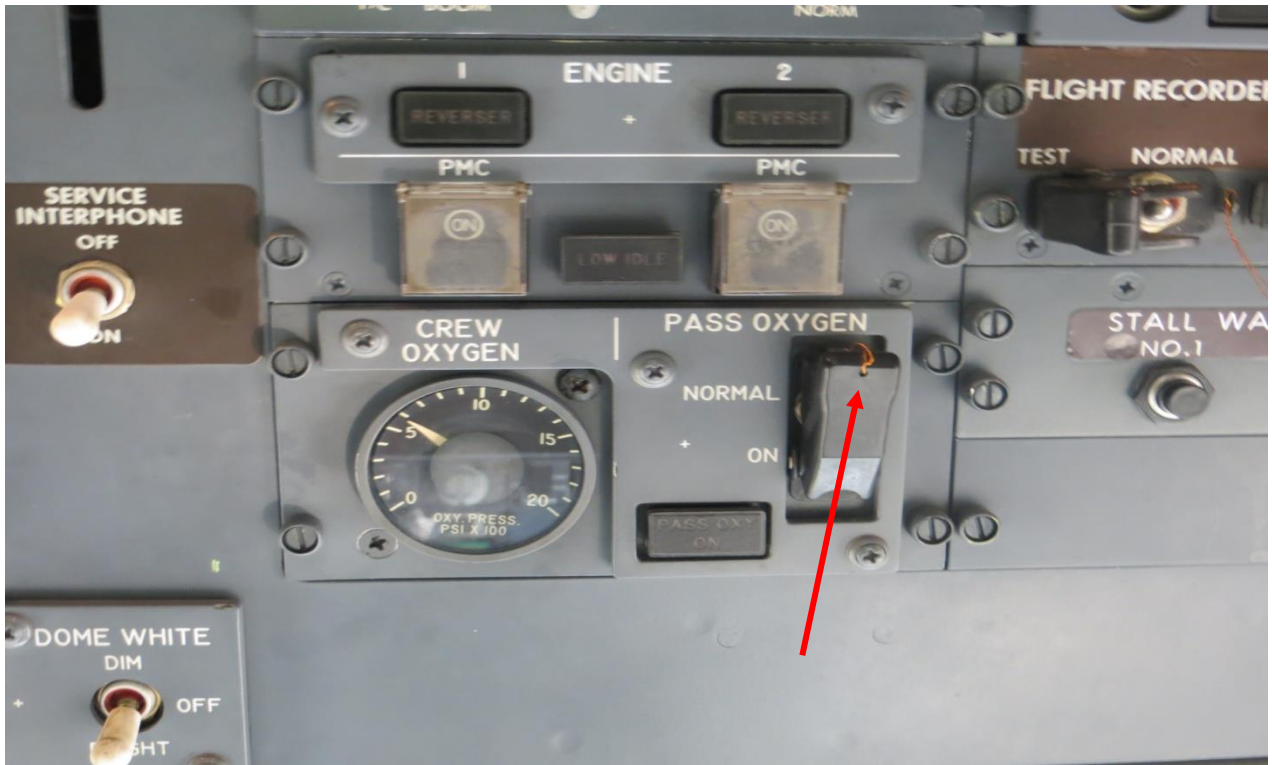
**Figure 4:** Photo showing the Passenger Oxygen switch wire locked in 'Normal' position as indicated by the Red arrow.
