PRELIMINARY REPORT ON THE SERIOUS INCIDENT INVOLVING GULFSTREAM G IV AIRCRAFT BELONGING TO SKYBIRD AIR LIMITED WITH REGISTRATION NUMBER 5N-BOD WHICH OCCURRED AT NNAMDI AZIKIWE INTERNATIONAL AIRPORT ABUJA ON 12TH SEPTEMBER, 2018.

Aircraft Type: Gulfstream G IV

Registration: 5N-BOD

Location: Runway 22, Nnamdi Azikiwe Int'l Airport Abuja

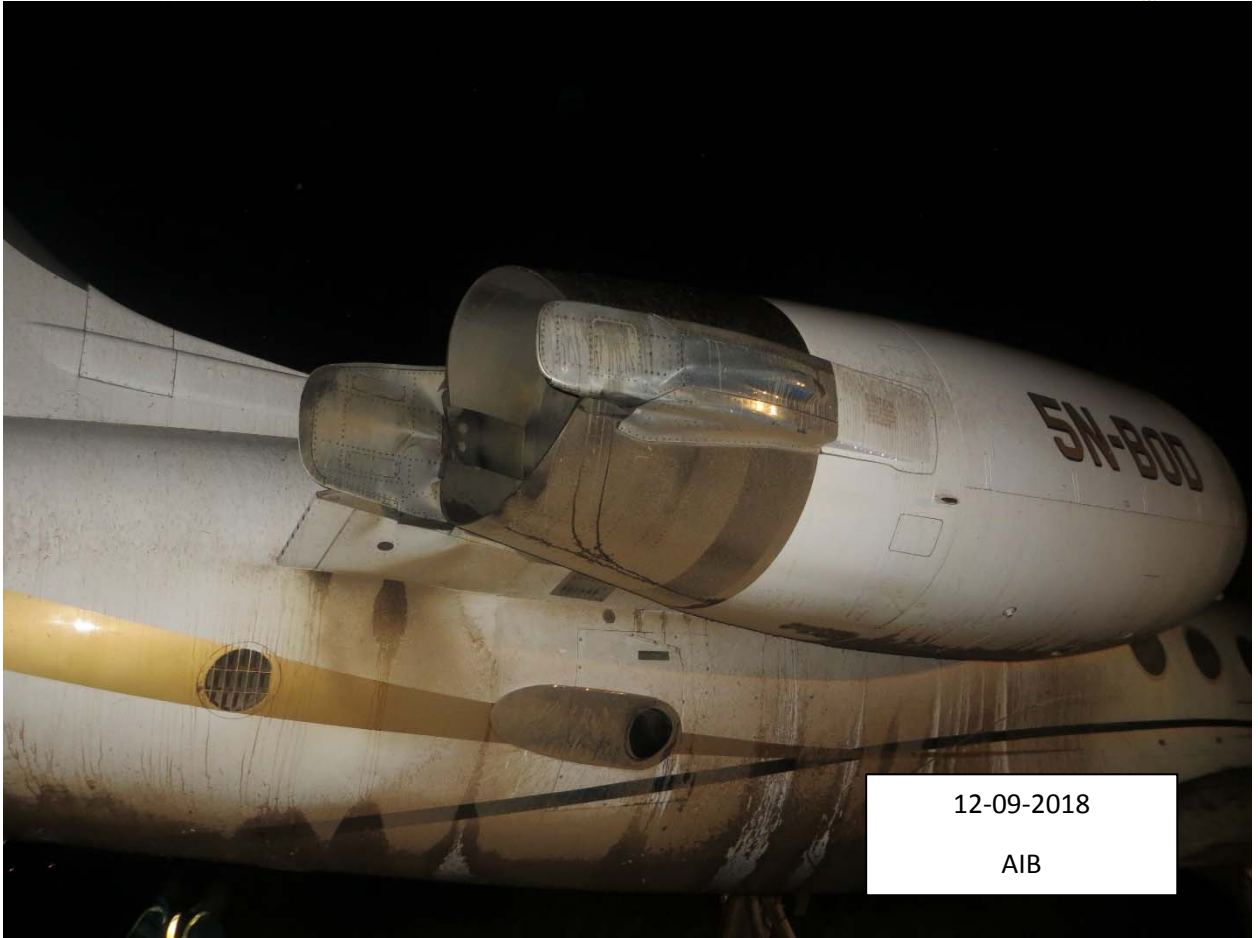
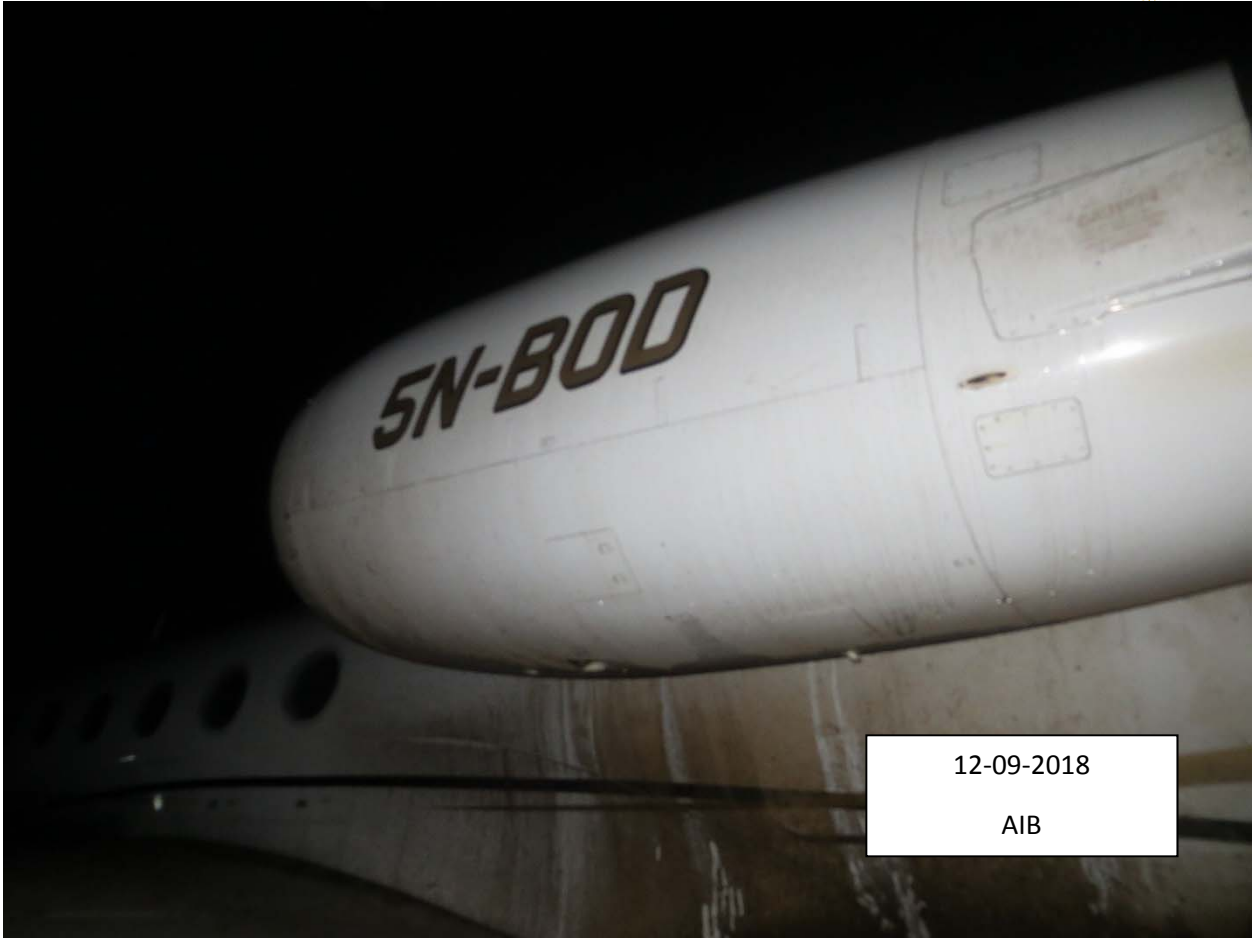
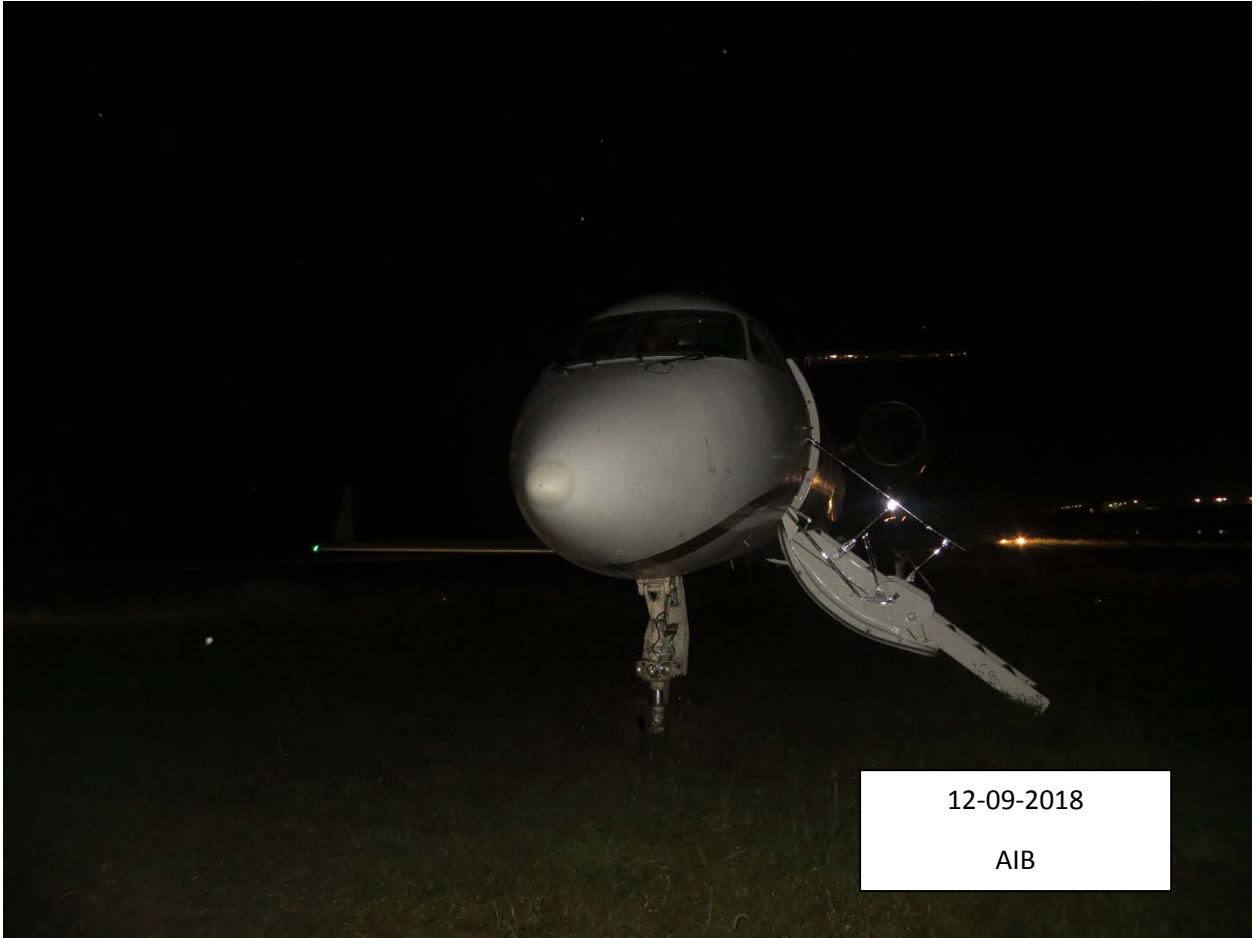
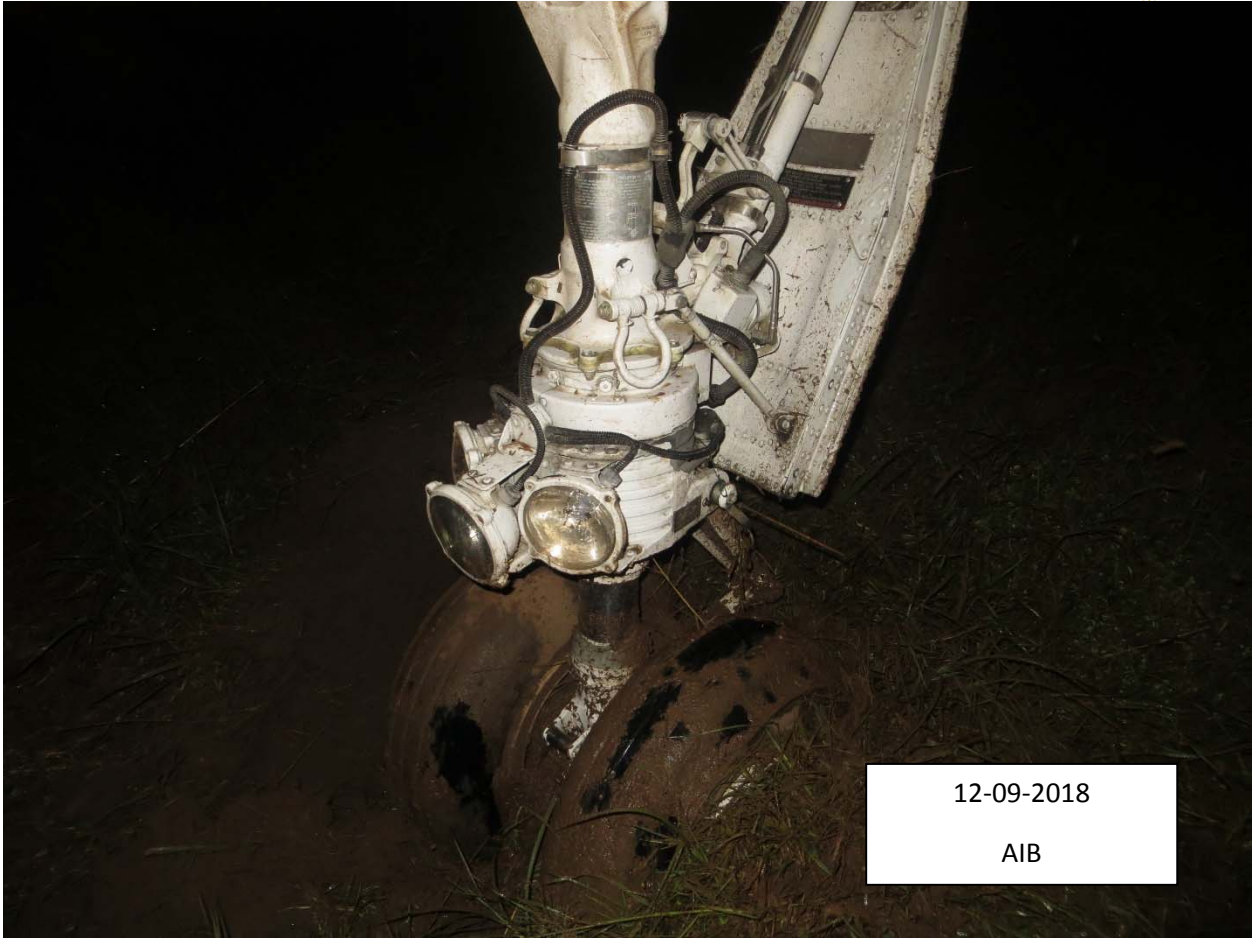
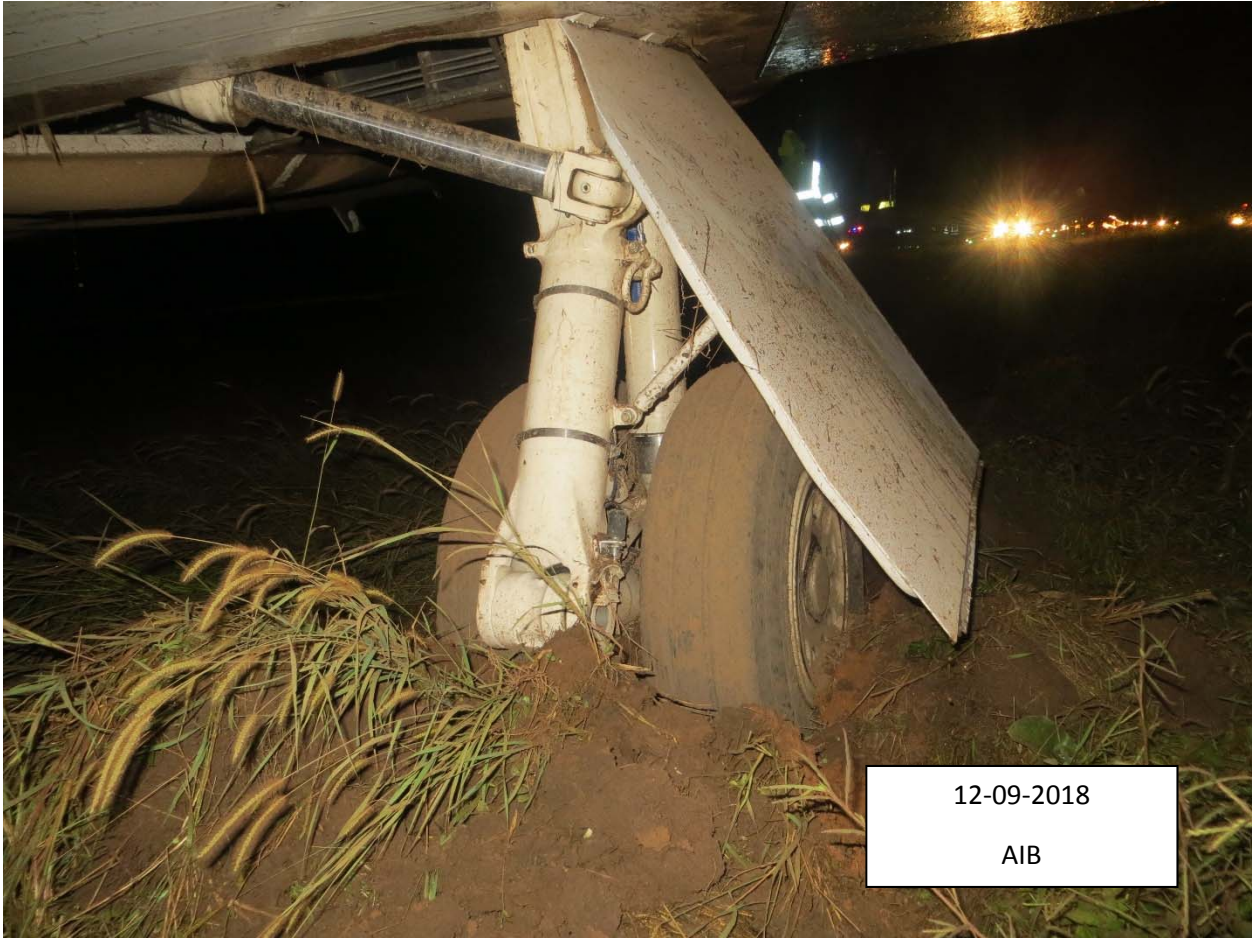
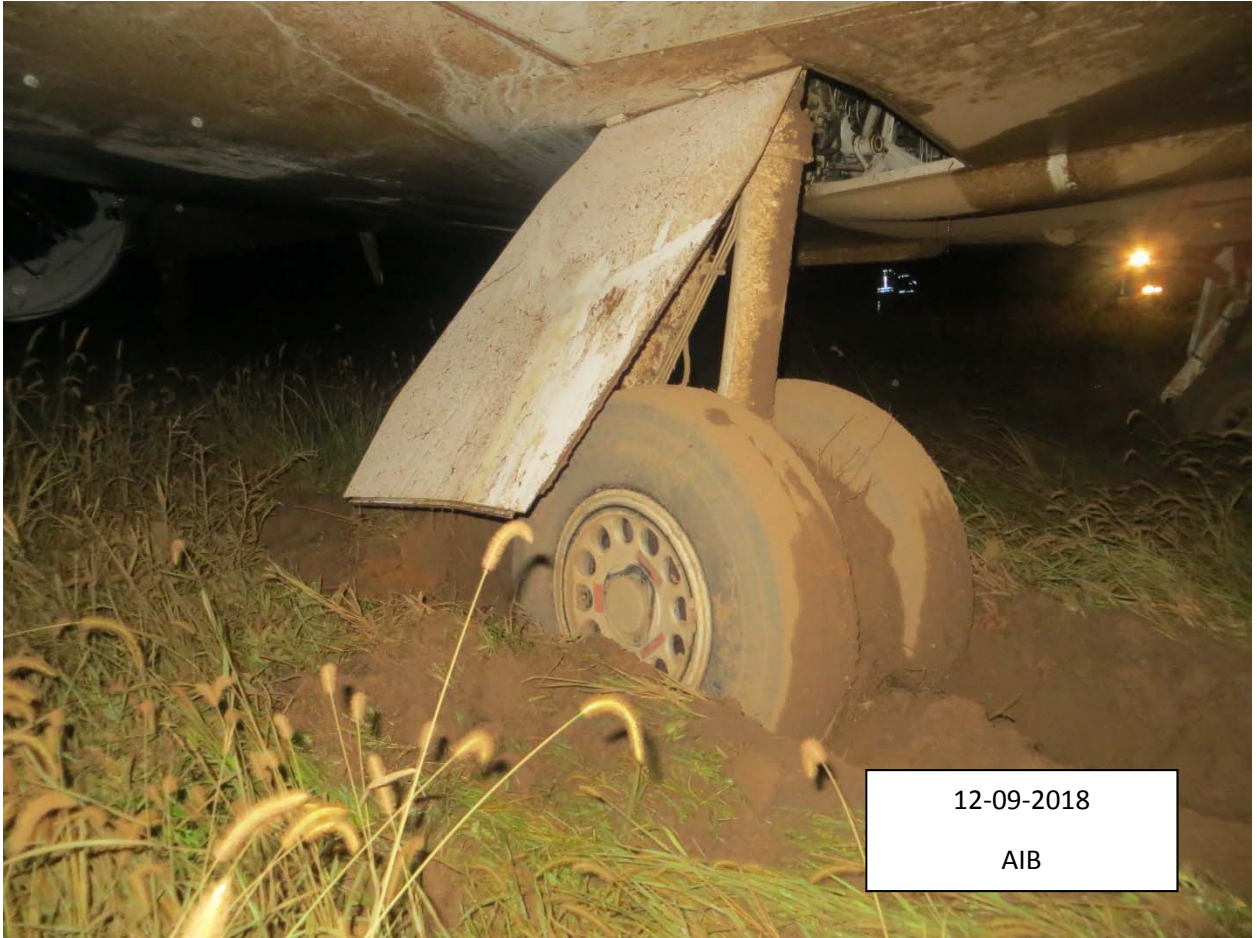
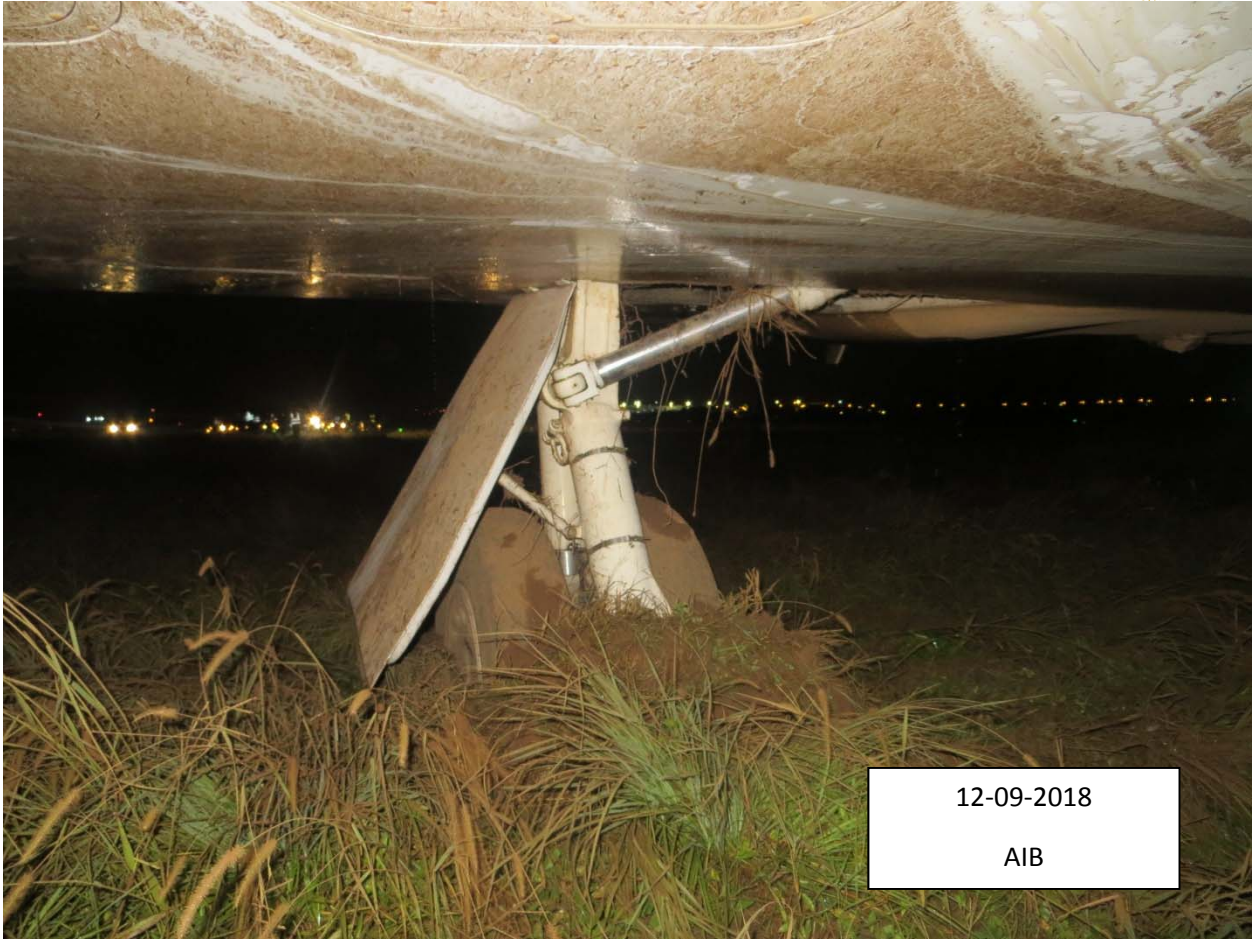
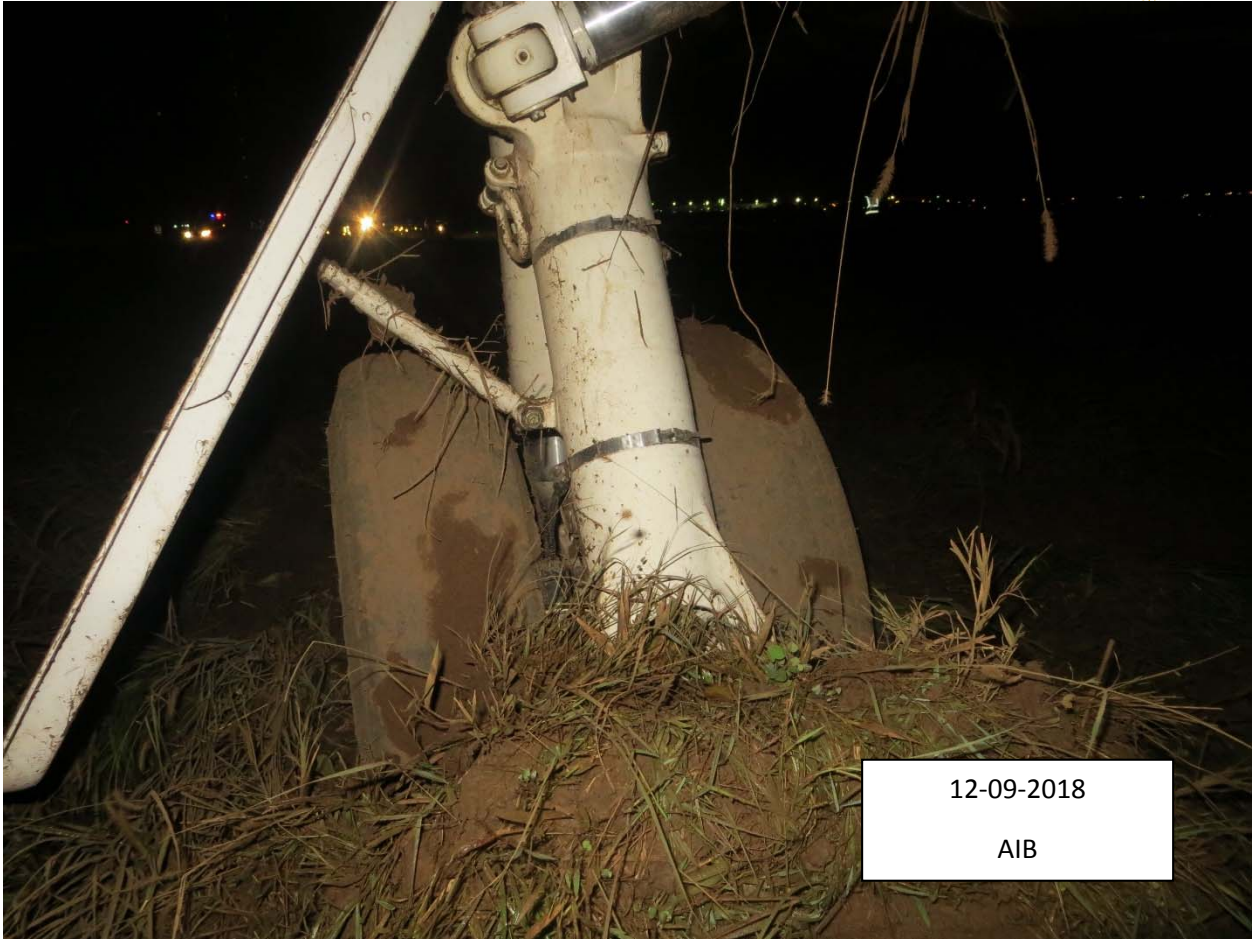
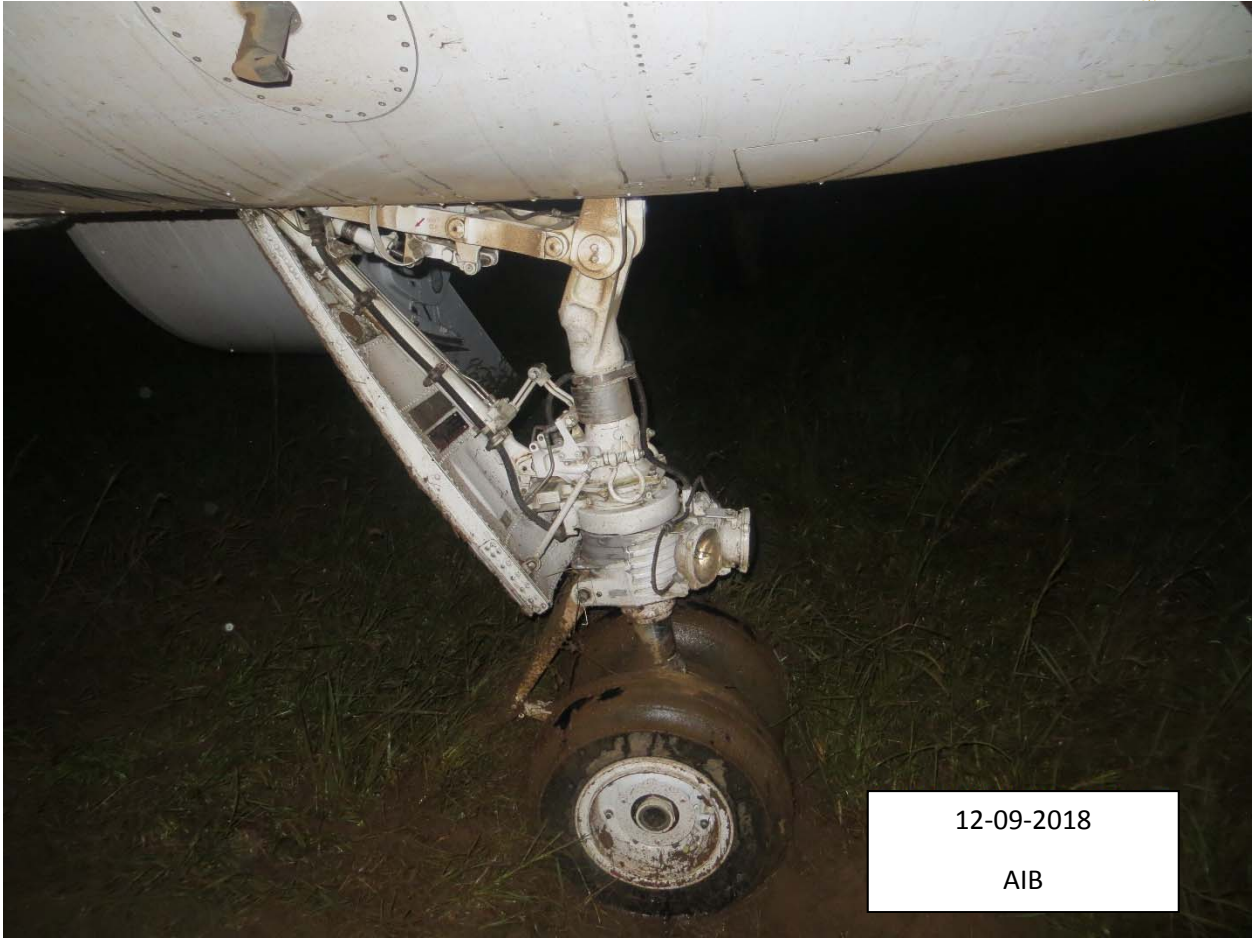
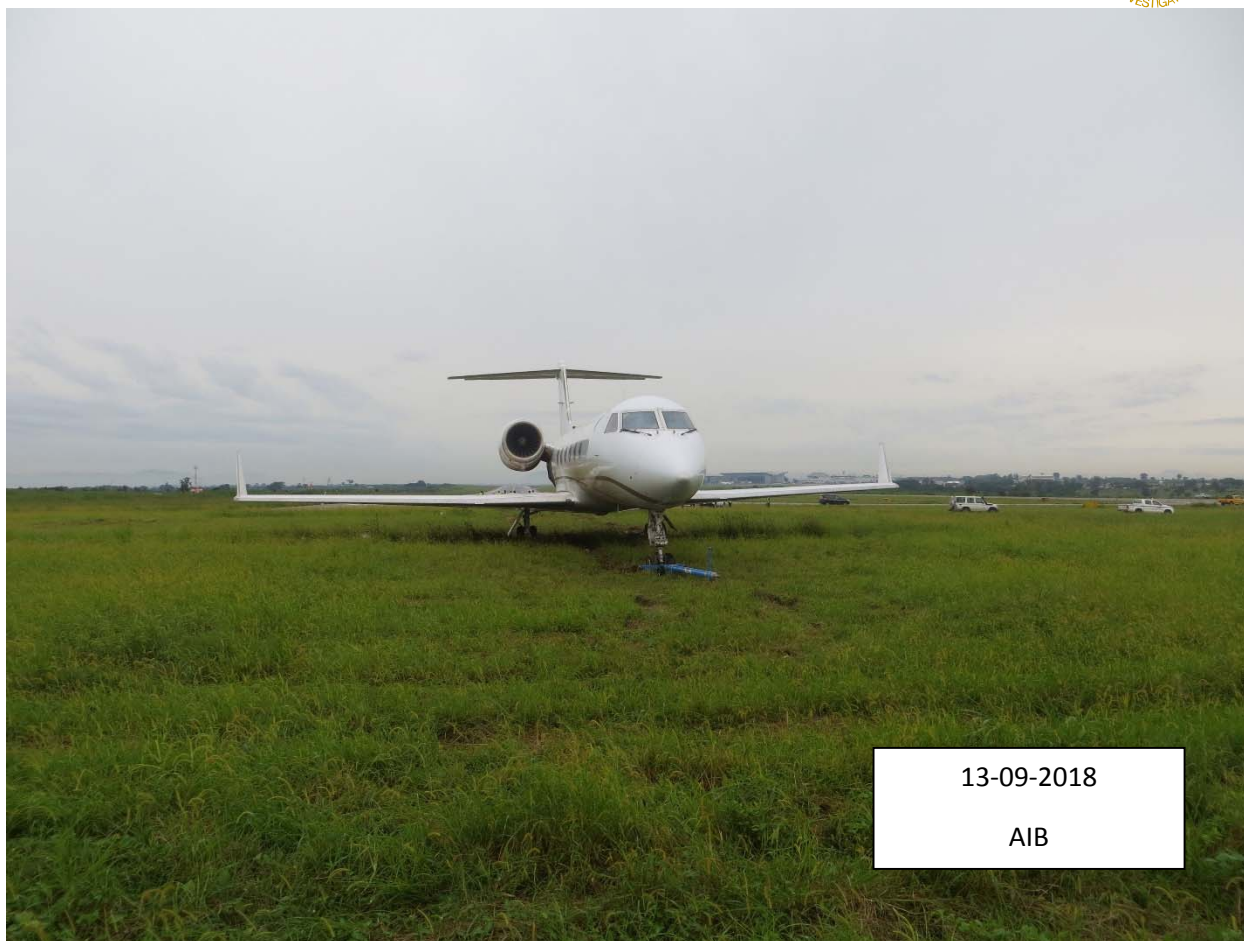
The aircraft exited the end of the runway and came to a stop in a mud, at a distance of 71m from the end of RWY 22 stop way.

Above: Pictures showing the aircraft at its final resting position.
