PRELIMINARY REPORT ON SERIOUS INCIDENT INVOLVING HAWKER 125-800XP AIRCRAFT BELONGING TO SWAT TECHNOLOGY LIMITED WITH REGISTRATION NUMBER N497AG ON RUNWAY 21 OF PORT HARCOURT INTERNATIONAL AIRPORT RIVERS STATE ON THE 11TH JUNE, 2015

Aircraft Type and Model: HS 125

Registration Number: N497AG

LOCATION: Runway 21

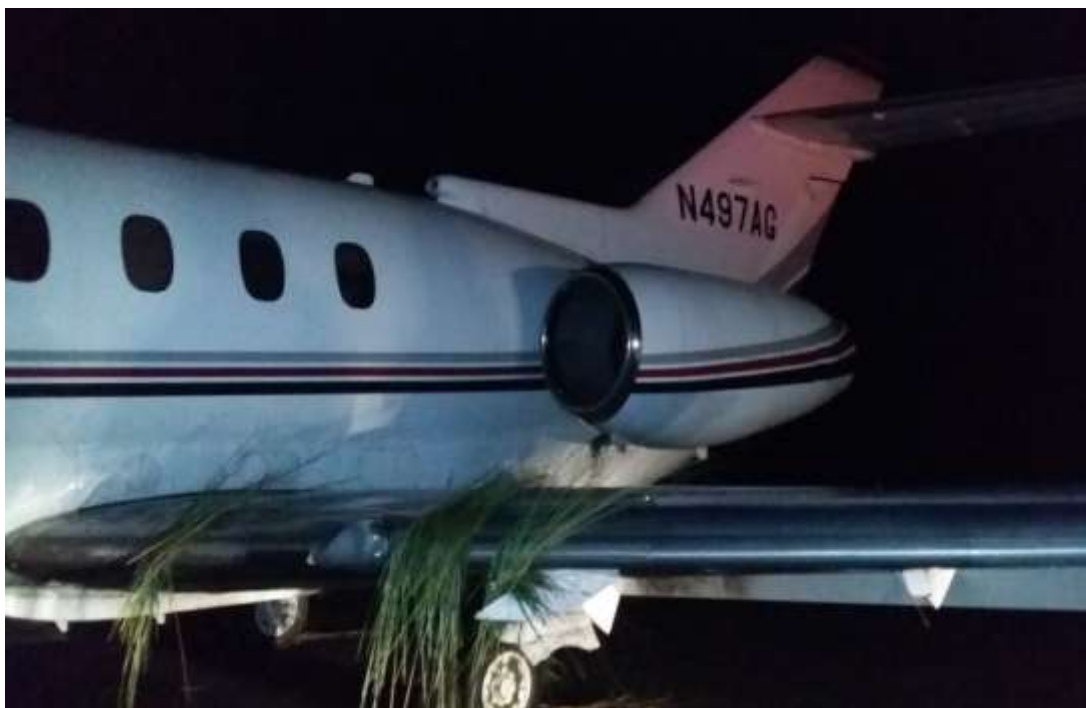
1. The nose wheel gear was dismembered from the airplane hinge point.
2. There was hydraulic leakage.
3. There was grass ingestion at the generator cooling inlet.

Figure 1: Photograph showing grass ingestion at the generator cooling inlet

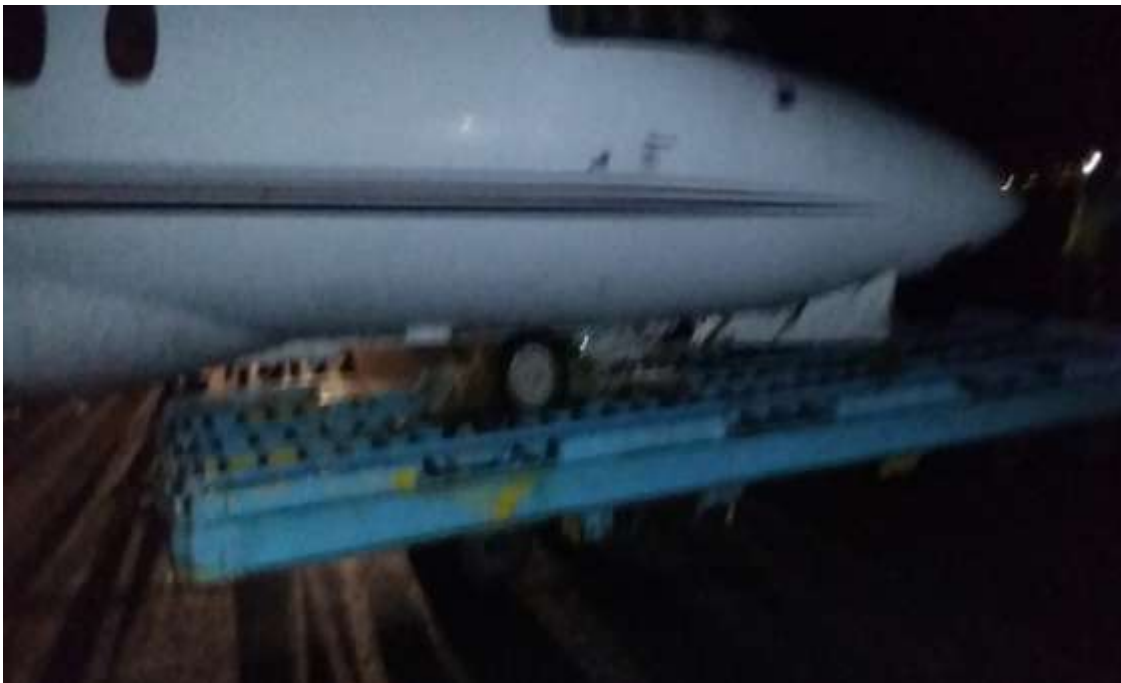
Figure 2: Photograph showing the aircraft being towed

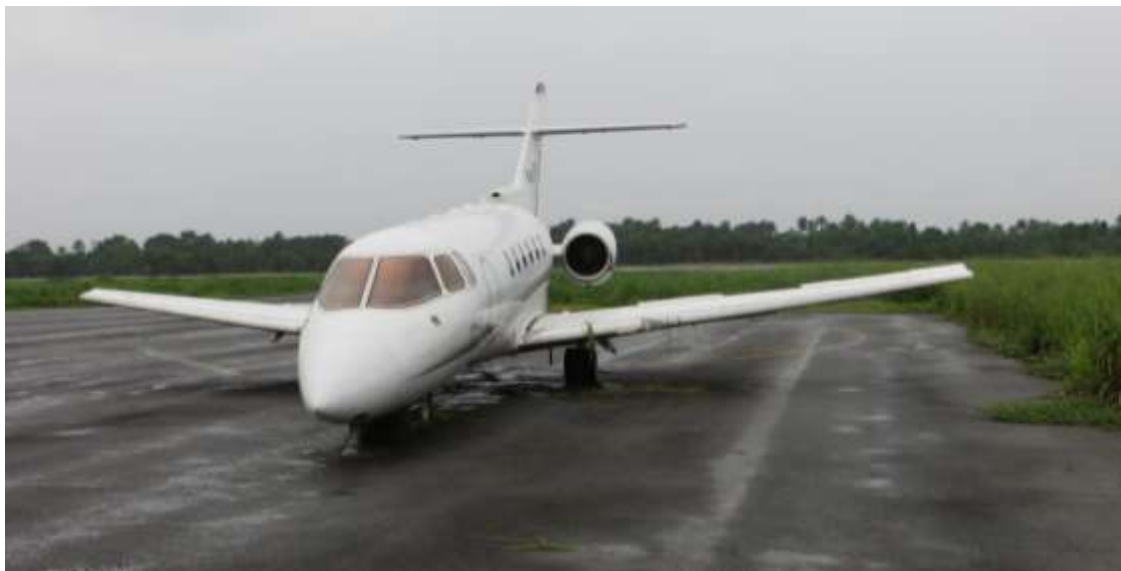
Figure 3: Photograph showing the aircraft parked at GAT Apron
