AIRCRAFT ACCIDENT REPORT

(WINGS/2008/03/15/F)

Accident Investigation Bureau

**Report on the Accident Involving
WINGS, Registration 5N – JAH,
Bushi Village, Obalinku.
(Near Bebi Airstrip) Obudu.
15th March, 2008.**

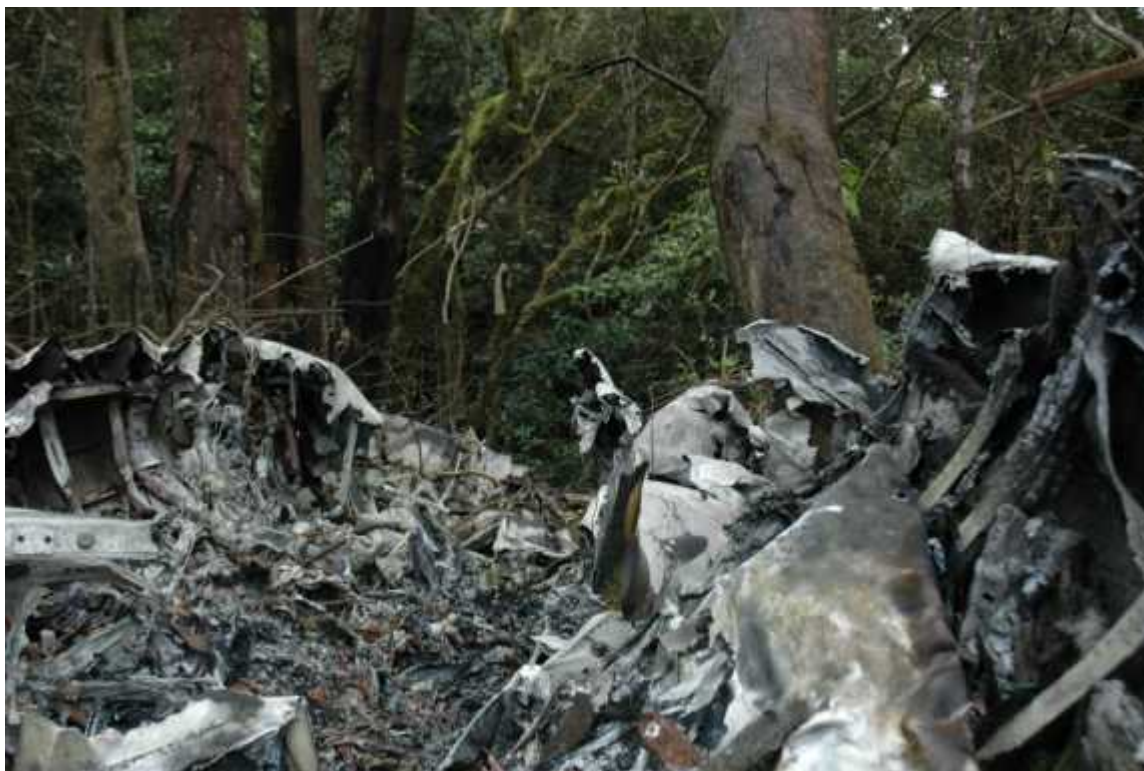
The aircraft was substantially destroyed by ground impact and post crash fire.

Burnt fuselage of the Wreckage

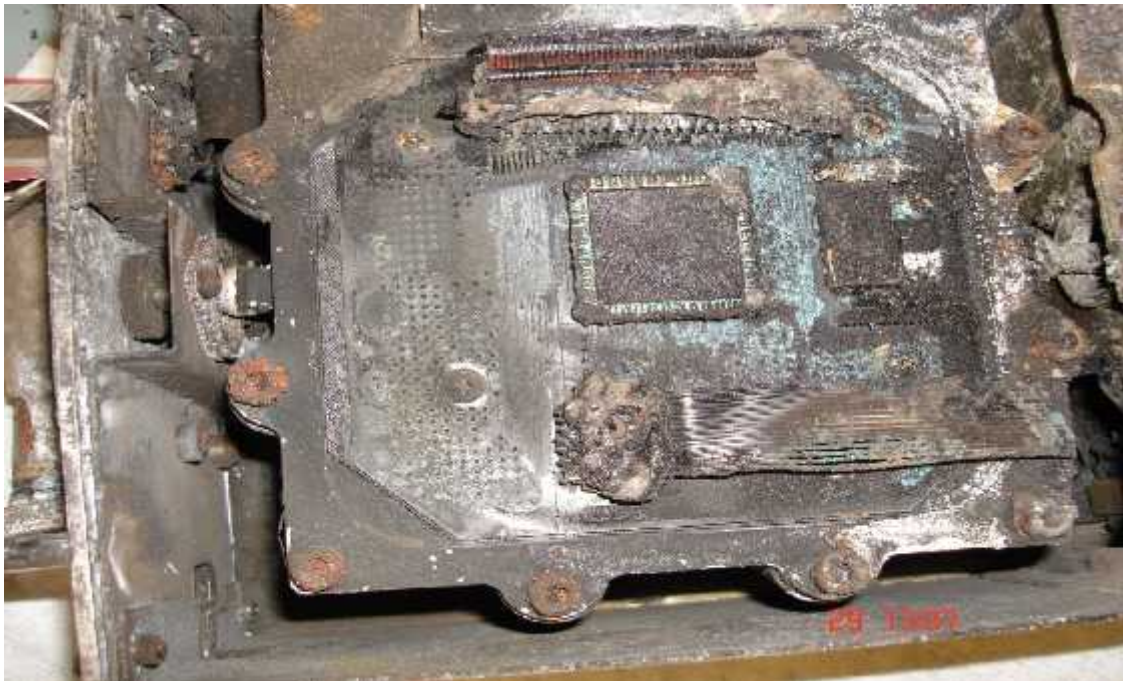
Cockpit voice recorder

The aircraft was fitted with a solid-state cockpit voice recorder (CVR) of 35 minutes duration and a Fairchild solid-state flight data recorder (FDR) the information on both of which were successfully downloaded by the Air Accident Investigation Branch (AAIB), United Kingdom. The recorders exhibited impact and severe fire damage. Data could not be extracted from units in normal manner. The crash protected memory were removed from the damaged accident box and transferred to a surrogate units in order to download the data. The FDR contained many hours of recorded data of which the event flight was the last data with a recording duration of 120 minutes. The three plots in this report contained data, which illustrated the event flight on the 15th march, 2008. Flight recorders parameters revealed that all engine and flight control inputs were functioning normally up till the moment the aircraft impacted terrain. The FDR data indicated that there was power on both engines, the speed at impact was over 150 kts, and the propeller speed on both engines was about 1500 rpm.

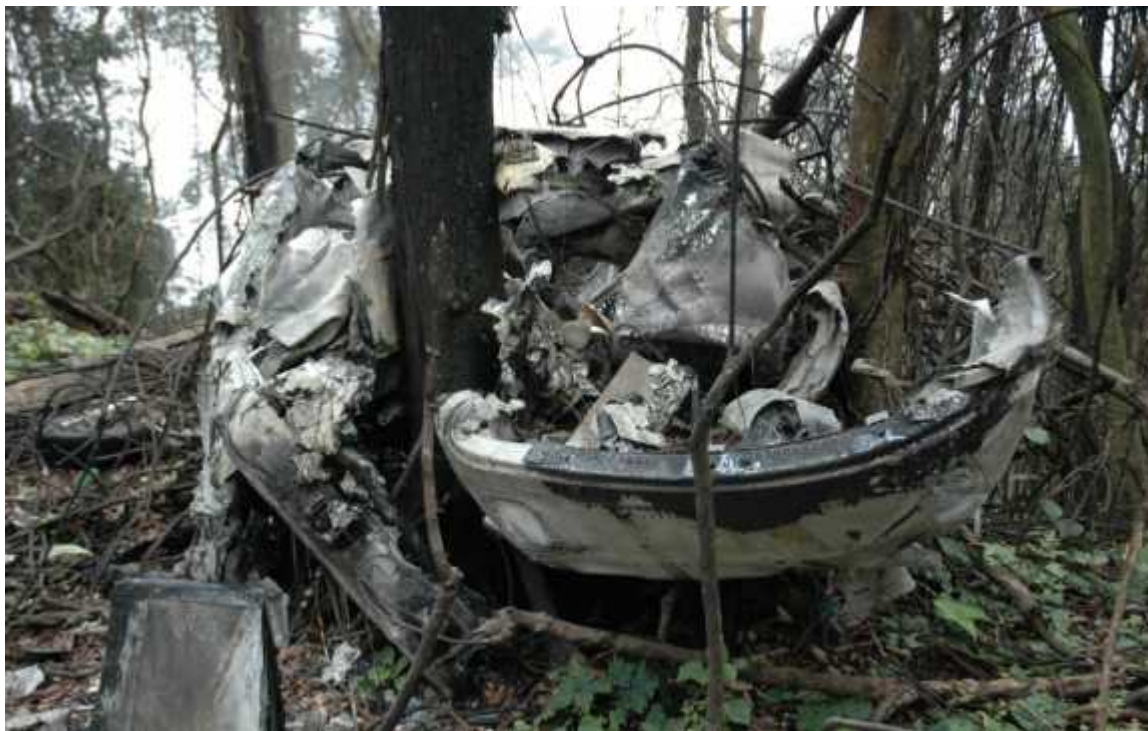
The airplane wreckage was found on the southwest side of Bebi airstrip in a Hilly terrain at about 3,200 feet high in a 200-foot-long wreckage path. The aircraft structures displayed heavy impact damage and fire damage consistent with a post crash ground fire. Examination of the wreckage area and vicinity revealed no evidence of a pre-impact fire or in-flight separation of components. The majority of the airplane's system components were located in and around the main debris field. All evidence, on close examination of the initial tree breaks indicated that the evidence were lost to

Part of the main wreckage

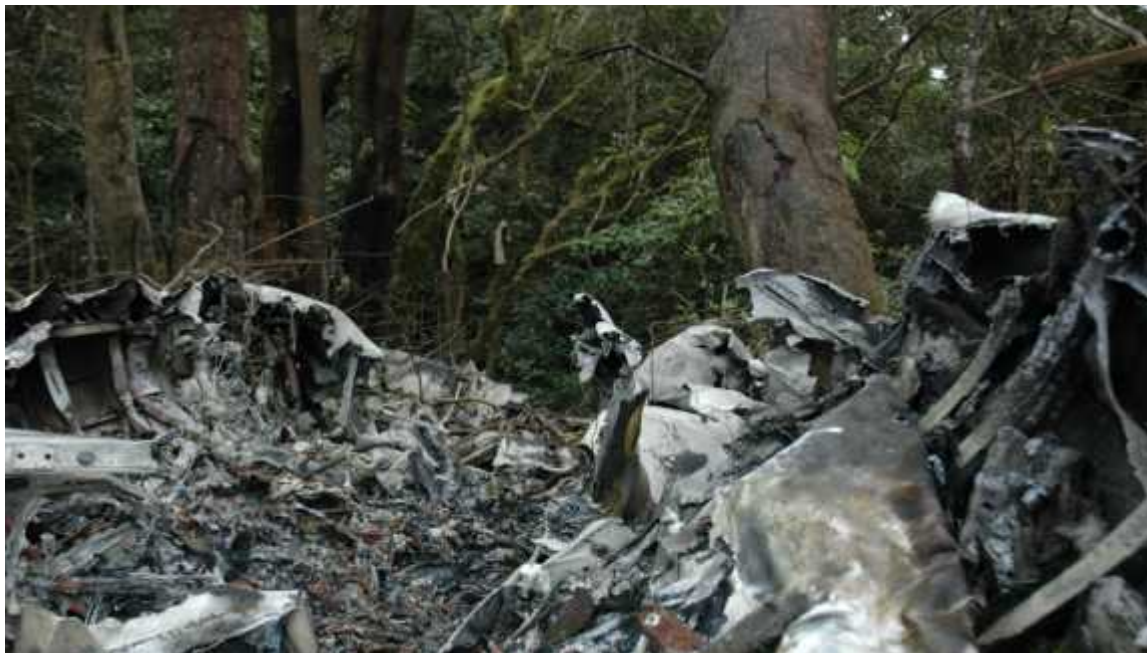
Burnt fuselage of the Wreckage

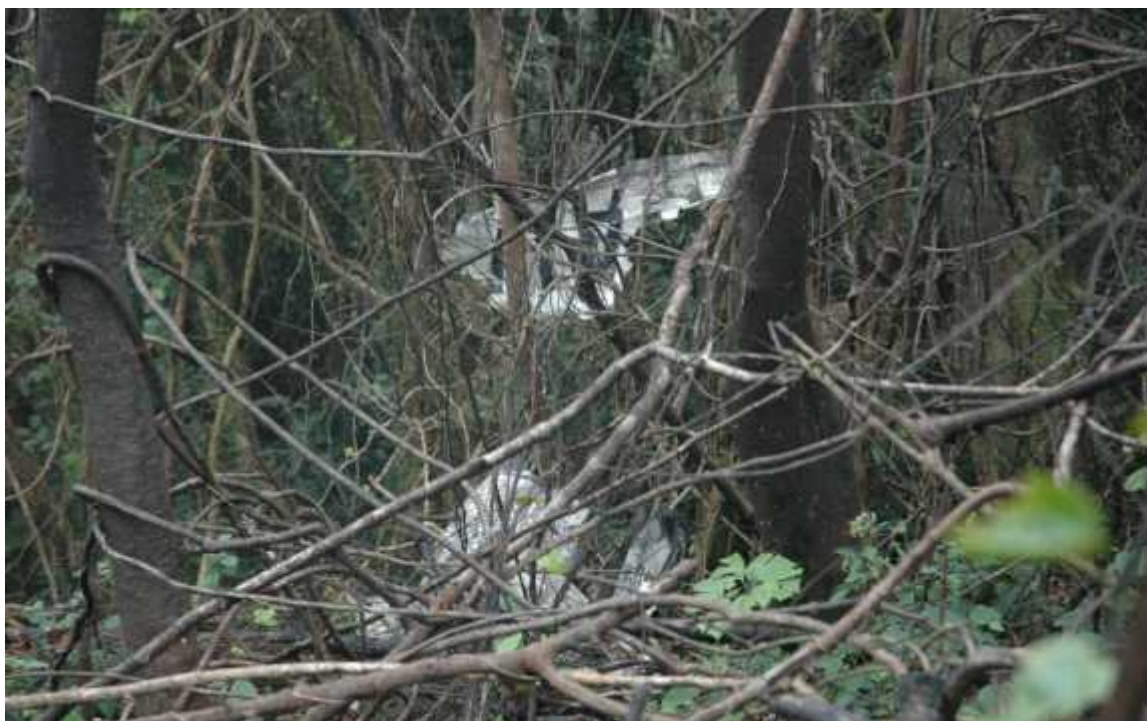
Wreckage showing section of the tail

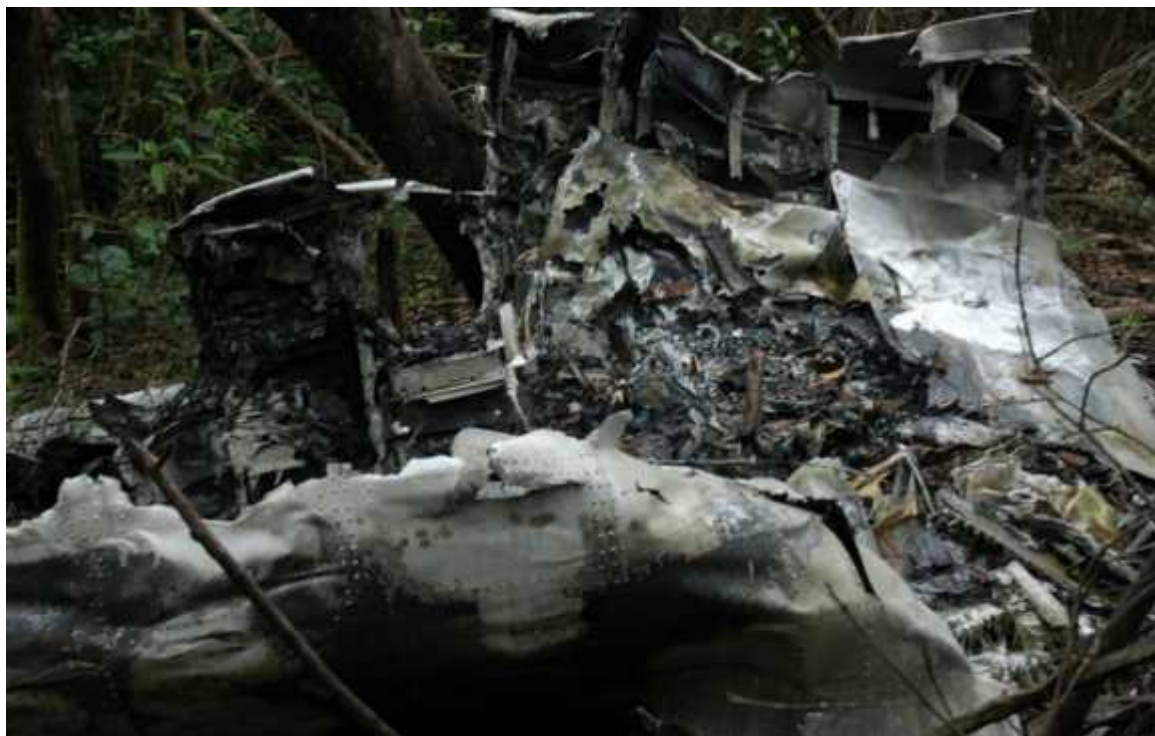
There was post impact fire. The fuselage and wings were severely burnt. Most of the trees around the main wreckage had their branches broken and effects of fire damage were seen extensively on many trees. Shortly before the aircraft crashed, it had a fuel endurance of three and half hours signifying there was a large quantity of fuel on board the aircraft before the accident.

SEVERELY BURNT FUSILAGE

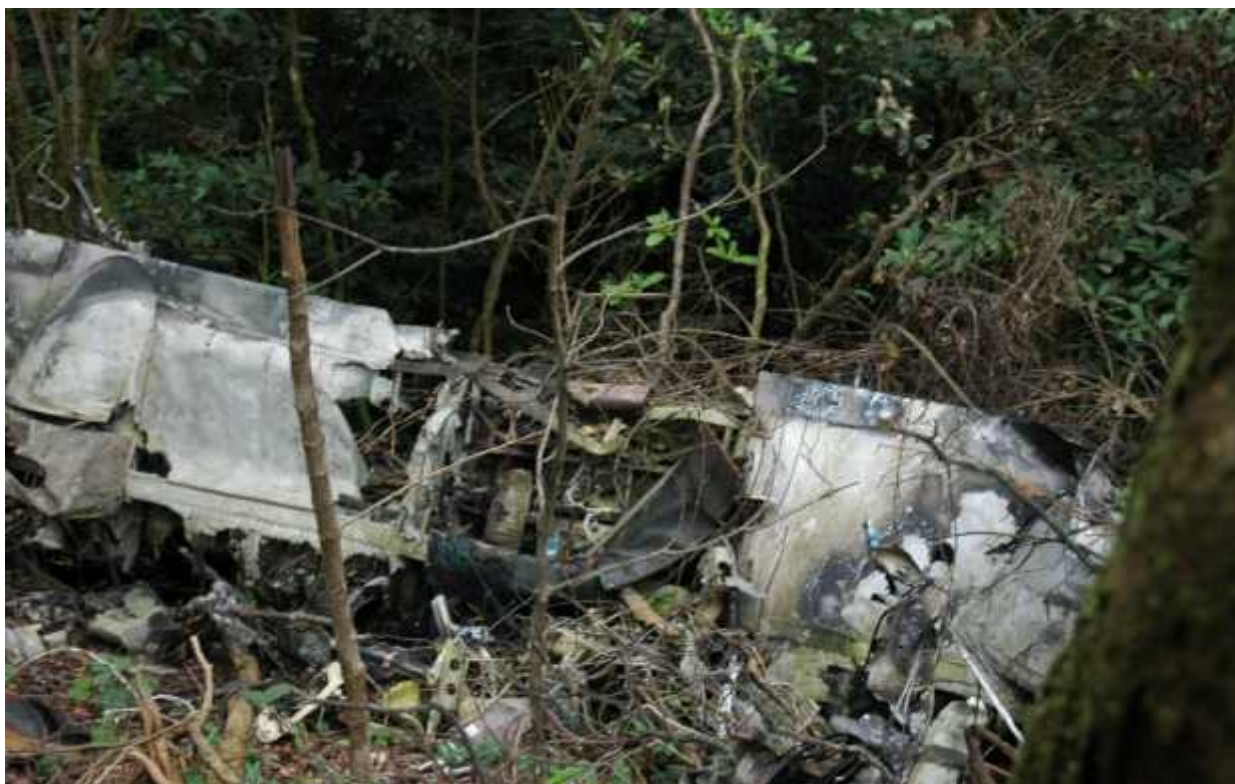
SEVERELY BURNT WING

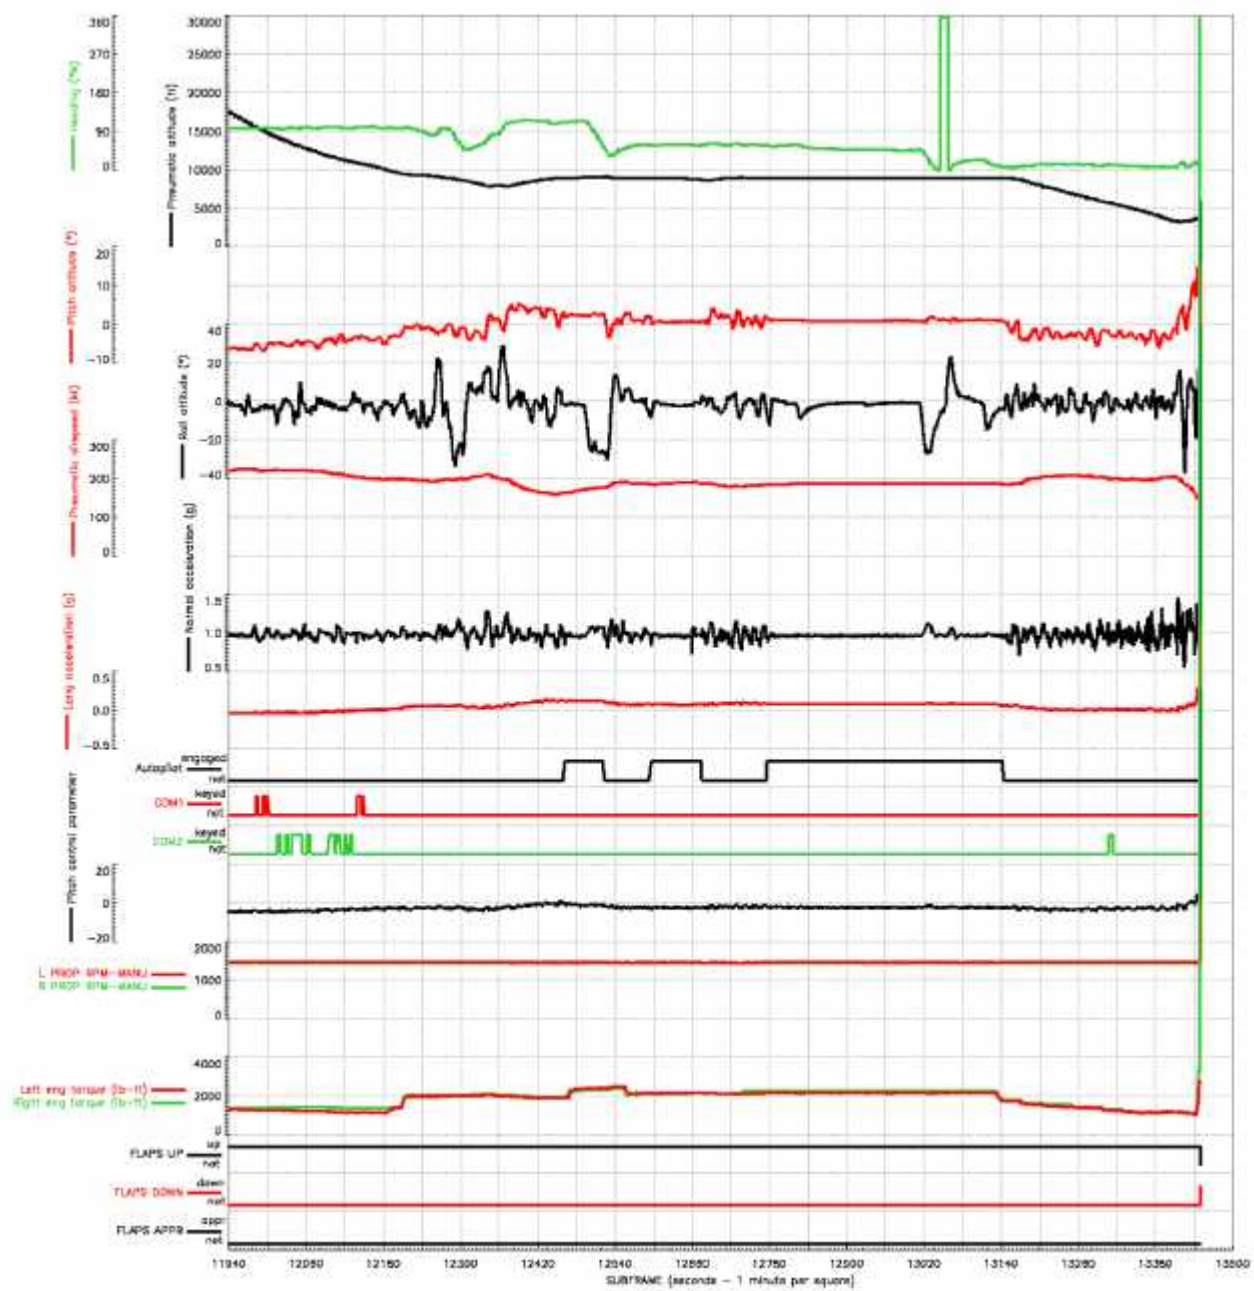
Fig. 2.2a

At 29 minutes 42 seconds, the first terrain proximity warning came from the GPWS followed by multiple GPWS warning at 29 minutes 51 seconds and continuous GPWS warning at 30 minutes 7 seconds and finally at 30 minutes 13 seconds the captain shouted ‘shit’ while the copilot shouted ‘climb!’ The aircraft impacted terrain at 30 minutes 18 seconds after 36 seconds of GPWS persistent warning. See the FDR plots overleaf figures 2.2a, 2.2b and 2.2c.

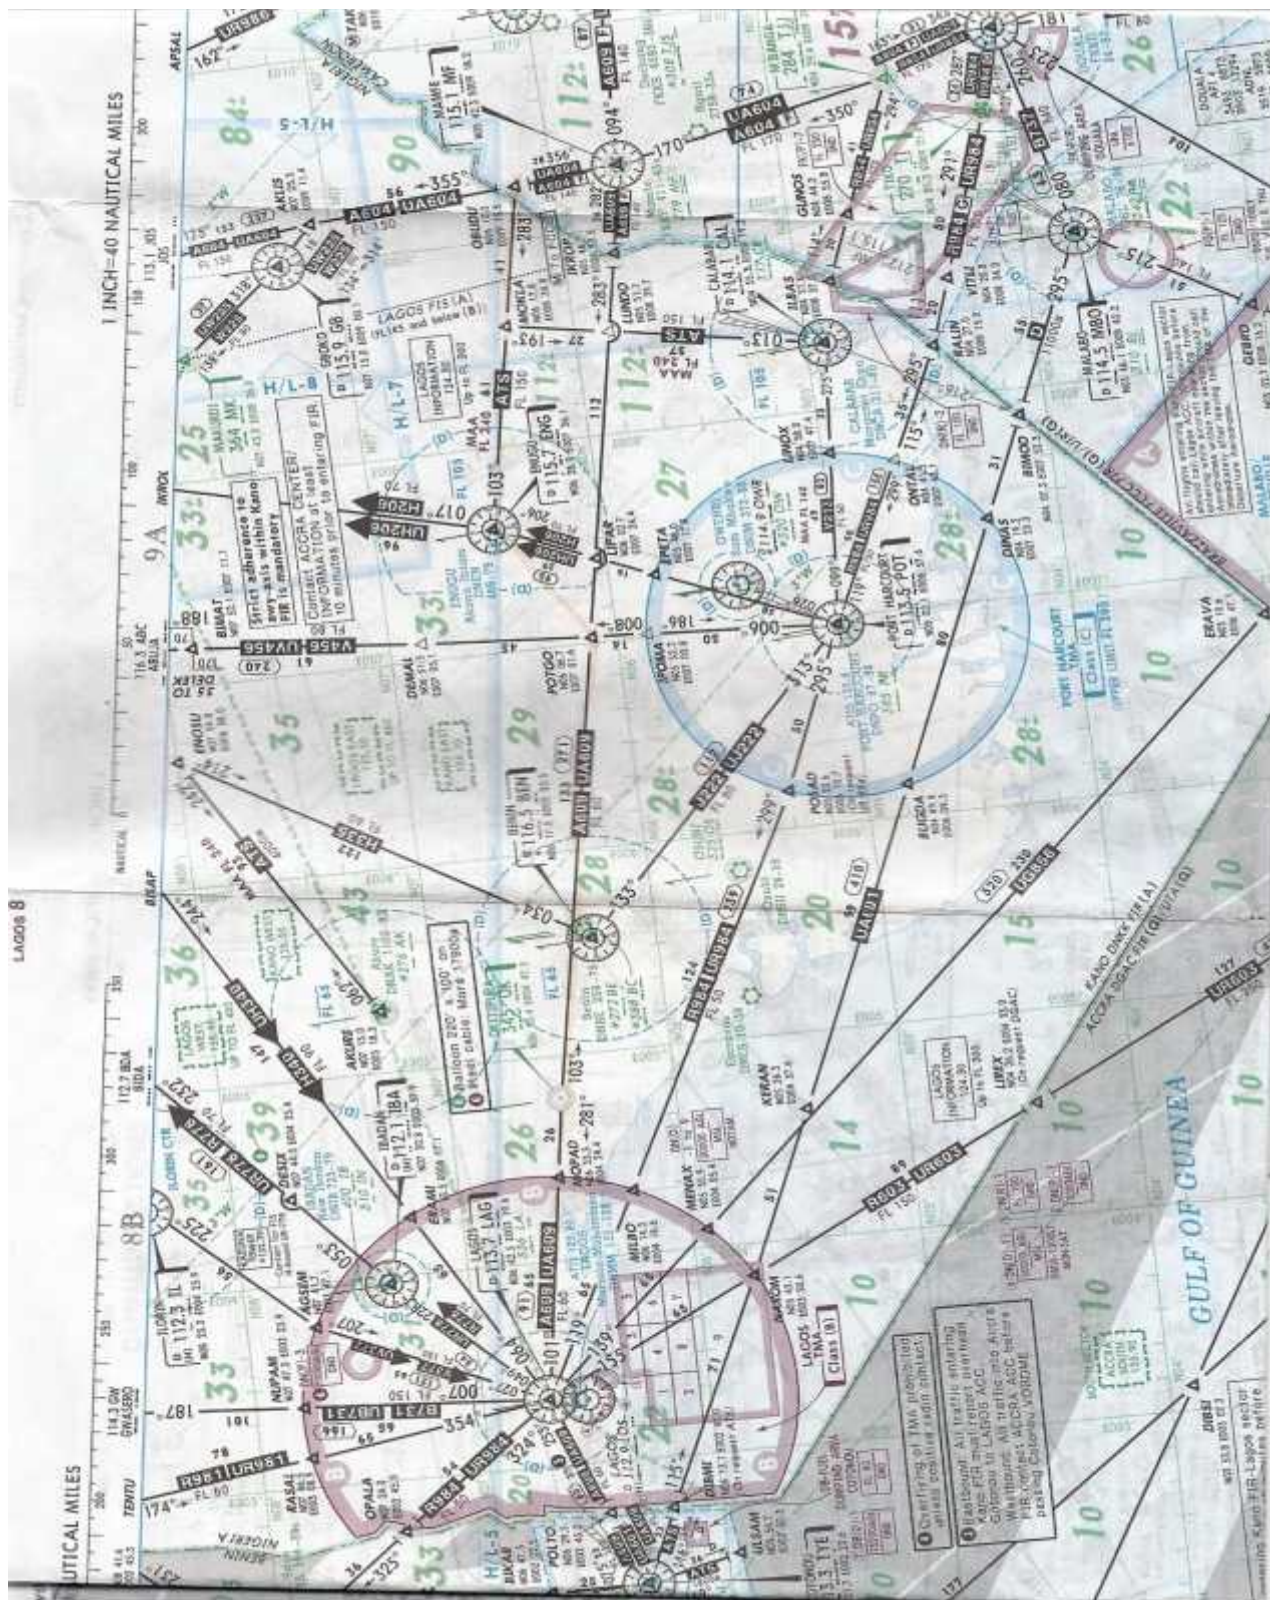
JEPPESEN ENROUTE CHART

Secondly, the waypoint LIPAR is neither on the planned route nor on UA609; according to Jeppesen chart, LIPAR is on the UH206 Airway while LUNDO and MOKLA are on the ATS route. (See Jeppesen chart on page 49). The pilot’s estimate which the Controller did not detect or correct was the beginning of the crew navigation problem. LIPAR and LUNDO reporting point/Navaid were never to be used for course guidance on UA609 Airway.

Enugu cleared the TWD 8300 to descend to 5000ft, even when the aircraft was outside its control area. The original flight plan was to route direct Enugu, but the deviation through IKROP removed Enugu from the control area. That descent also endangered the aircraft, since that sector minimum enroute altitude is 11,200ft (Jeppesen).
