**PRELIMINARY REPORT ON THE SERIOUS INCIDENT INVOLVING BOEING 737-300 AIRCRAFT OWNED AND OPERATED BY AIR PEACE LIMITED WITH NATIONALITY AND REGISTRATION MARKS 5N-BUK WHICH OCCURED AT MURTALA MUHAMMED INTERNATIONAL AIRPORT, LAGOS ON THE 15TH OF MAY 2019**

<b>Aircraft Accident Report No.:</b>	AIRPEACE/2019/05/15/D
<b>Registered Owner and Operator:</b>	Air Peace Limited
<b>Aircraft Type and Model:</b>	Boeing 737-300
<b>Manufacturer:</b>	The Boeing Company, USA
<b>Date of Manufacture:</b>	1997
<b>Registration Marks:</b>	5N-BUK
<b>Serial Number:</b>	28561
<b>Location:</b>	Runway 18R, Murtala Muhammed International Airport, Lagos
<b>Date and Time:</b>	15th May, 2019 at about 19:34 h <i>All times in this report are local time (UTC +1) unless otherwise stated</i>

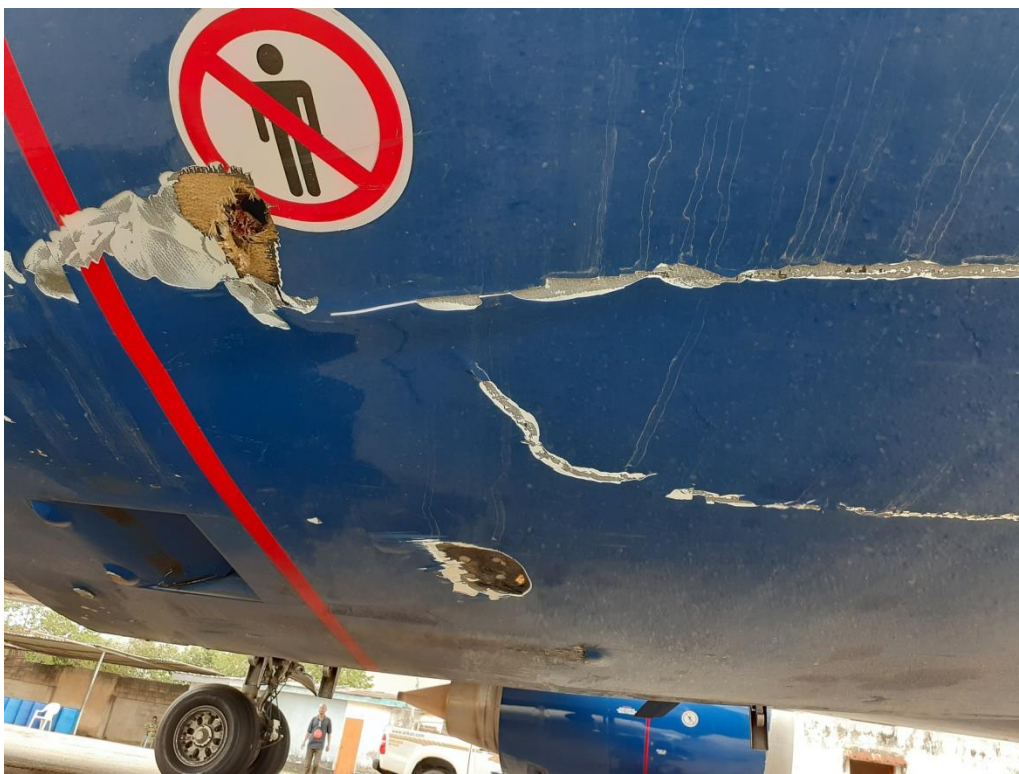
**Figure 1:** Picture showing Scrapes and dents on the No. 2 engine cowling

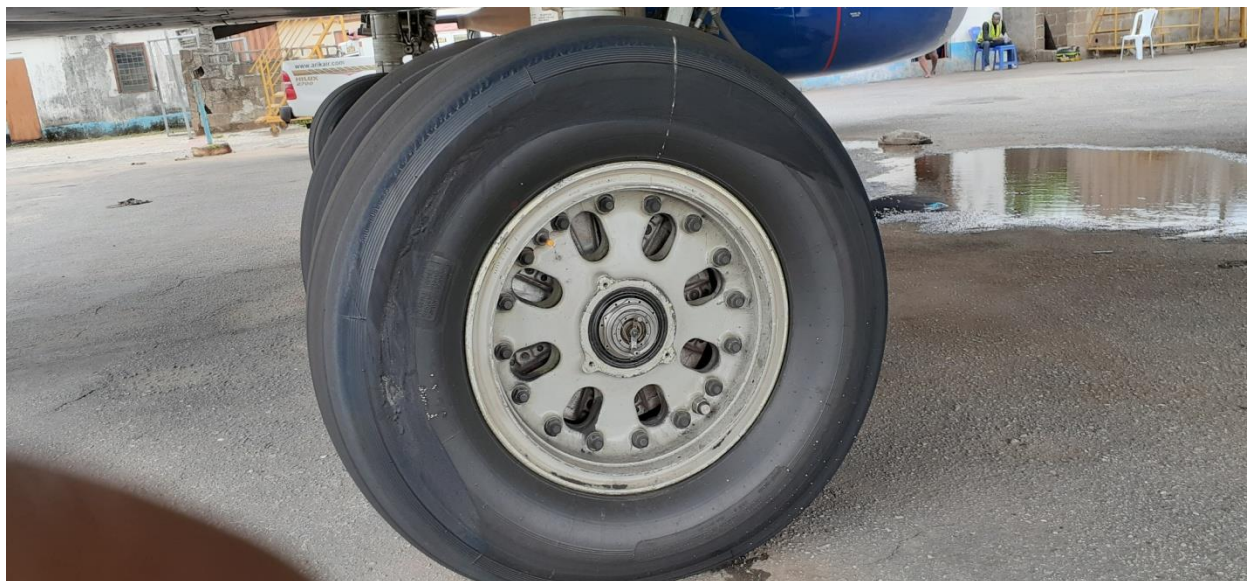
**Figure 2:** Picture showing Scuff marks on the No. 4 main wheel tyre

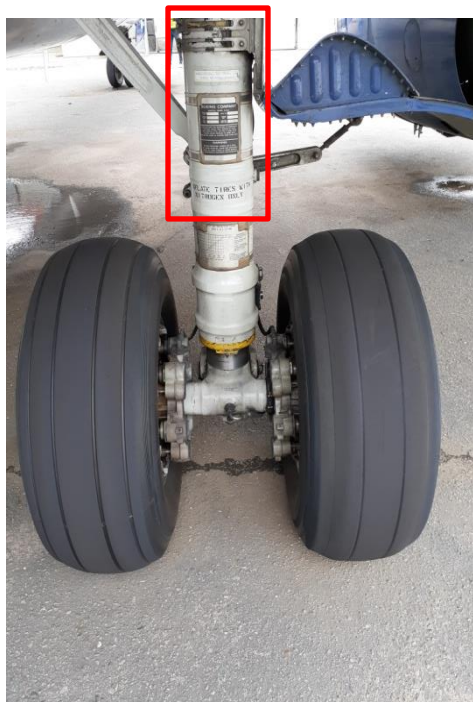
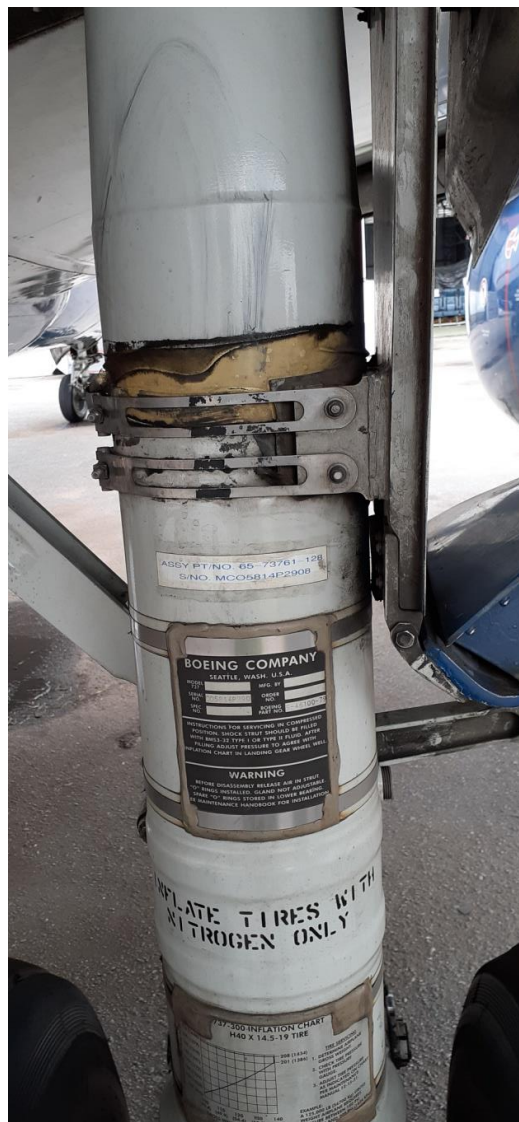
**Figure 3:** Pictures showing evidence of collapsed Oleo Strut
