PRELIMINARY REPORT ON SERIOUS INCIDENT INVOLVING BOEING 737-500 AIRCRAFT OWNED AND OPERATED BY AIR PEACE LIMITED WITH NATIONALITY AND REGISTRATION MARKS 5N-BRN WHICH OCCURRED AT PORT HARCOURT INTERNATIONAL AIRPORT ON 22ND JUNE, 2019

Registered Owner and Operator:	Air Peace Limited
Aircraft Type and Model:	Boeing 737-500
Manufacturer:	Boeing Aircraft Company
Date of Manufacture:	1993
Nationality and Registration Marks:	5N-BRN
Serial Number:	25234
Location:	Runway 21, Port Harcourt International Airport 05°00'56"N, 006°56'58"E
Date and Time:	22nd June, 2019 at about 14:57 h

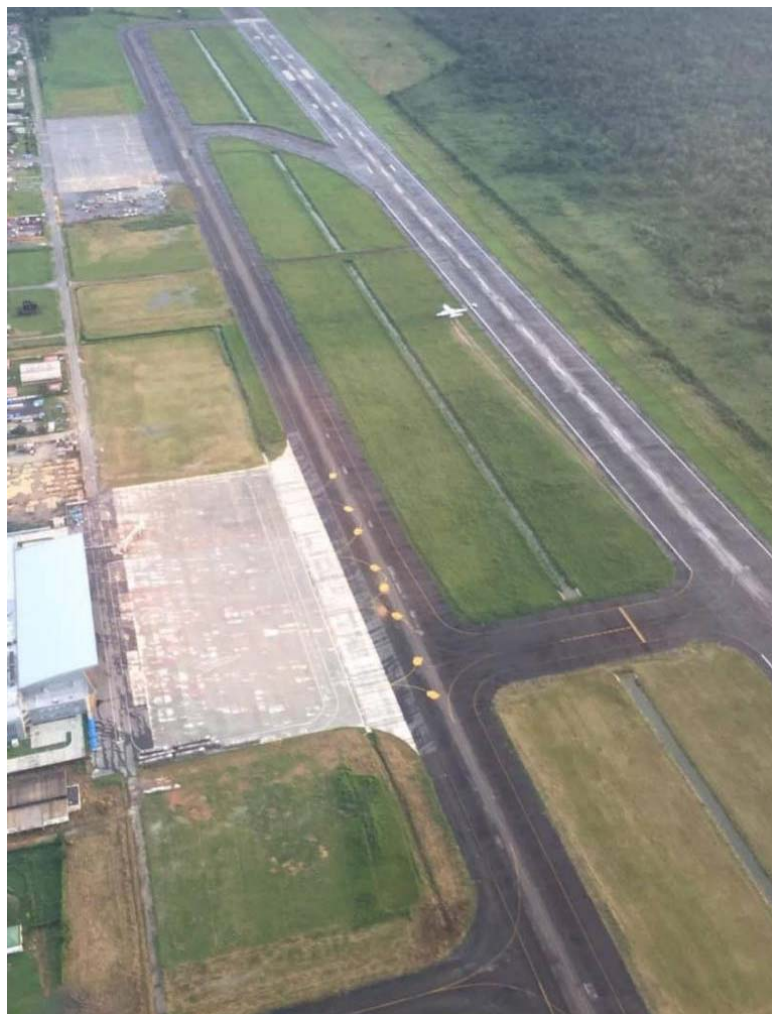
The aircraft touched down with the left main wheel on the grass verge and the right main wheel on the runway shoulder, at about 1,260 m from the runway 21 threshold and continued until it came to a stop parallel to the runway at about 1,620 m from runway 21 threshold, with the right wing tip aligned with the edge of the runway shoulder and the landing gears stuck in the mud.

Figure 1: Aerial view of the aircraft at its final position

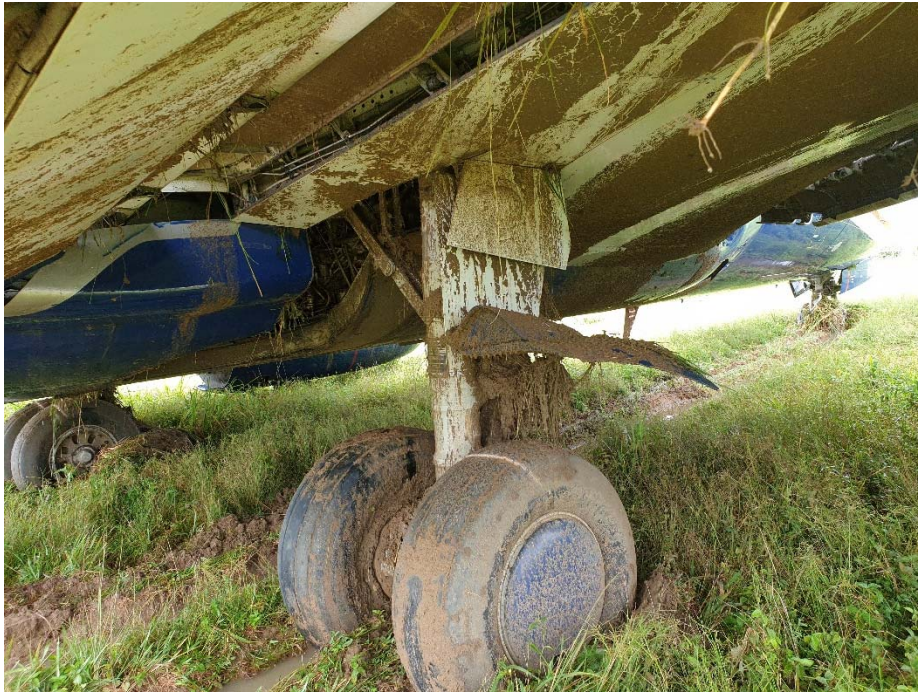
Figure 2: Picture showing the aircraft wheels stuck in mud

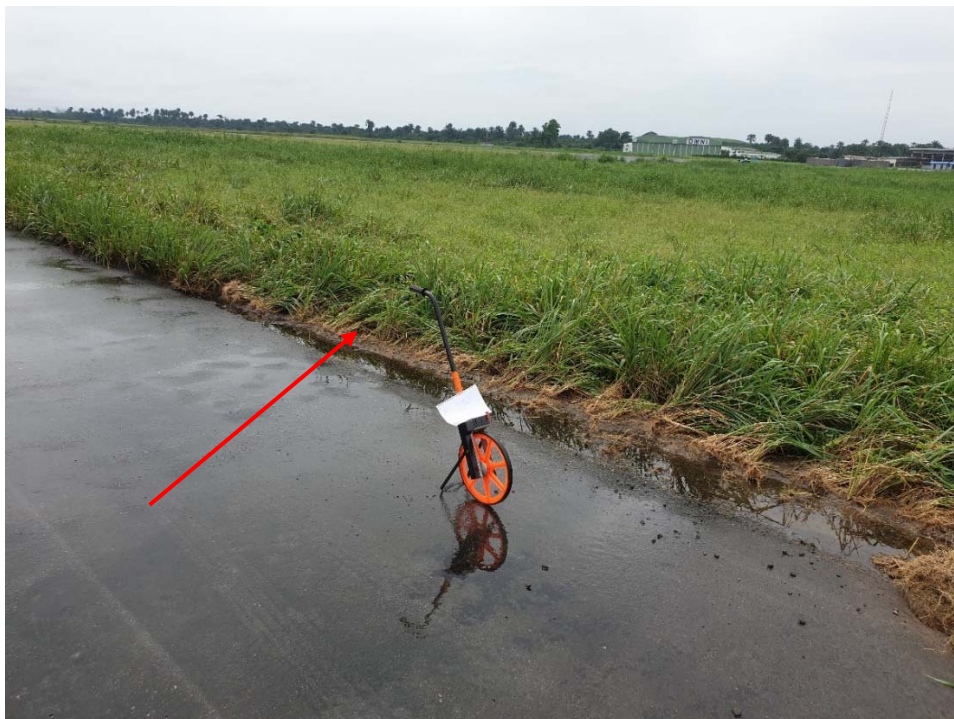
Tyre tracks on the grass verge showed that the aircraft touched down with the left main wheel on the grass verge and the right main wheel on the runway shoulder, at about 1,260 m from the threshold. It continued on its landing roll until it came to a stop parallel to the runway at 1,620 m from the threshold, with the right wing-tip aligned with the edge of the runway shoulder and the landing gears stuck in the mud.

Figure 3: Picture showing tracks of the left main wheel at the touchdown point

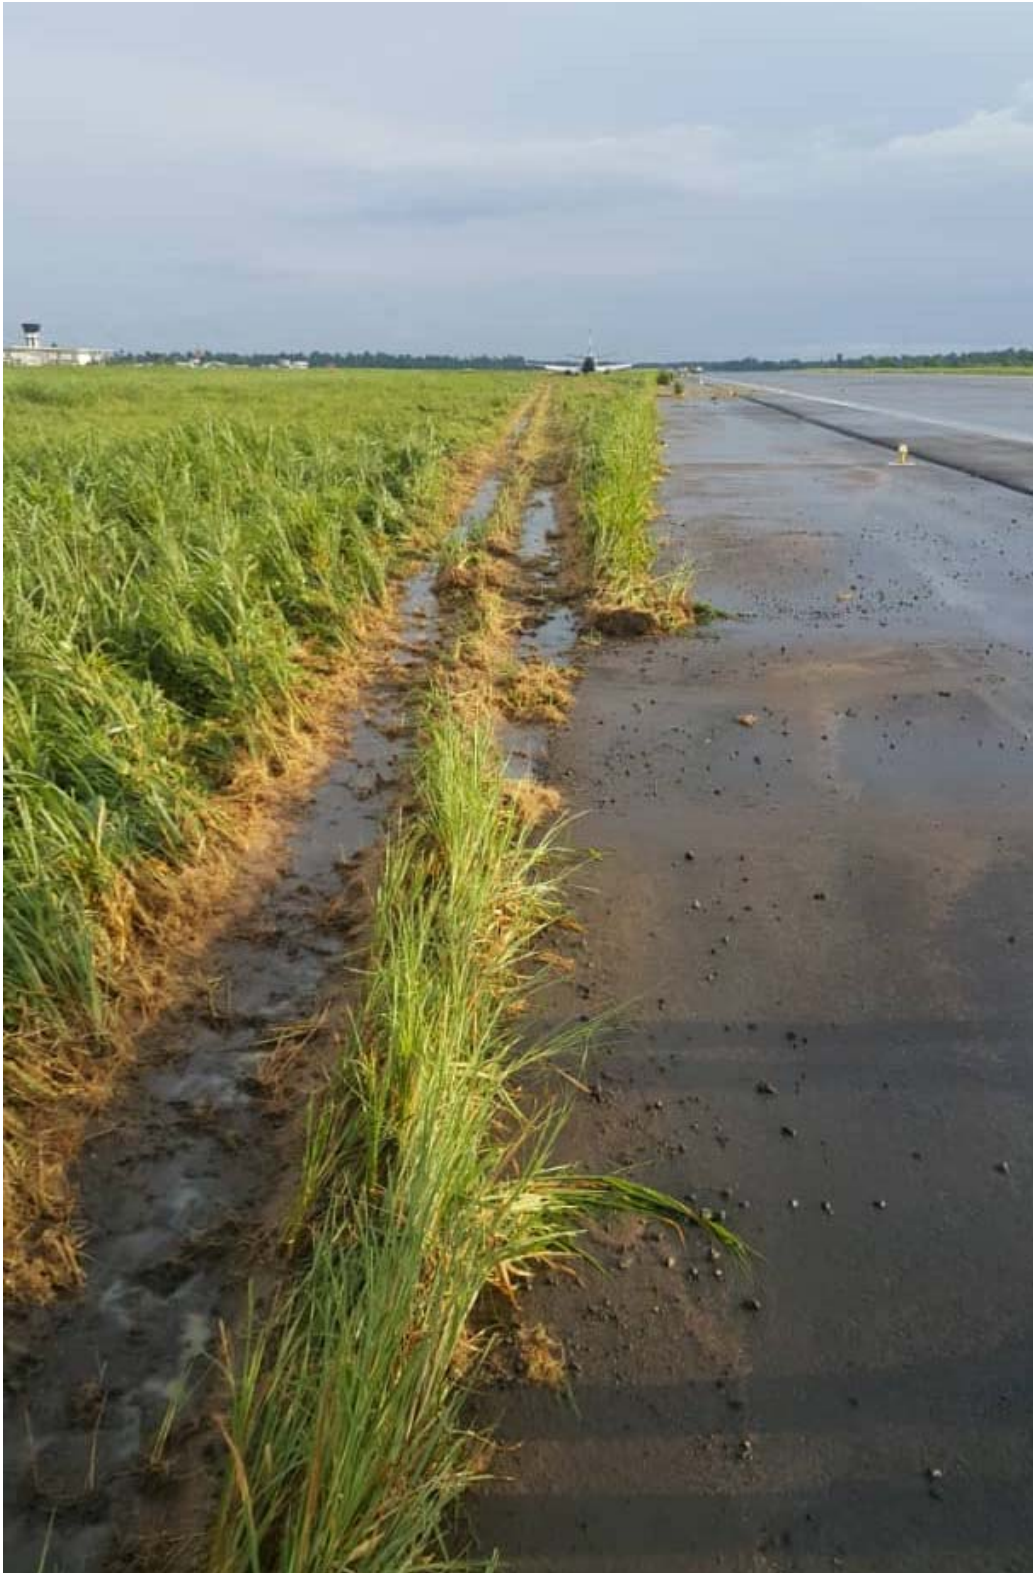
Figure 4: Picture showing the tracks of the main wheels leading into the grass verge

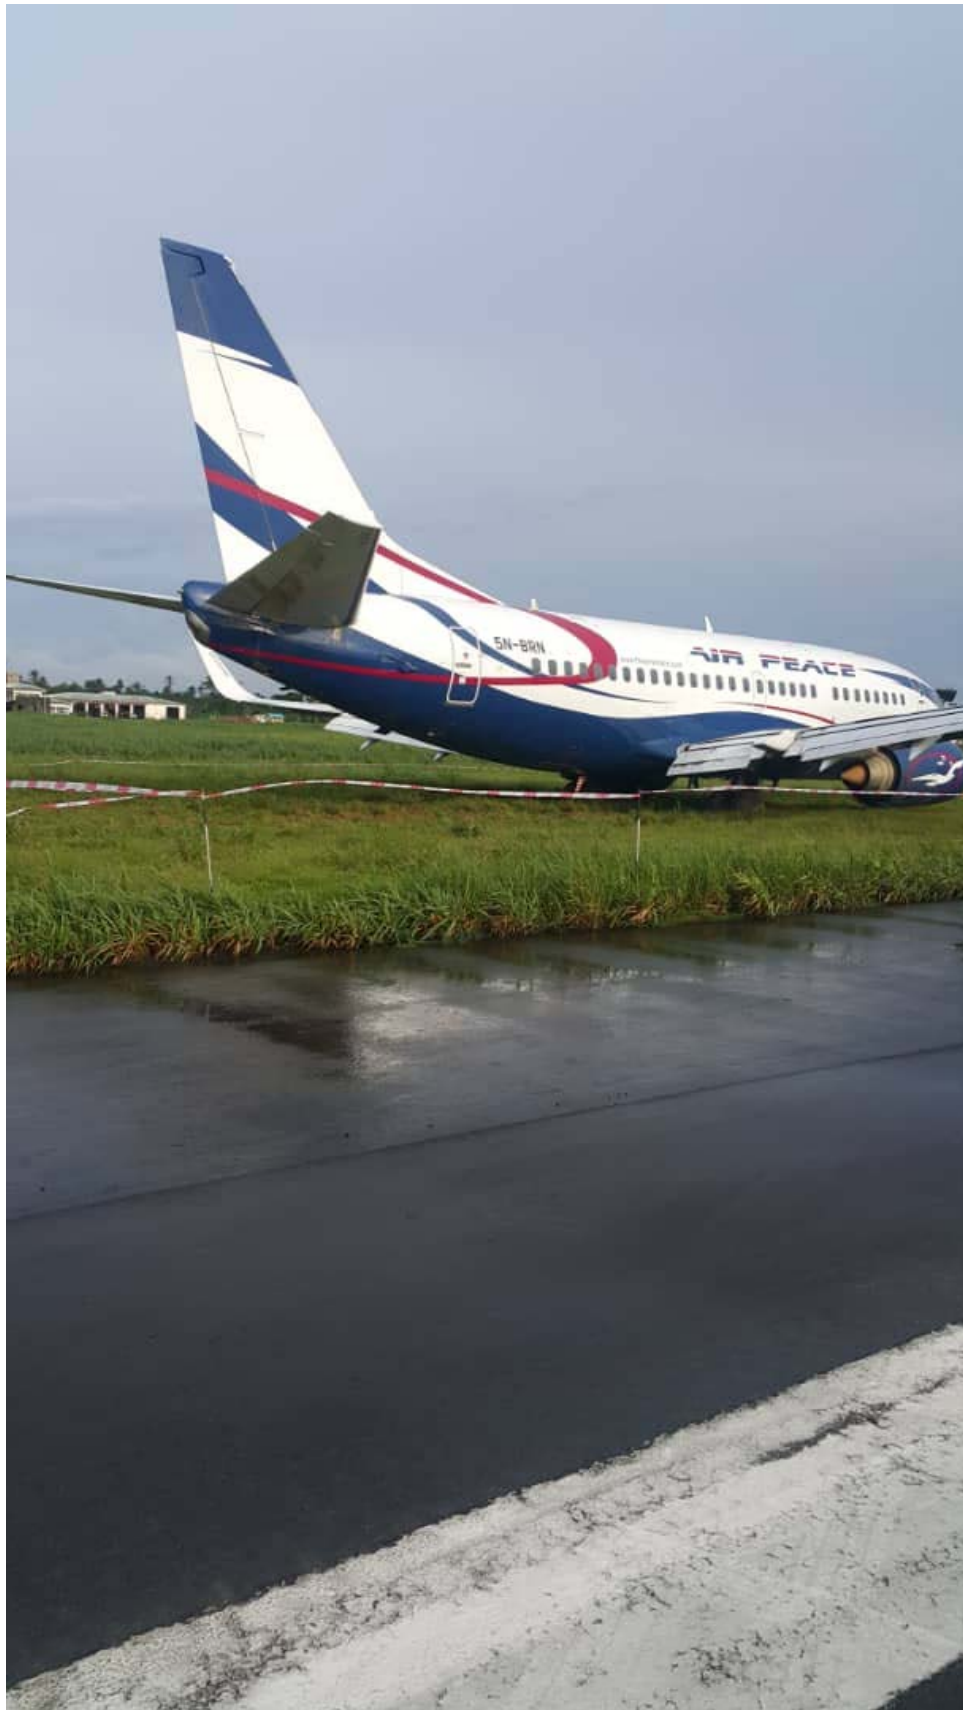
Figure 5: Picture of the aircraft at its final position
