PRELIMINARY REPORT ON SERIOUS INCIDENT INVOLVING BOEING 737-500 AIRCRAFT OWNED AND OPERATED BY AIR PEACE LIMITED WITH NATIONALITY AND REGISTRATION MARKS 5N-BRN WHICH OCCURRED AT PORT HARCOURT INTERNATIONAL AIRPORT ON 22ND JUNE, 2019

Registered Owner and Operator:	Air Peace Limited
Aircraft Type and Model:	Boeing 737-500
Manufacturer:	Boeing Aircraft Company
Date of Manufacture:	1993
Nationality and Registration Marks:	5N-BRN
Serial Number:	25234
Location:	Runway 21, Port Harcourt International Airport 05°00'56"N, 006°56'58"E
Date and Time:	22nd June, 2019 at about 14:57 h

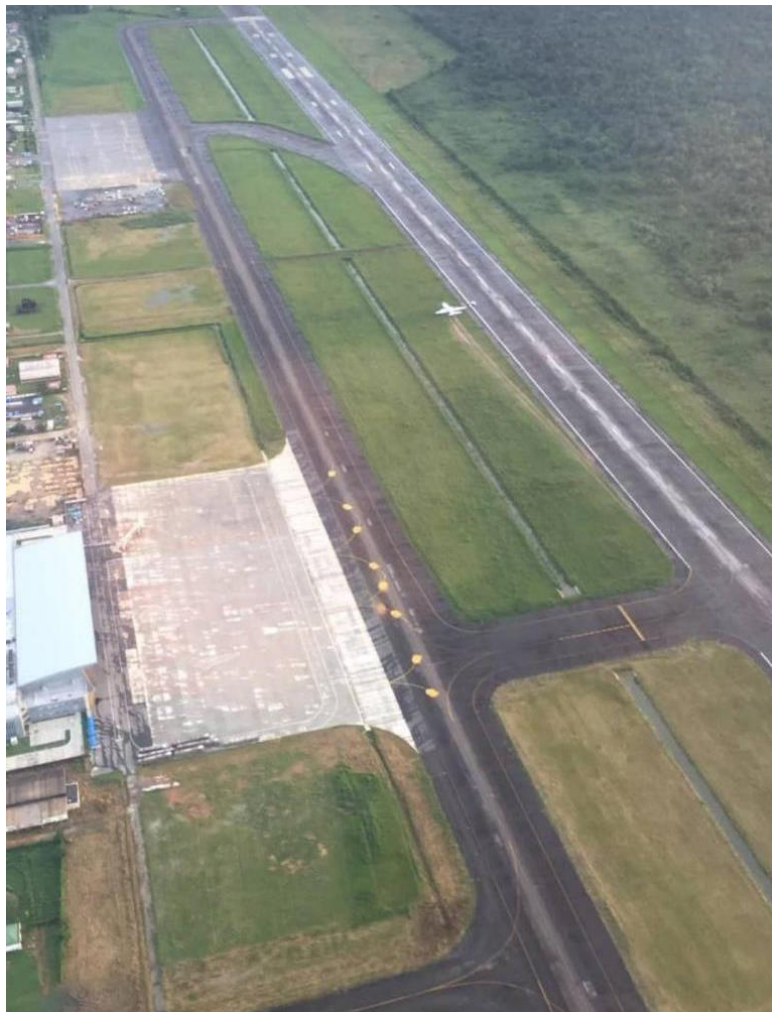
The aircraft touched down with the left main wheel on the grass verge and the right main wheel on the runway shoulder, at about 1,260 m from the runway 21 threshold and continued until it came to a stop parallel to the runway at about 1,620 m from runway 21 threshold, with the right wing tip aligned with the edge of the runway shoulder and the landing gears stuck in the mud.

Figure 1: Aerial view of the aircraft at its final position

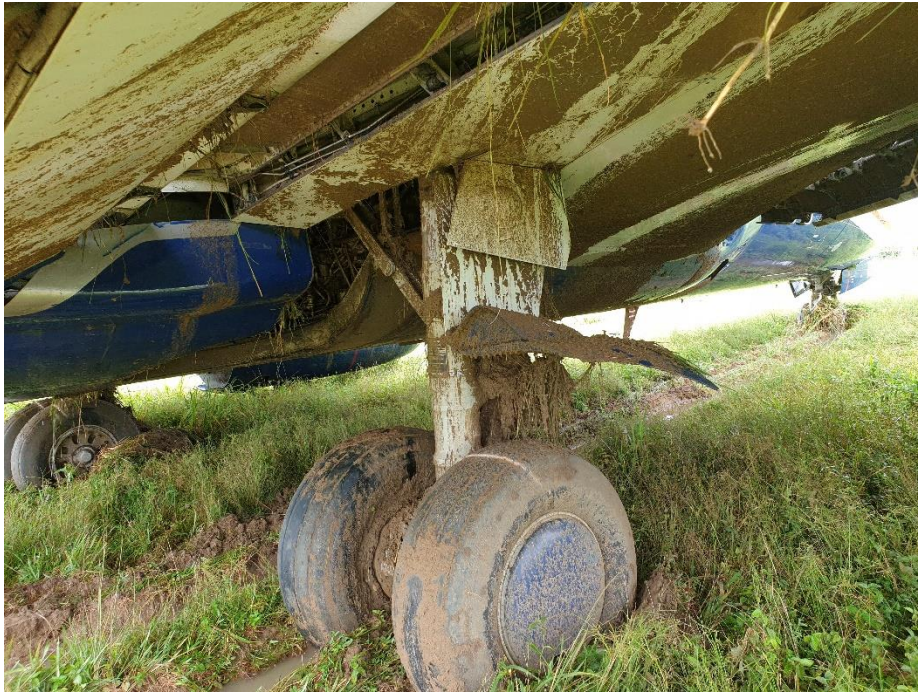
Tyre tracks on the grass verge showed that the aircraft touched down with the left main wheel on the grass verge and the right main wheel on the runway shoulder, at about 1,260 m from the threshold. It continued on its landing roll until it came to a stop parallel to the runway at 1,620 m from the threshold, with the right wing-tip aligned with the edge of the runway shoulder and the landing gears stuck in the mud.

Figure 2: Picture showing the aircraft wheels stuck in mud

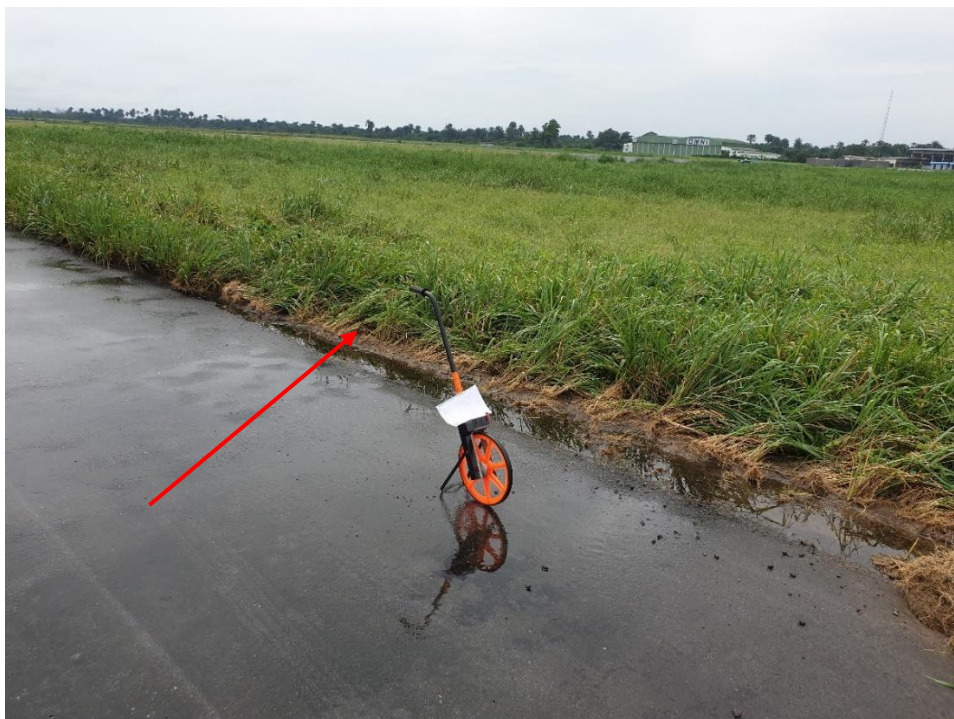
Figure 3: Picture showing tracks of the left main wheel at the touchdown point

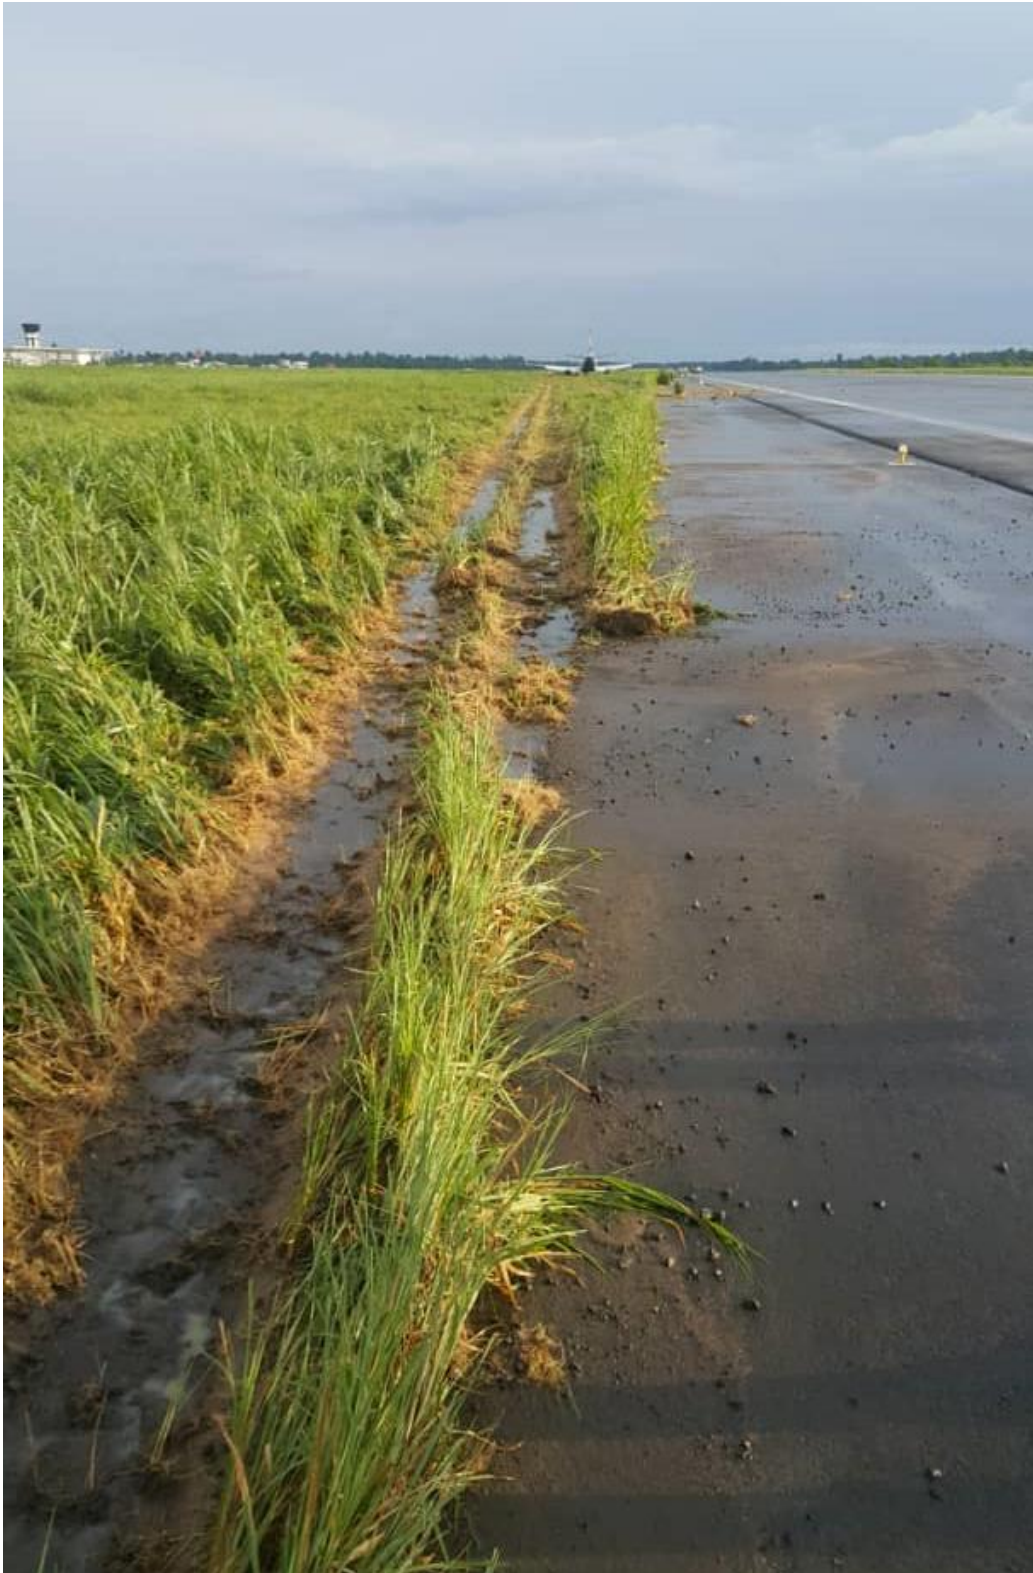
Figure 4: Picture showing the tracks of the main wheels leading into the grass verge

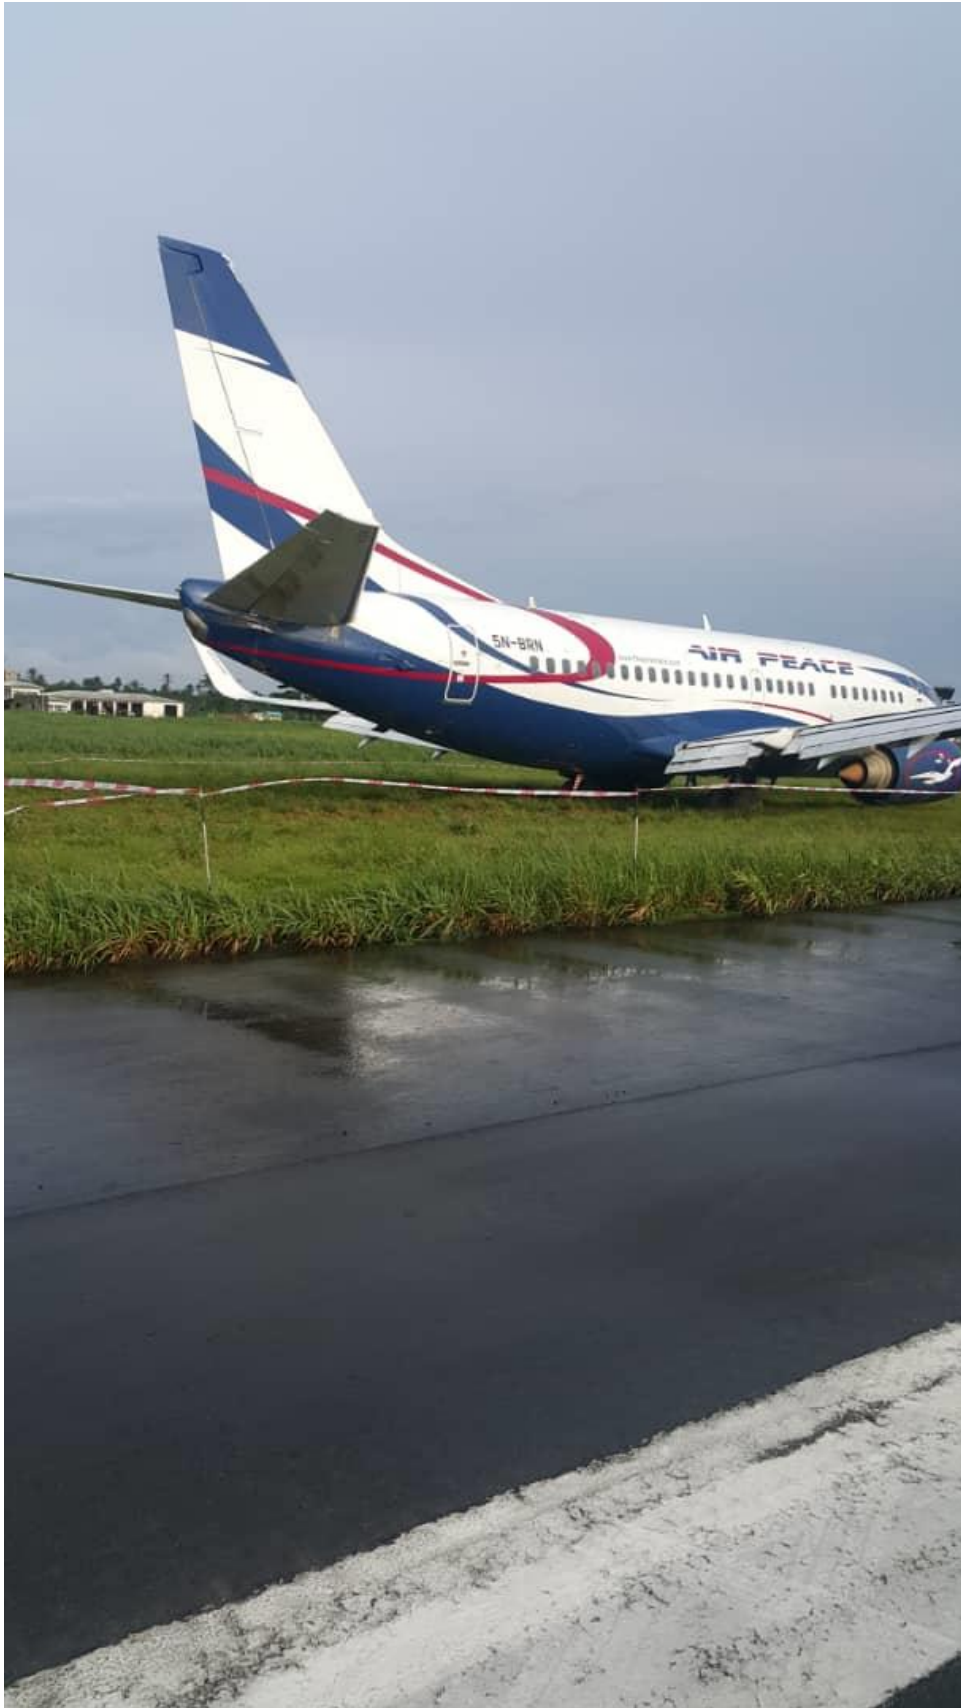
Figure 5: Picture of the aircraft at its final position
