**PRELIMINARY REPORT ON THE SERIOUS INCIDENT INVOLVING BOEING 737-500 AIRCRAFT OWNED AND OPERATED BY MED-VIEW AIRLINE WITH NATIONALITY AND REGISTRATION MARKS 5N-BQM WHICH OCCURRED AT THIRTY-TWO THOUSAND FEET ABOVE MEAN SEA LEVEL (FL320) EN-ROUTE MURTALA MUHAMMED INTERNATIONAL AIRPORT, LAGOS ON 23RD JULY, 2019**

**Aircraft Accident Report No.:** MED-VIEW/2019/07/23/D

**Aircraft Type and Model:** Boeing 737-500

**Nationality and Registration Marks:** 5N-BQM

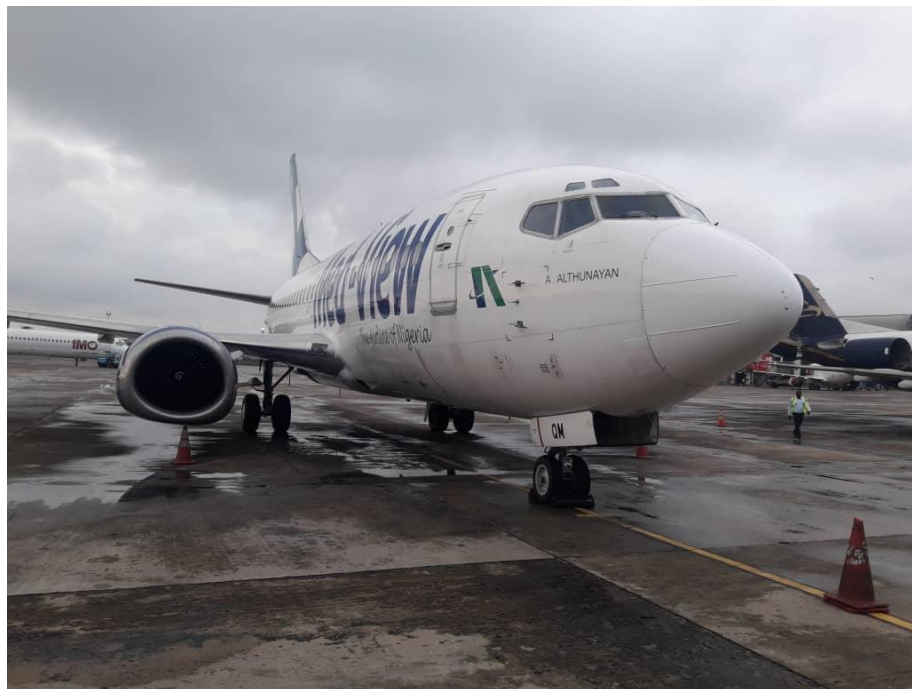
Figure 1: Photo of the aircraft parked on the apron after the incident

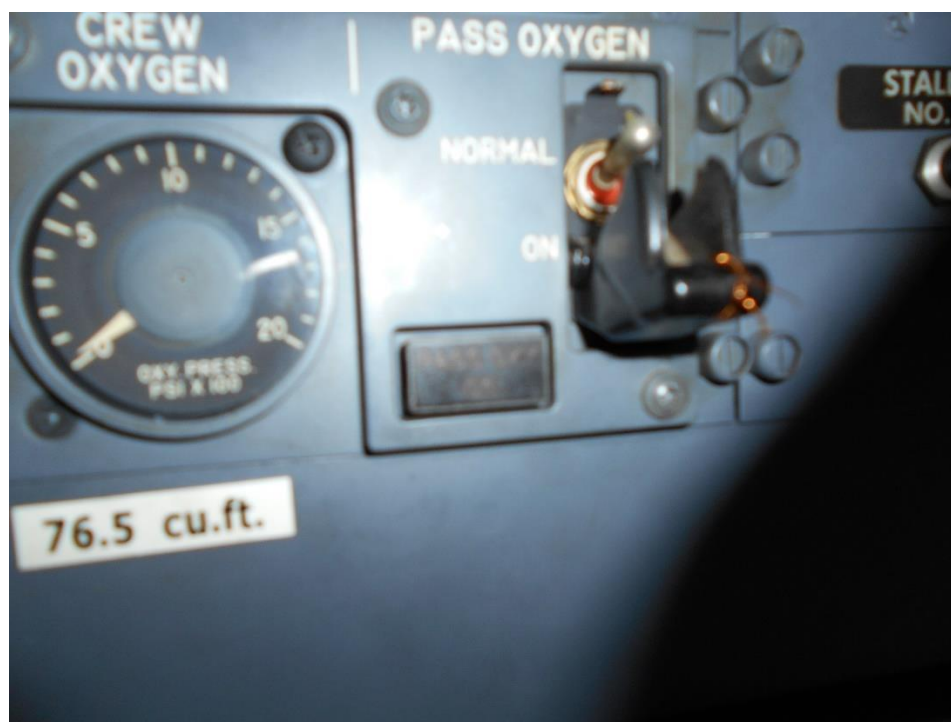
12. The CVR recordings of the occurrence were overwritten.
13. During the post incident inspection by the Bureau's safety investigators, the passenger oxygen switch was found in the 'NORMAL' position with its wire lock broken.
14. The Bureau became aware of the occurrence from news media and the incident was not reported to the Bureau as required by regulation 13(1) of the Civil Aviation (Investigation of Accidents and Incidents) Regulations 2019.

Figure 2: Photo of passenger oxygen switch in the NORMAL position, with broken wirelock

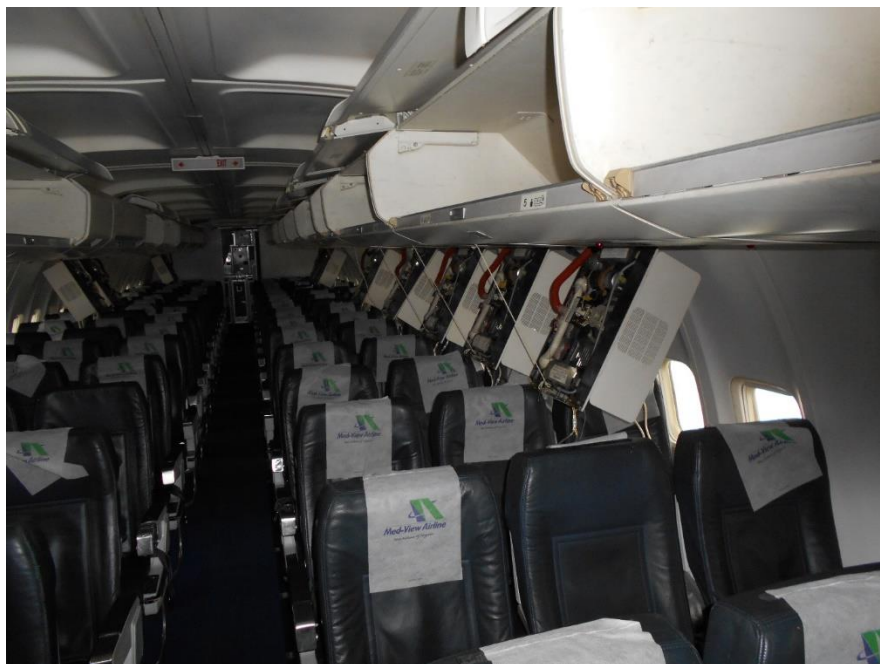
Figure 3: Photo of the passenger service units (PSUs) in open position when investigators arrived

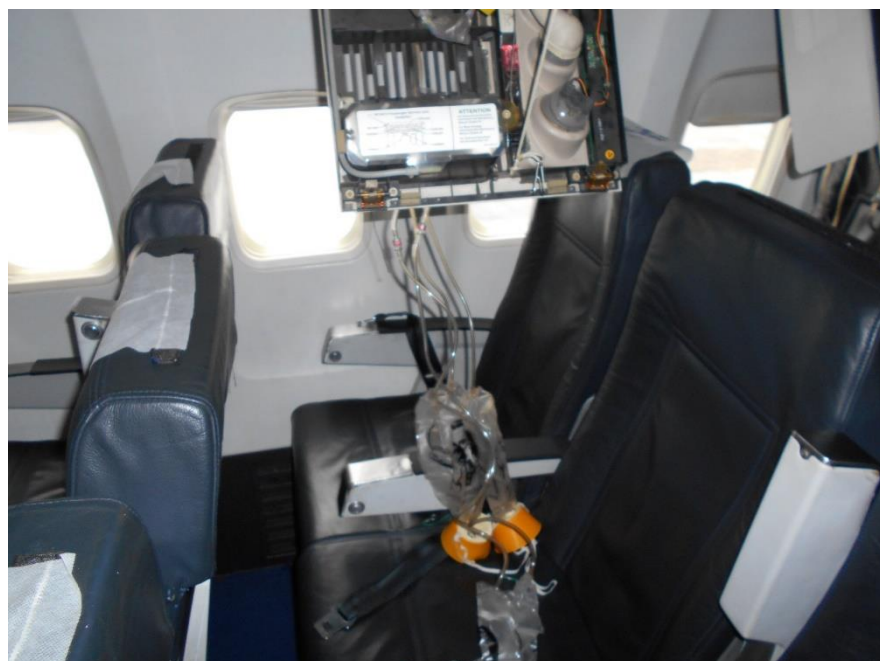
6. The crew experienced loss of pressurization on descent and requested for priority landing without initially disclosing the nature of the emergency.
7. The passenger oxygen mask automatically deployed.

Figure 4: Photo of a deployed cabin oxygen mask
