**PRELIMINARY REPORT ON THE ACCIDENT INVOLVING OLAM NIGERIA LIMITED AIR TRACTOR AT-401B AIRCRAFT REGISTRATION NUMBER 5N-BTV WHICH OCCURRED AT RUKUBI, DOMA LOCAL GOVERNMENT AREA OF NASARAWA STATE, NIGERIA ON 04<sup>th</sup> OCTOBER, 2018.**

AIRCRAFT TYPE/MODEL: Air Tractor/AT-401B

REGISTRATION NUMBER: 5N-BTV

DATE/TIME: 04<sup>th</sup> October, 2018 @ 0915hrs

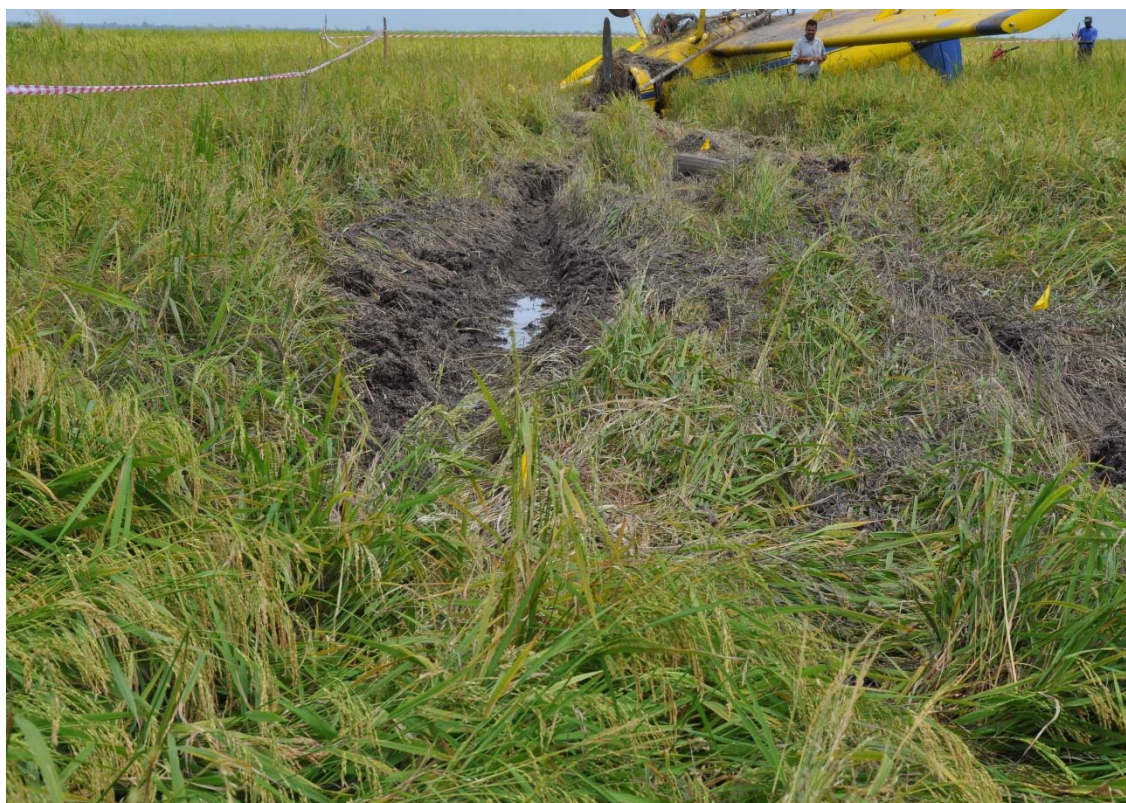
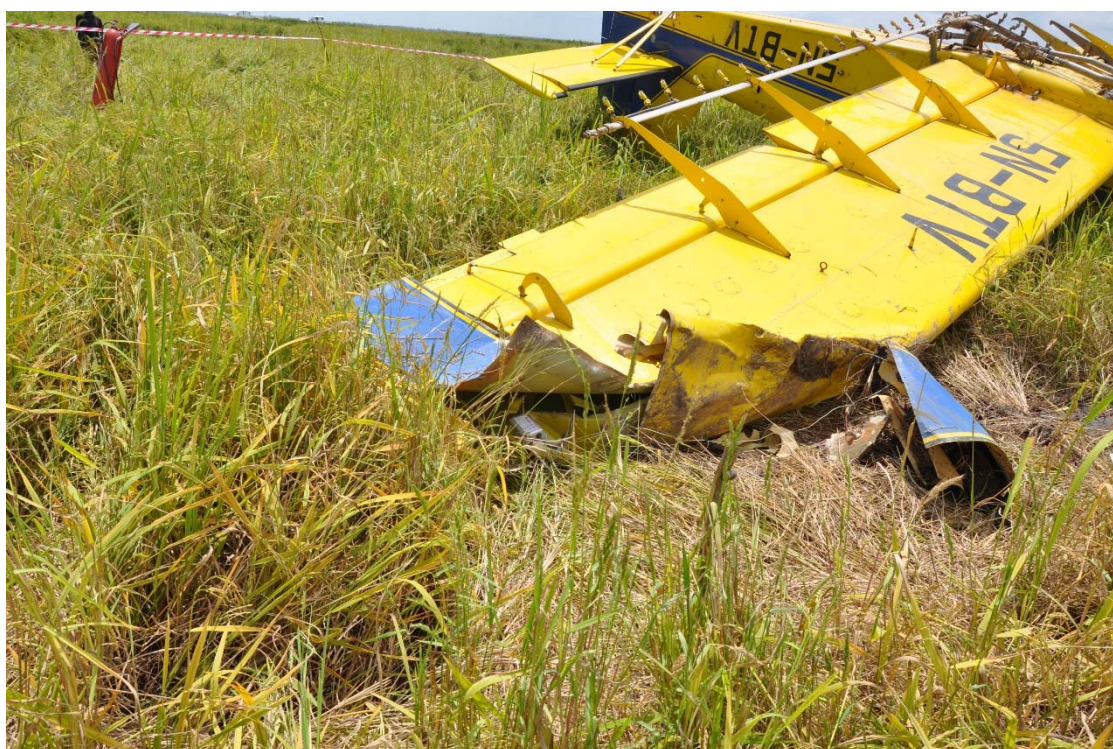
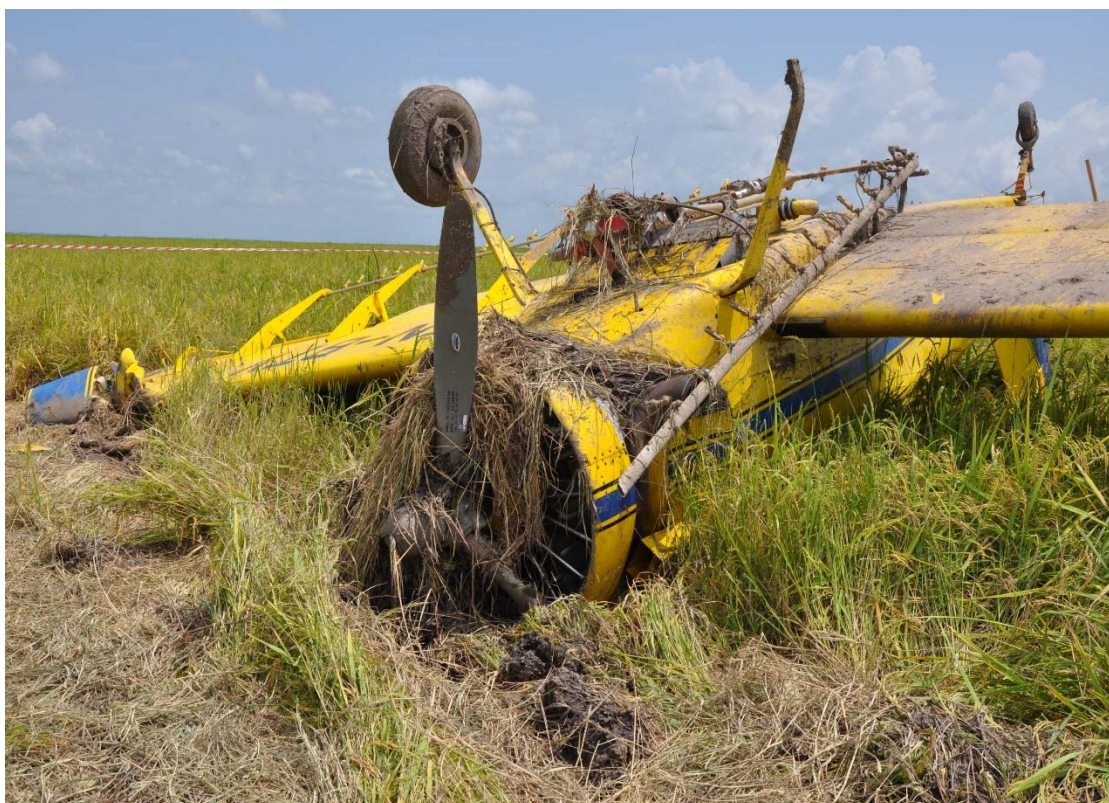
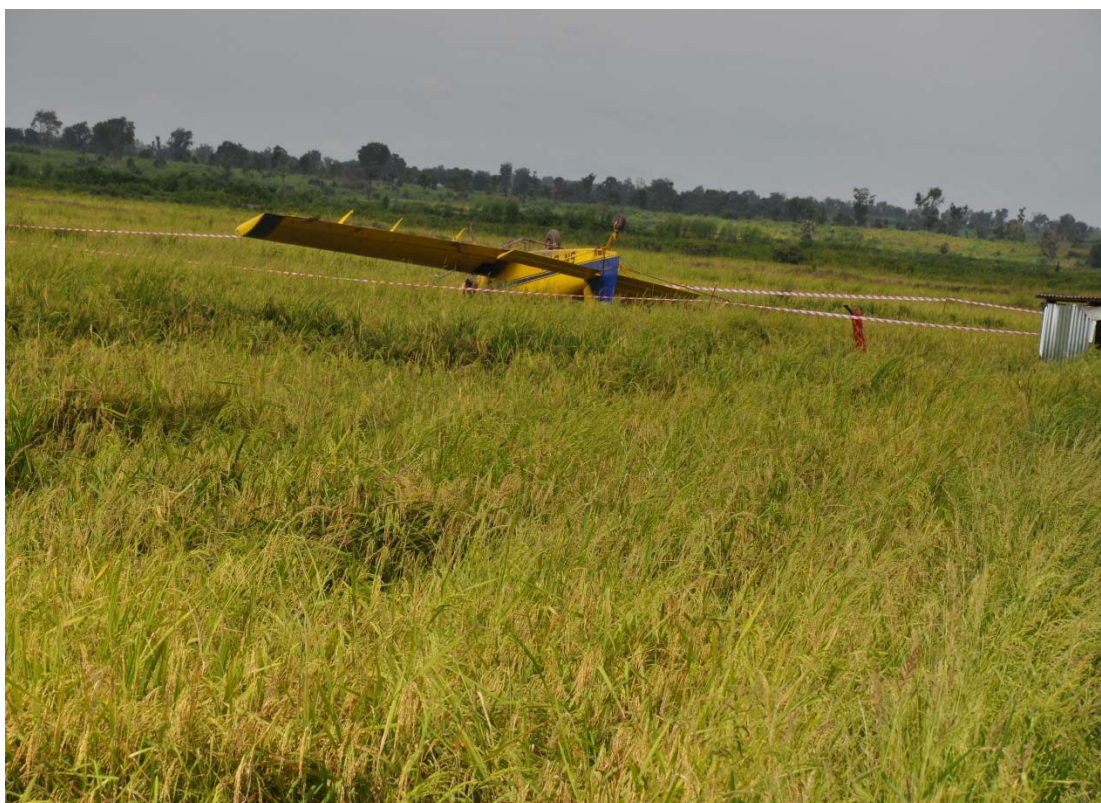
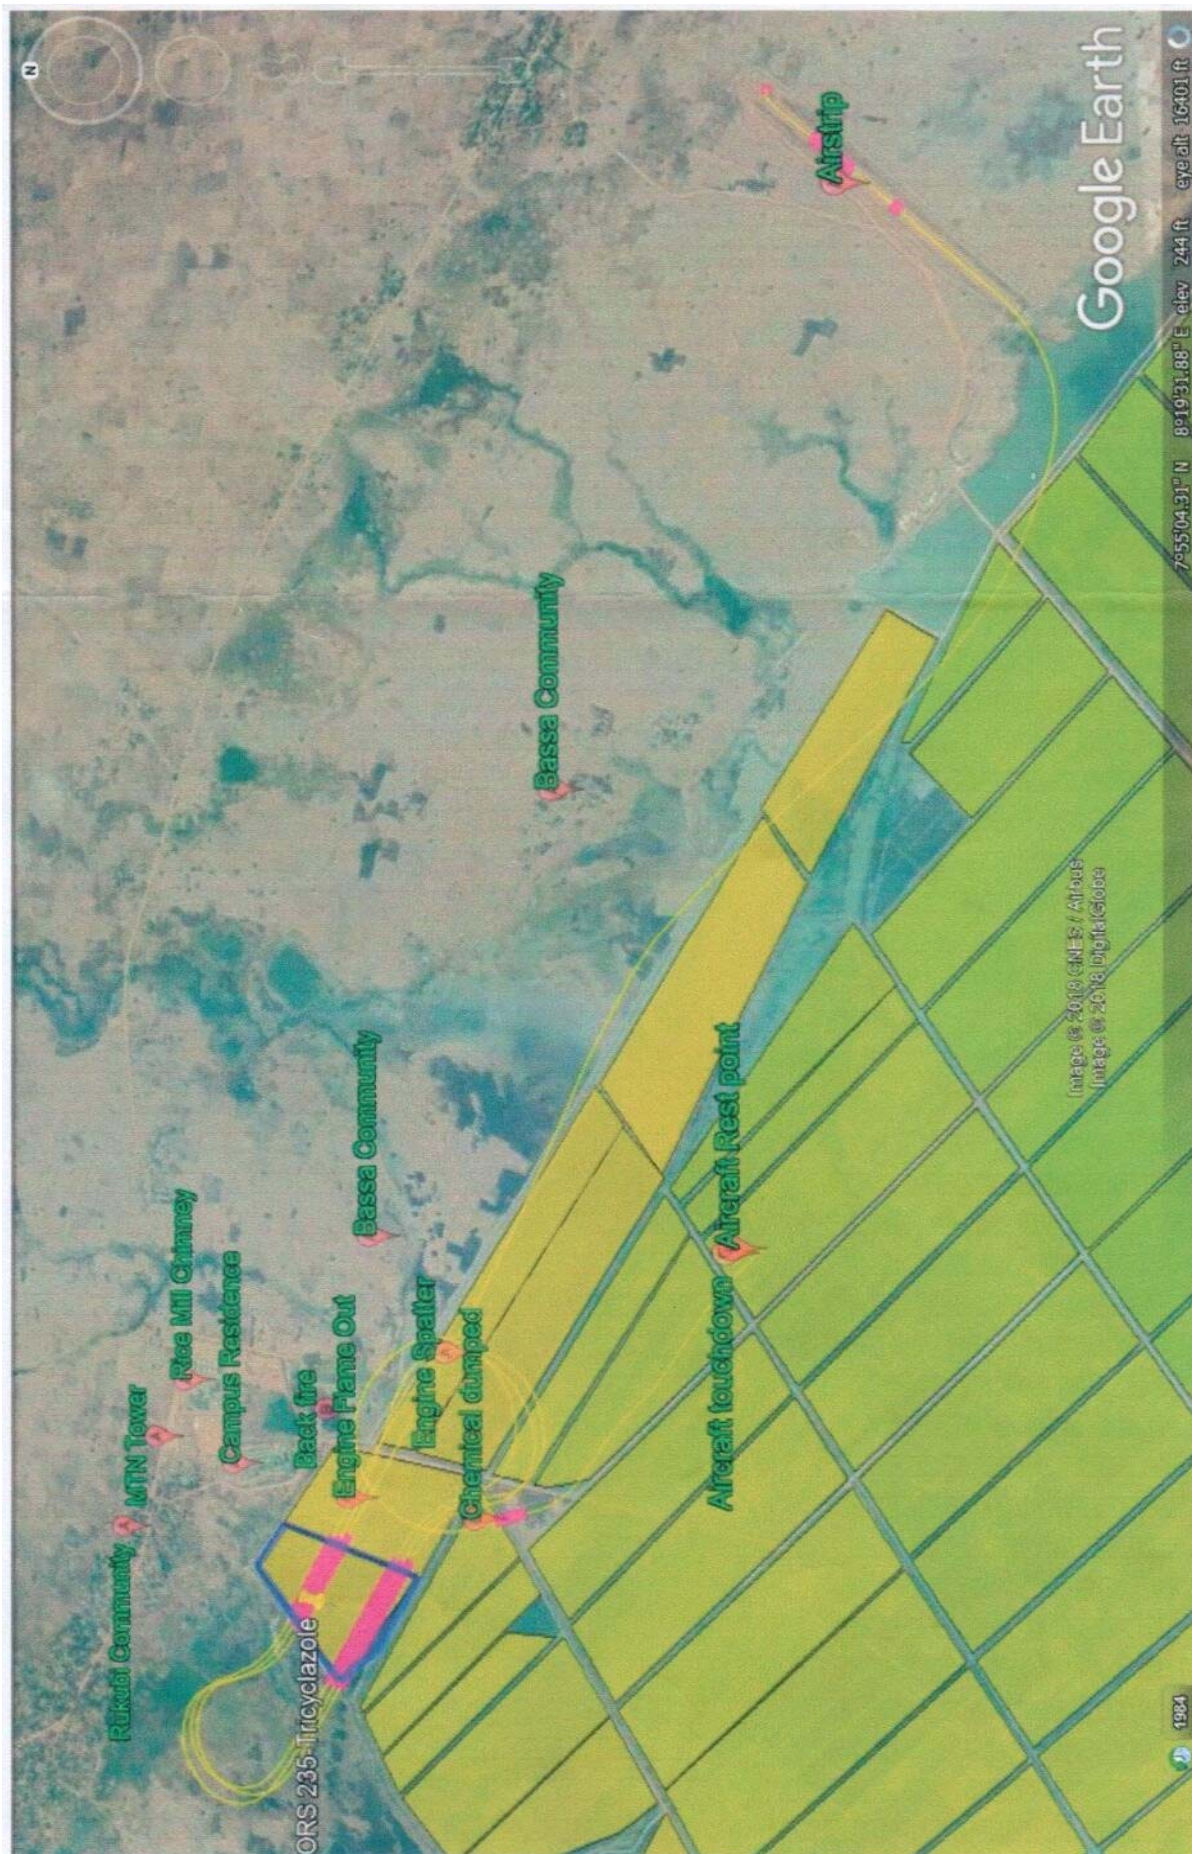
The aircraft glide and finally landed with the right main landing gear touching down first followed by the left main landing gear at a distance of 3m. The right main wheel sheared off from its attachment point at 7m and was found 24m away. A detached section of the sprayer was also located 8m from the first touch down point. Nine propeller slash marks on the ground were found before the nose of the aircraft hit the ground and tipped over. The left wing tip leading edge impacted the ground and caused substantial damage to the section and the fuselage. One of the propeller blades was bent. The wreckage was generally intact in one piece. The aircraft came to rest 38m from the first touch down point.
