**Preliminary Report on serious incident involving Cessna 172 aircraft operated by Skypower Express Airways Nigeria Limited with Nationality and Registration marks 5N-APE which occurred at Bini village, Bida Local Government Area Niger State, on 19<sup>th</sup> November, 2019.**

<b>Aircraft accident report number:</b>	SEA/2019/11/19/D
<b>Registered owner:</b>	Private Flyers International Limited
<b>Operator:</b>	Skypower Express Airways Nigeria Limited
<b>Manufacturer:</b>	Cessna Aircraft Company, USA
<b>Aircraft type and model:</b>	Cessna 172
<b>Year of manufacture:</b>	1971
<b>Serial number:</b>	59912
<b>Nationality and registration marks:</b>	5N-APE
<b>Location:</b>	Bini village, Bida Local Government, Niger state, coordinates; 7°33'2"N 6°0'25"E, elevation of 420 ft
<b>Date and time:</b>	19 <sup>th</sup> November, 2019 at about 12:10 h

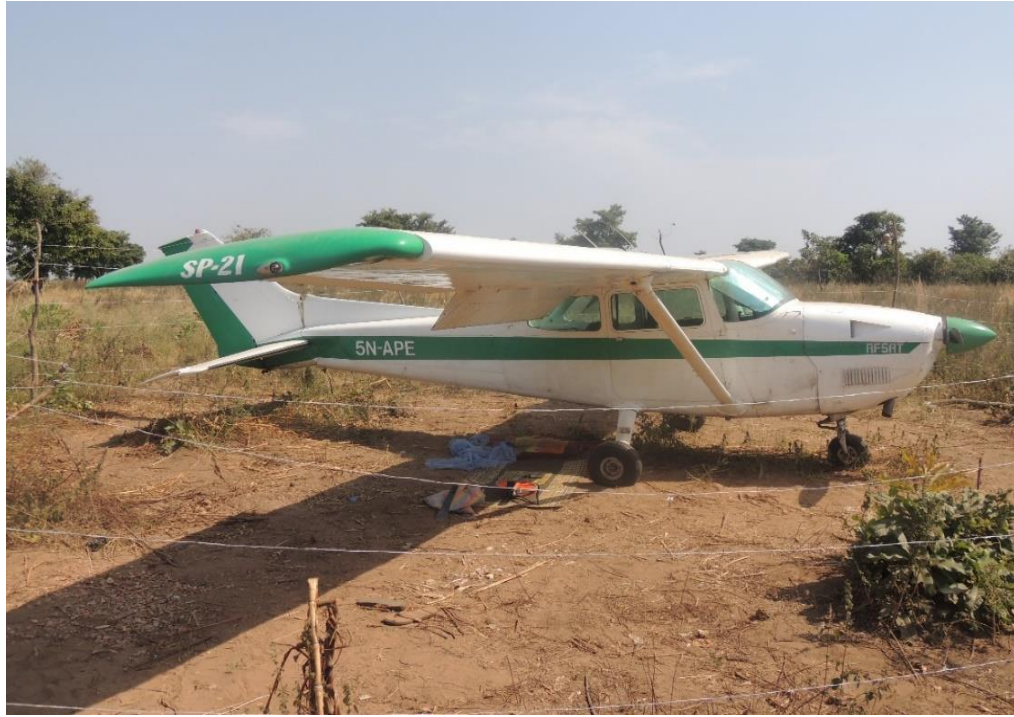
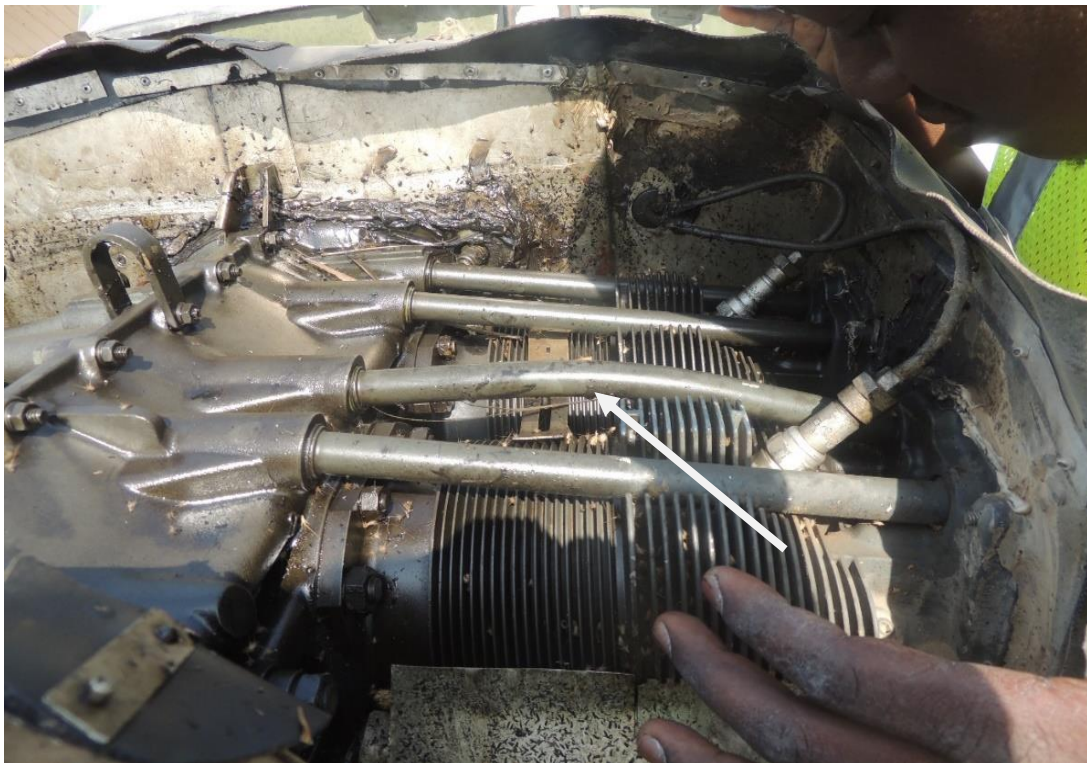
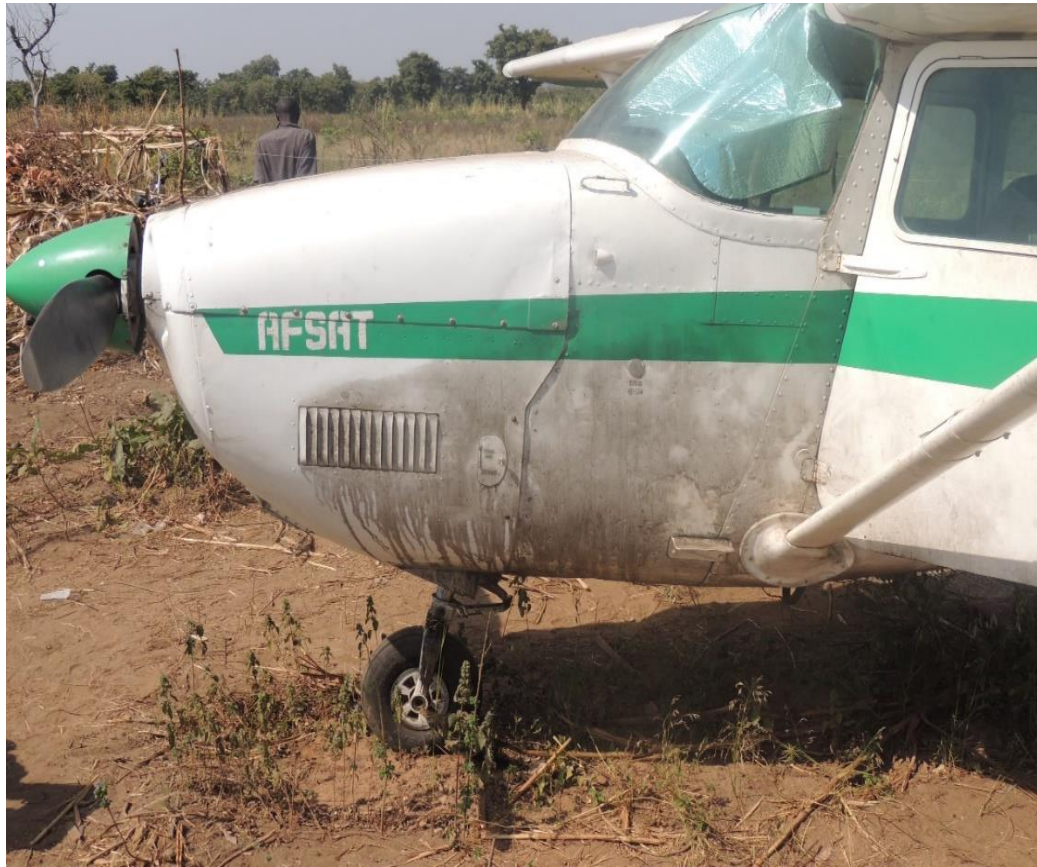
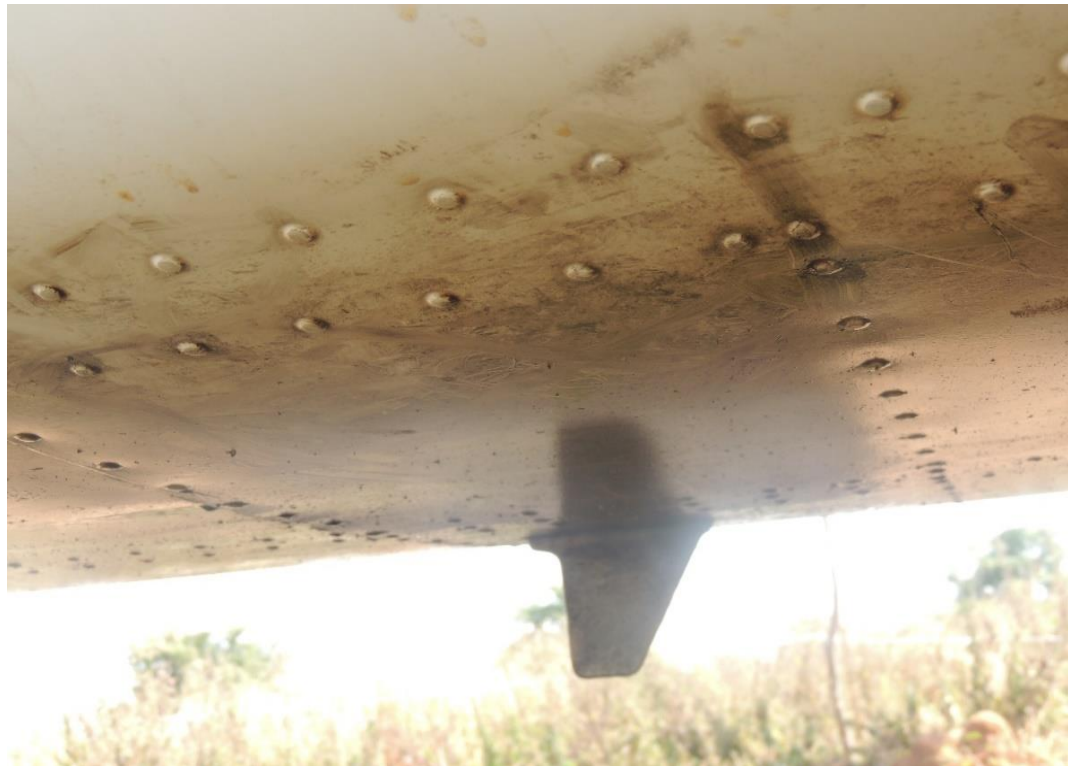
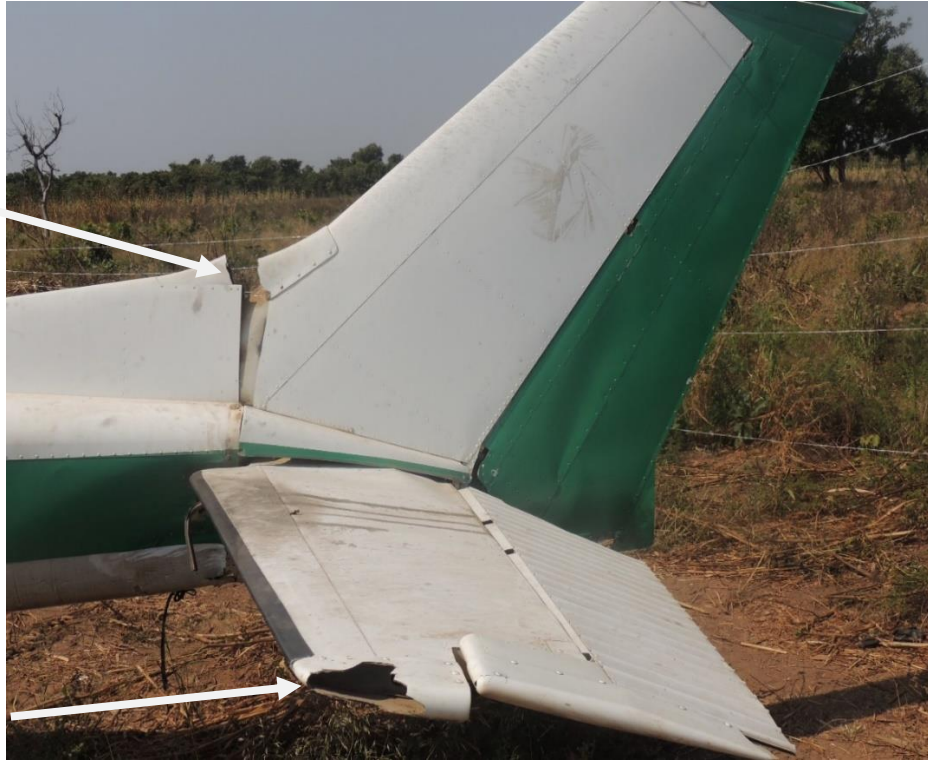
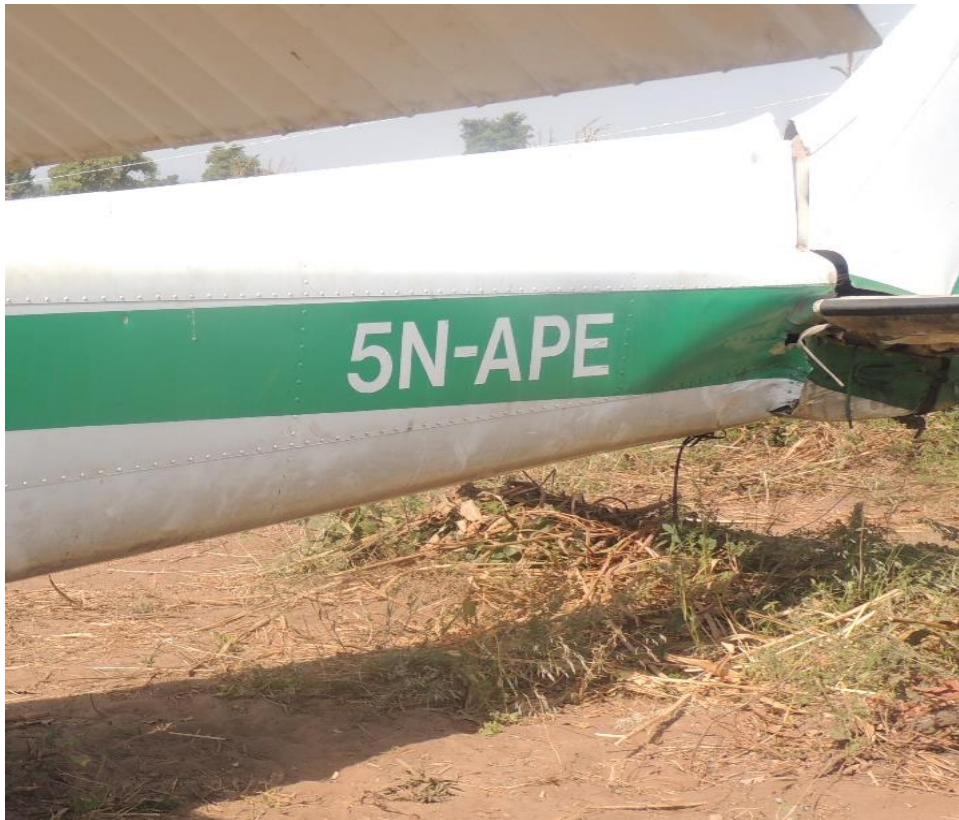
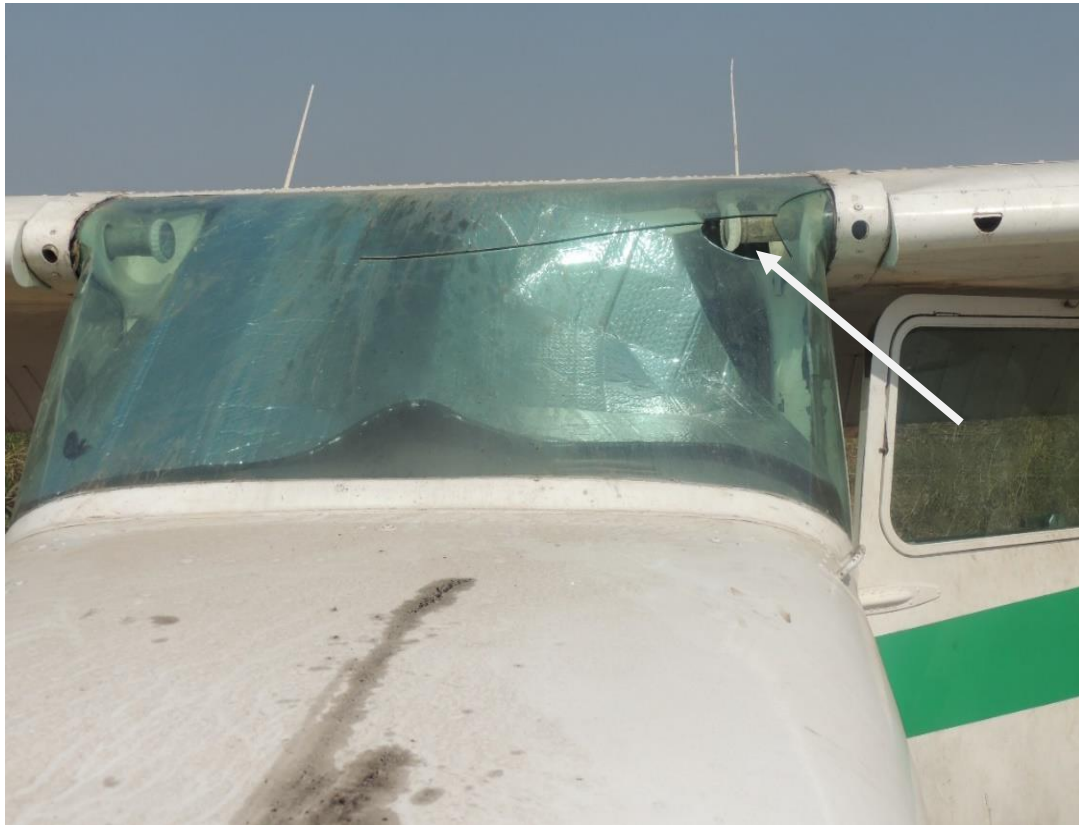
The post occurrence inspection of the aircraft reveals the following damage.

1. one of the push rods for number two cylinder of the engine was bent
2. there was engine oil spillage all over the aircraft
3. the tail cone was bent and damaged (torn)
4. the left horizontal stabilizer was damaged at the tip
5. the leading edge of the vertical stabilizer was also damaged
6. the elevator was also damaged
7. the windshield was broken
