AIRCRAFT ACCIDENT REPORT

CAL/2008/07/14/F

Report on the accident involving a Boeing 737-282 Aircraft with nationality and registration marks 5N-BIG operated by Chanchangi Airlines Limited which occurred at Port-Harcourt International Airport on 14th July, 2008.

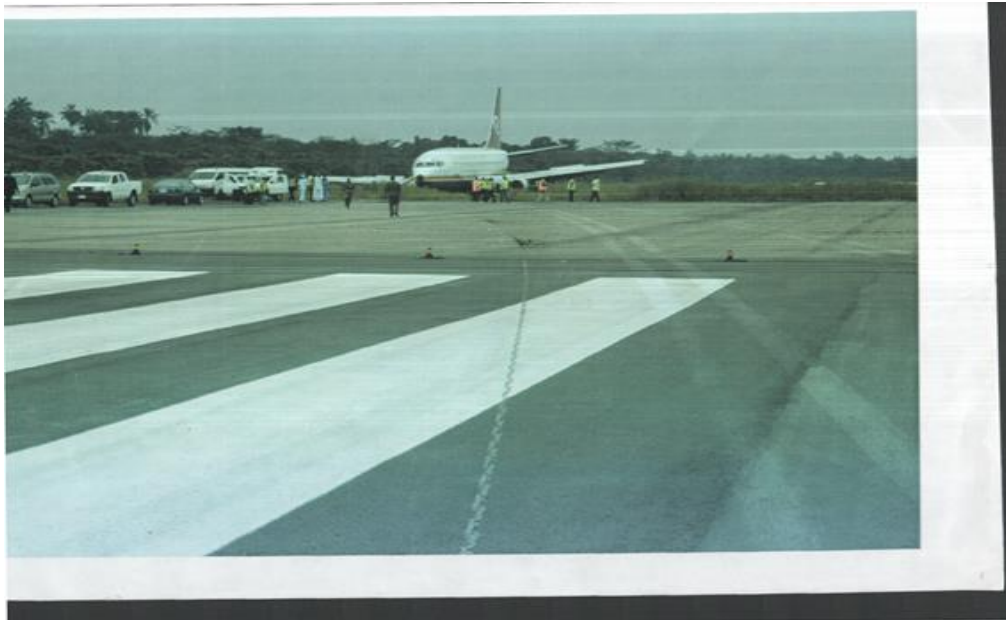
Figure 1: Aircraft position beyond the stopway.

The aircraft overran the runway, cut an NDB cable, made a 180° turn with the right engine hitting the ground. The aircraft came to a final stop on the left side, 10 m beyond the stopway. Upon observation, the following damage was noticed:

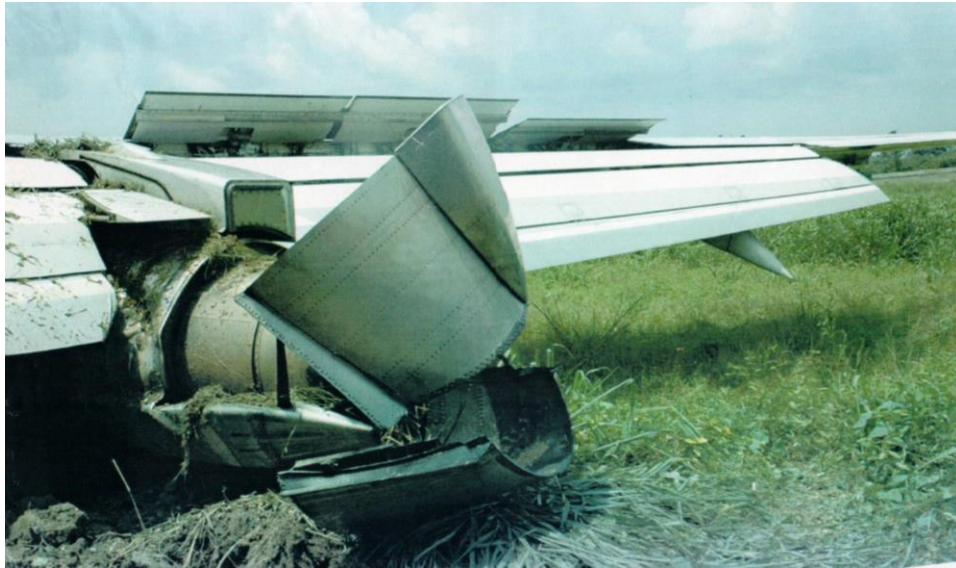
1. Nose wheel sheared off leaving the bolt behind.
2. No. 2 and 4 Main wheel assemblies were damaged.
3. No. 2 and 4 Main wheel tyres were burst.
4. Both engines ingested gravels/sand and debris.
5. No. 2 Engine tail cone and thrust reverser were damaged.

Figure 2: The number 2 engine thrust reverser damage.

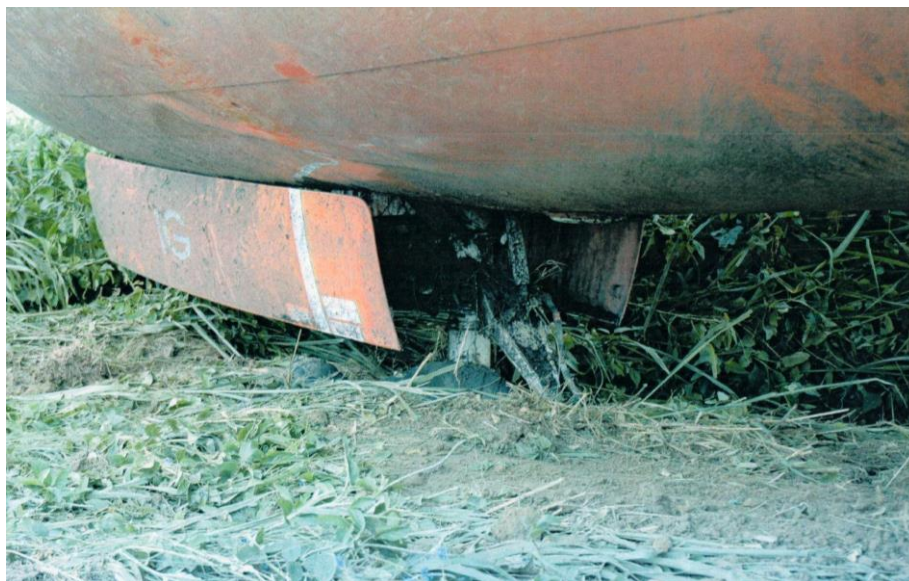
Figure 3: Damaged nose wheel gear

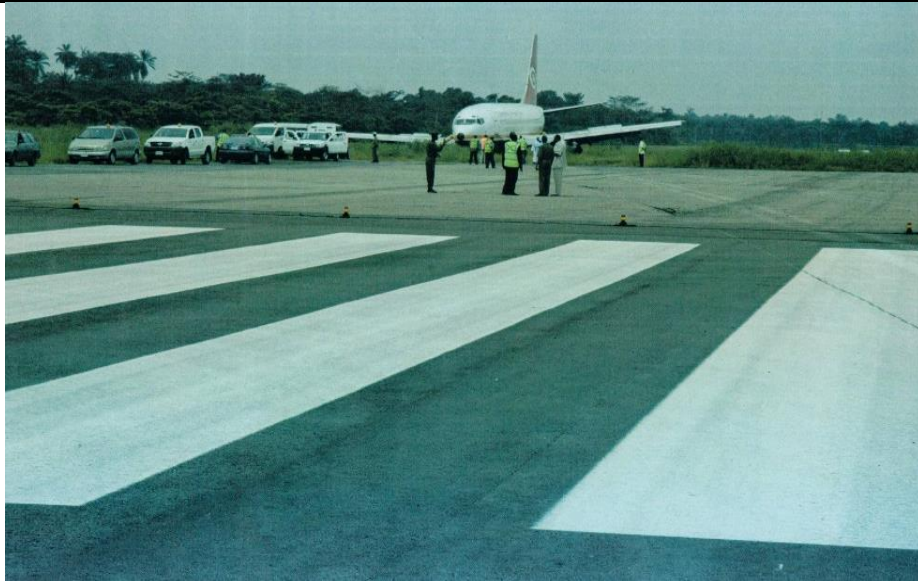
Figure 4: Final position of the aircraft relative to the runway

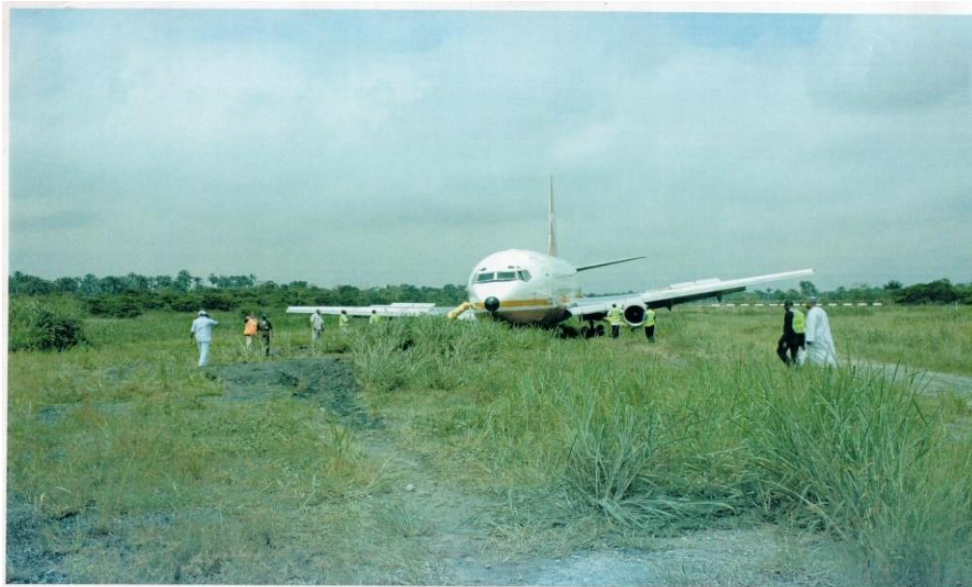
Figure 5: Final position of the aircraft

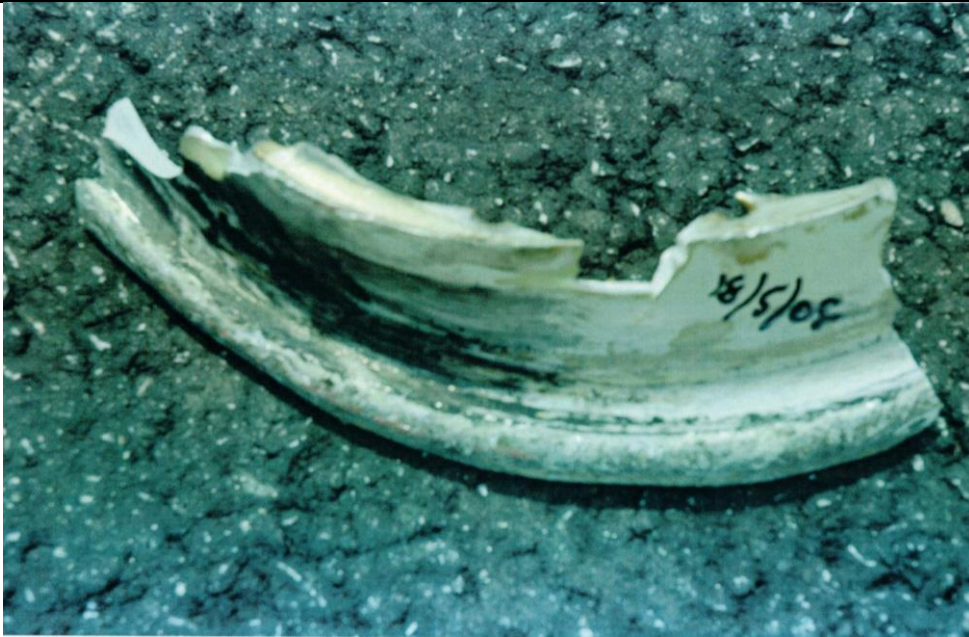
The aircraft touched down at 1700 m into runway 21, bounced several times, skidded left off the extended centre line, back to the centre and continued to the right at 2100 m. The broken pieces of the nose wheel rim and the damaged tyre were found at 2100 m and 2200 m, respectively.

Figure 6: A broken piece of the nose wheel rim

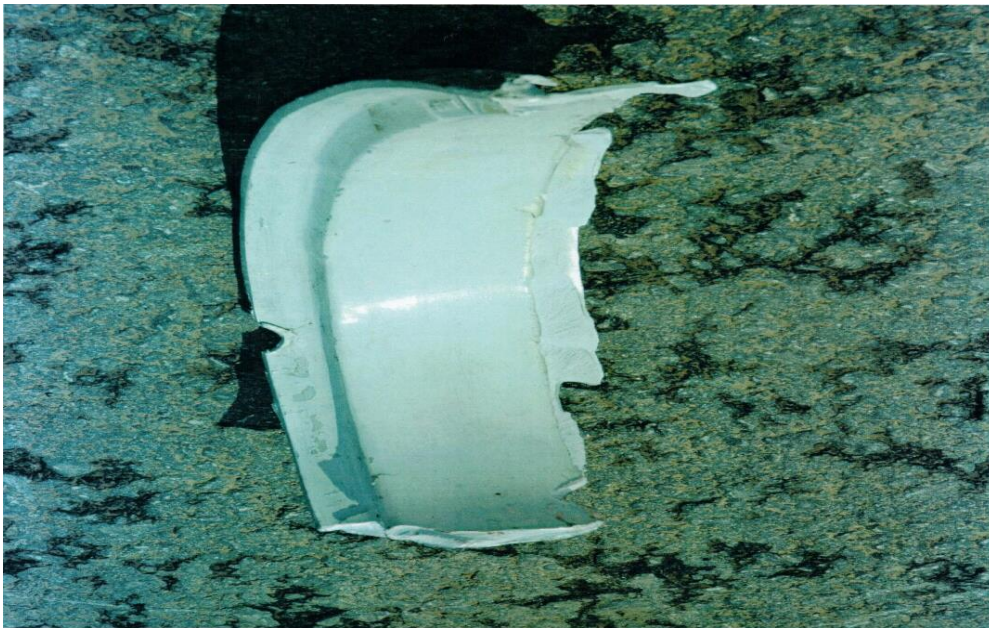
Figure 7: Another broken piece of the nose wheel rim

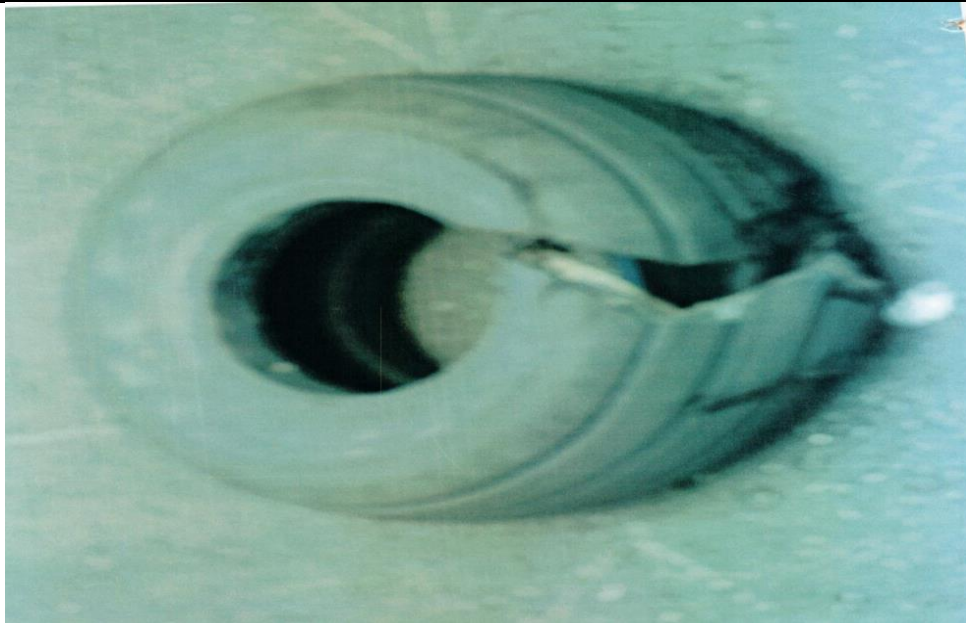
Figure 8: Damaged nose wheel tyre

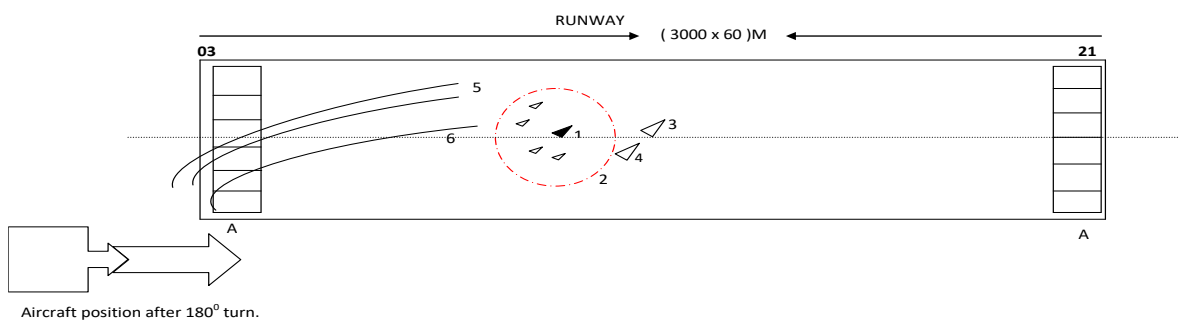
Impact and wreckage trail sketch diagram

- 1 – Impact shown at 1700 meters from end of runway 21
- 2 – Scattered debris of nose wheel and nose wheel scratches at (1600 – 1700) meters from end of runway 03
- 3 – Tyre at 1500 meters from end of runway 03
- 4 – Position of side strip at 1400 meters from end of runway 03
- 5 – Tyre markings of main landing gear on runway
- 6 – Strut marks of nosewheel on runway
- A – Threshold point
