AIRCRAFT ACCIDENT REPORT

NCAT/2018/09/26/F

Report on the accident involving Tampico TB-9 with nationality and registration marks 5N-CBJ operated by Nigerian College of Aviation Technology (NCAT) Zaria which occurred at Zaria Aerodrome on 26th September, 2018.

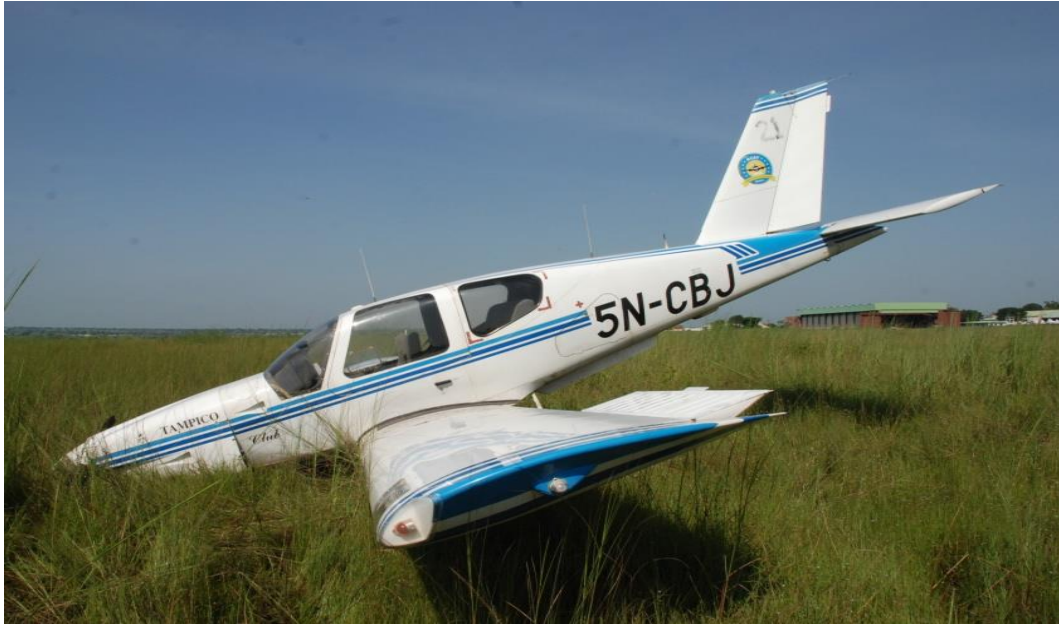
The aircraft travelled 133 m in the waterlogged grass area, came to rest on a heading of approximately 160° and at a perpendicular distance of about 73 m from the runway centreline. The seats, seat belts and shoulder harnesses were found intact.

Figure 1: Aircraft wreckage at its final position

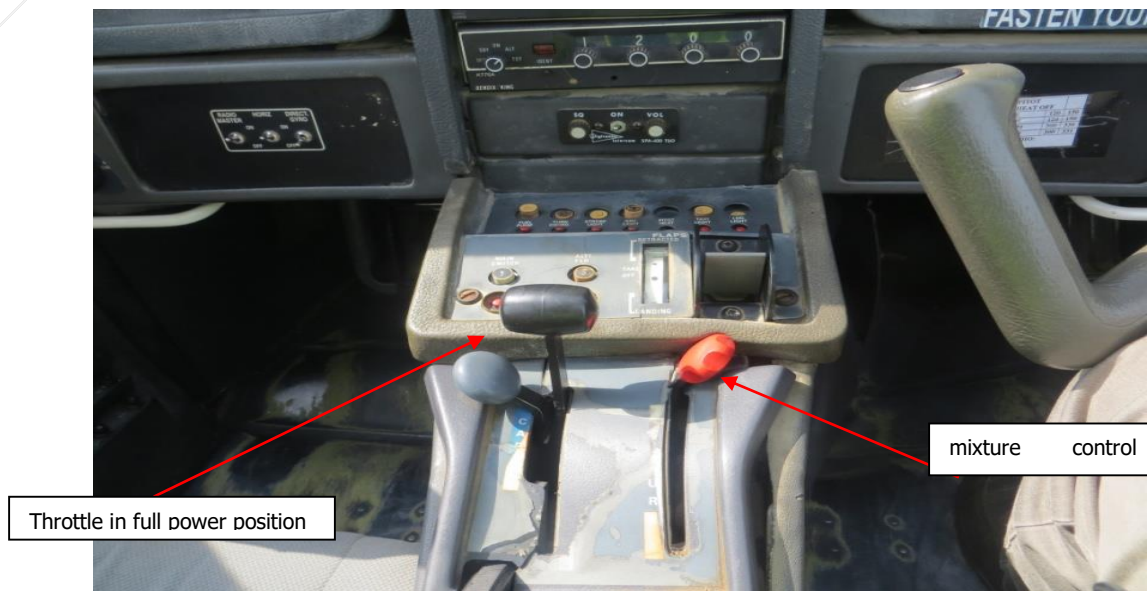
1. The throttle was found at FULL position
2. Mixture lever was at RICH position
3. Fuel selected to the left tank
4. The rudder pedals were found in the full left position
5. The rudder was deflected to full left
6. The ailerons were deflected to full left roll
7. Flaps fully down
8. All the three tires were found to be in good condition and remained inflated
9. Flight control surfaces were checked and found in good condition
10. The main landing gears were checked and found in good condition

Figure 2: Engine Control Levers with throttle at FULL power position and Fuel Mix Lever at RICH position after the incident.

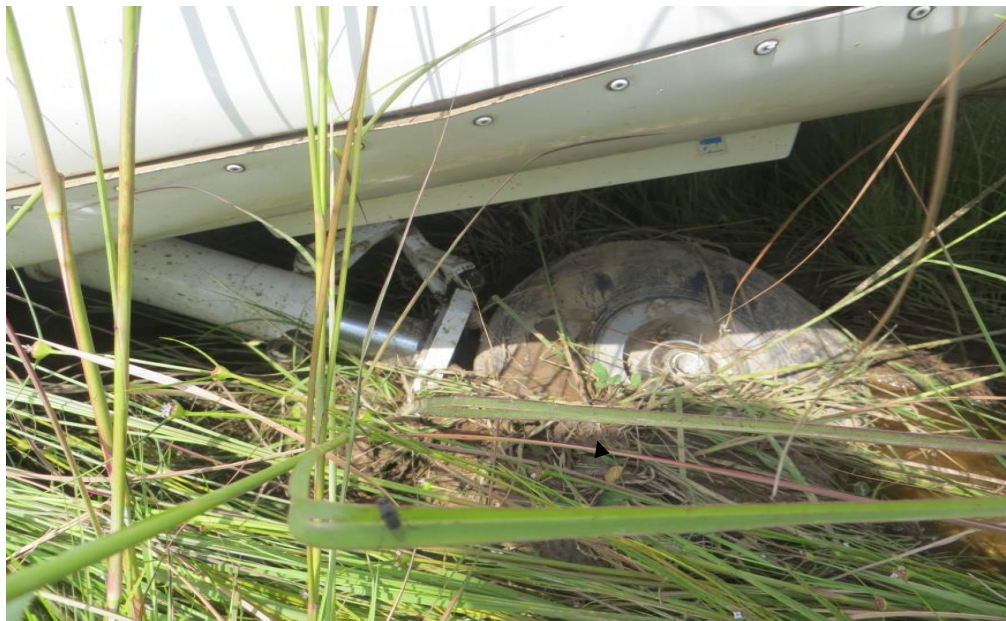
ground. The nose gear bounced twice and on the third bounce, sank into the soft ground, got bogged down and broke off at some of the firewall attachment points.

Figure 3: Collapsed Nose Landing Gear

13. The nose landing gear was damaged by impact forces in the grass area
14. Rudder pedals were found full left position and rudder was at corresponding full left deflection

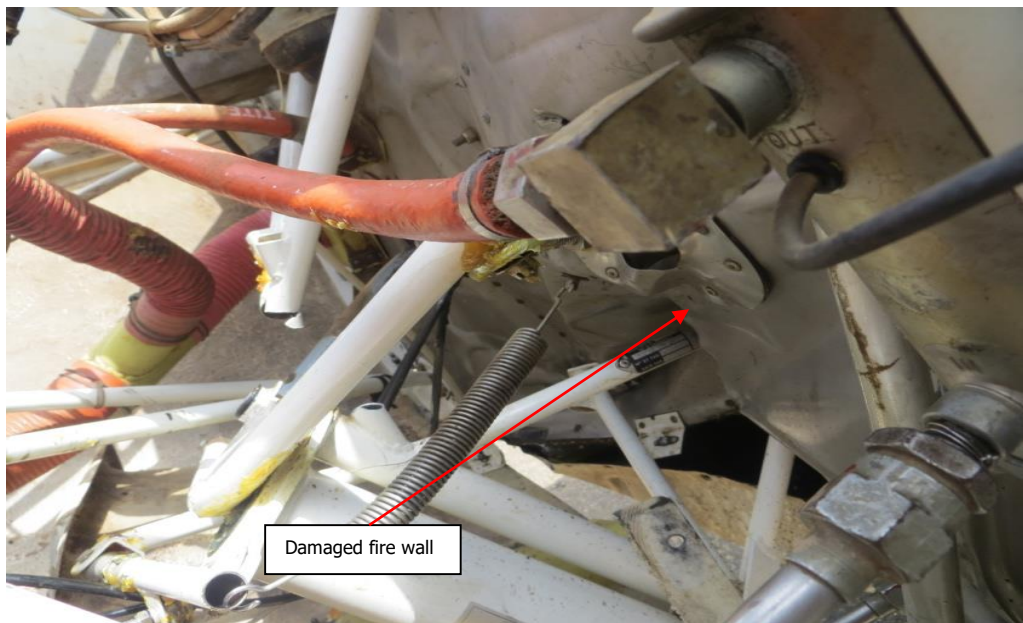
1. Nose landing gear attachment points.
2. The fire wall.
3. The right side of the cockpit floor.

Figure 4: Damaged fire wall and detached nose gear mounts

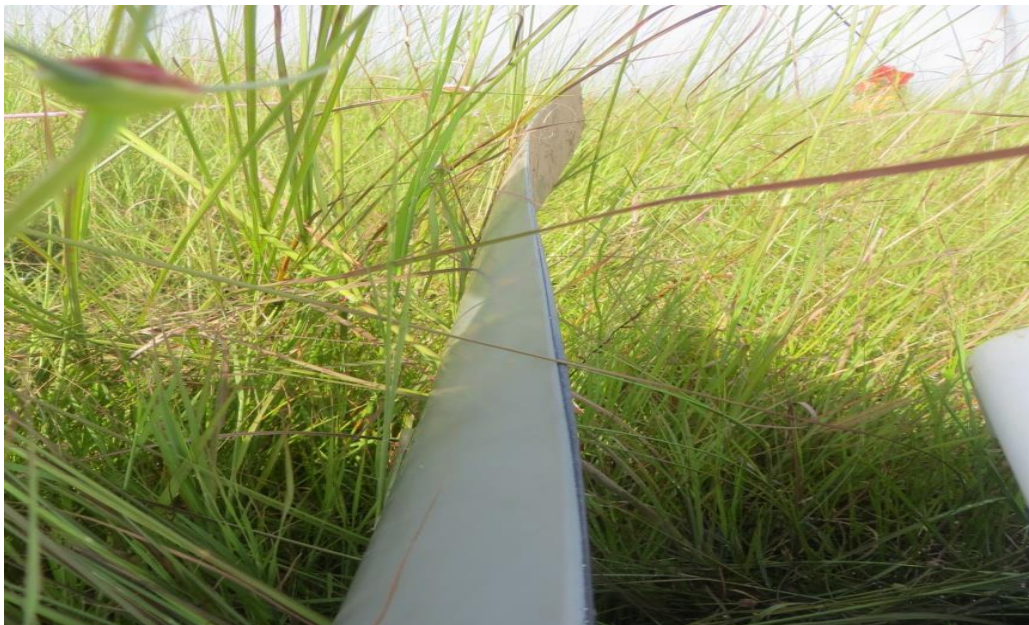
4. Lower engine cowling.
5. One propeller blade bent rearward.

Figure 5: Damaged propeller blade.

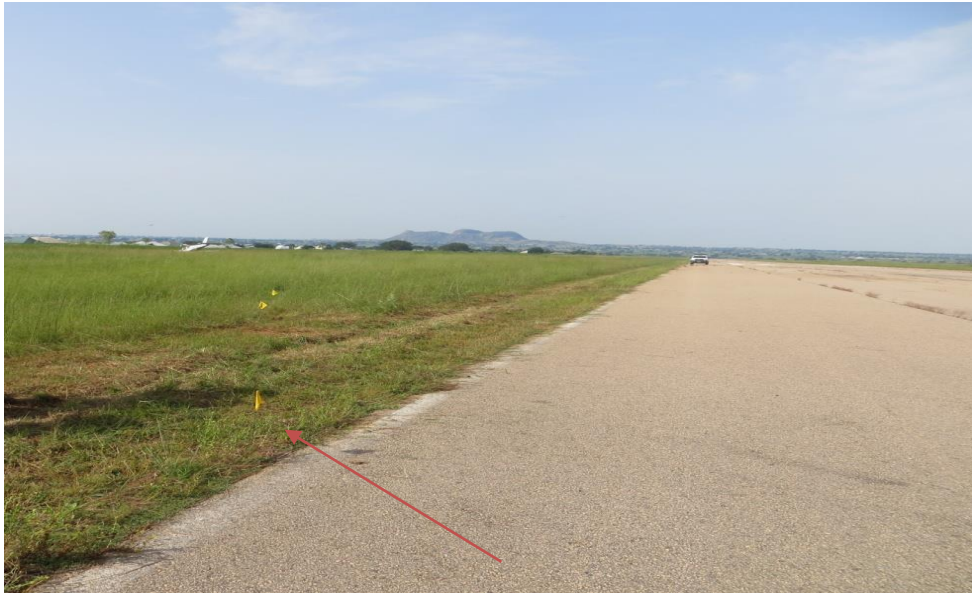
The left main wheel tyre marks seen on the runway depicted a curved track from the touchdown point to where the aircraft exited the runway to the left. The nose wheel tyre marks were seen at just three spots along the grass area until a few feet to where the aircraft stopped.

Figure 6: Aircraft exit point on RWY 23 showing left wheel tyre marks
