AIRCRAFT ACCIDENT REPORT

SEIL/2011/05/24/F

**Report on the accident involving a Beechcraft C90
with nationality and registration marks N364UZ
operated by Shoreline Energy International Limited
which occurred at Barakallahu village near Old
Kaduna (Military) Airport, Kaduna State, Nigeria on
24th May, 2011.**

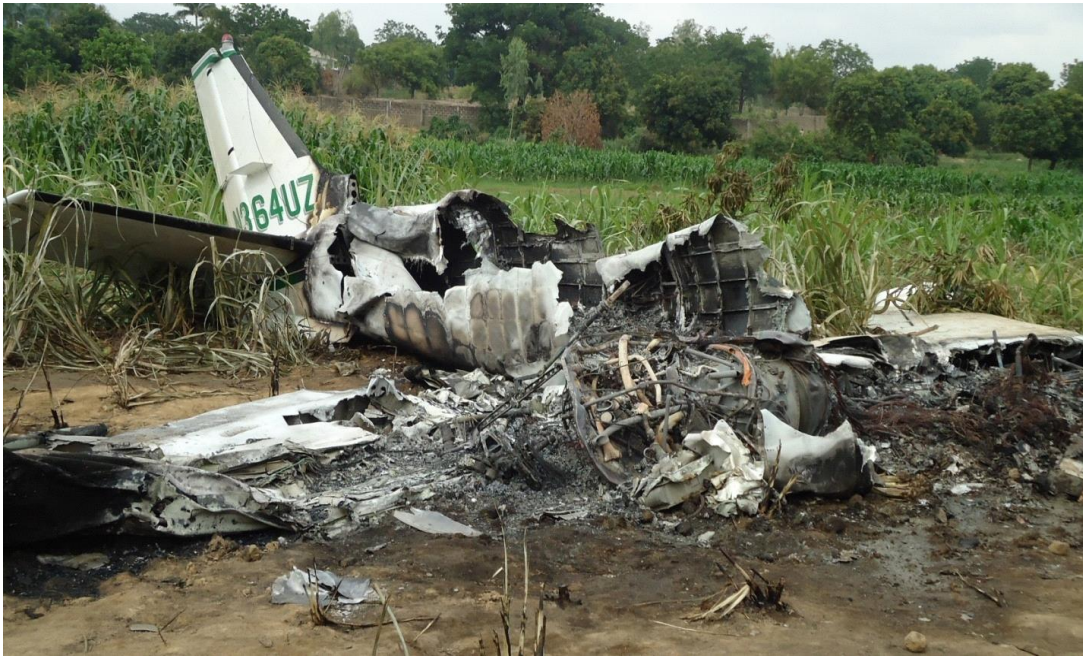
The aircraft was completely burnt except the tail section.

Figure 1: Burnt fuselage of the aircraft

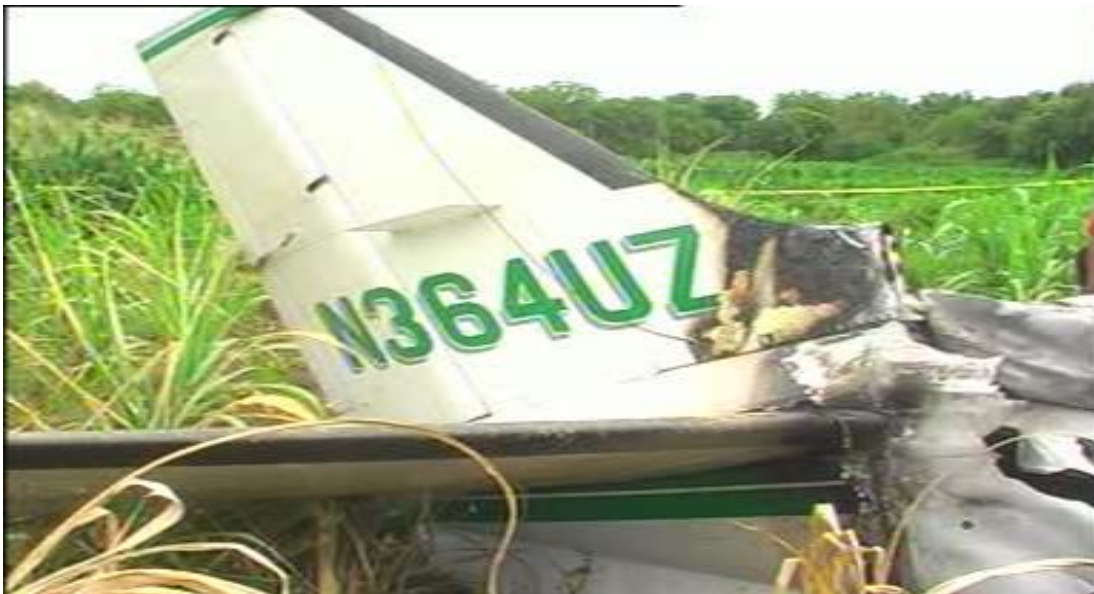
Figure 2: Tail section of the aircraft

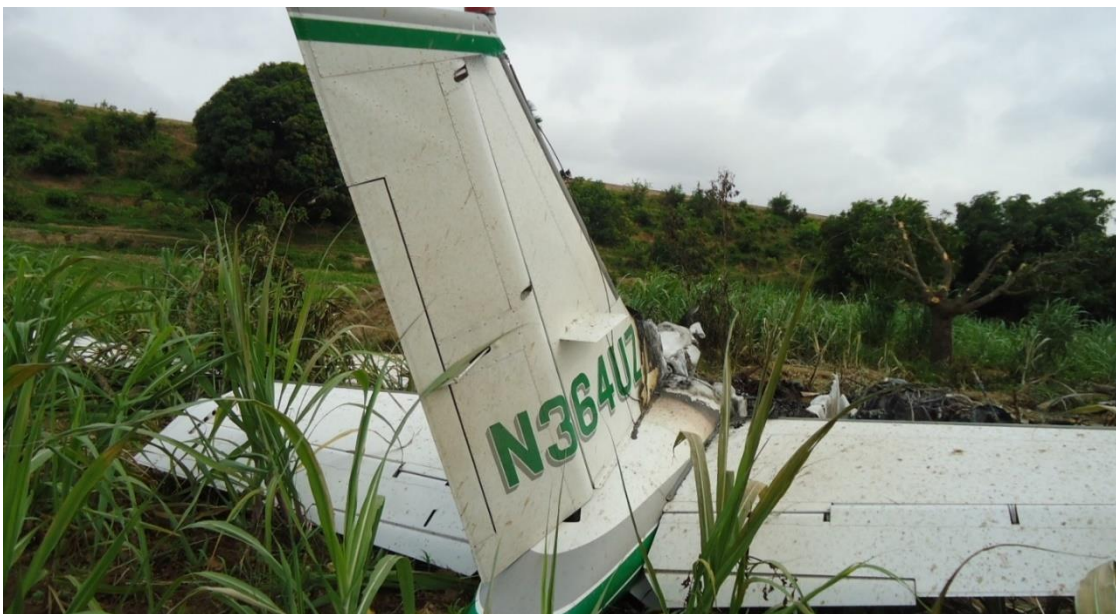
Figure 3: Aircraft wreckage in relation to mango tree

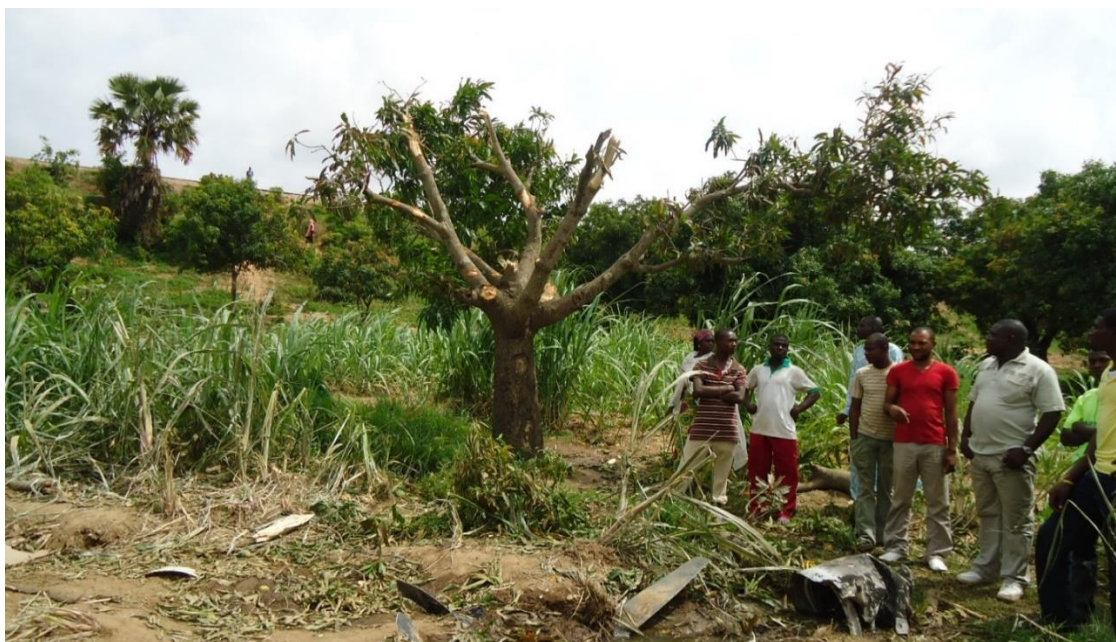
Figure 4: The Mango tree impacted by the aircraft before the crash

On finals the aircraft impacted a mango tree at a distance of about 878 m from the runway threshold. The right propeller assembly separated from the engine and was found partially embedded in the ground, while the left propeller remained attached to the engine. For the aircraft to be at a very low altitude to strike a mango tree at a distance of about 800 m to the runway threshold; it was an indication that either the aircraft was gliding or the engines were operating at very low rpm (revolution per minute) and producing inadequate power to enable the pilot maintain the appropriate approach profile (height, speed and glide path) to cover the required distance to threshold.

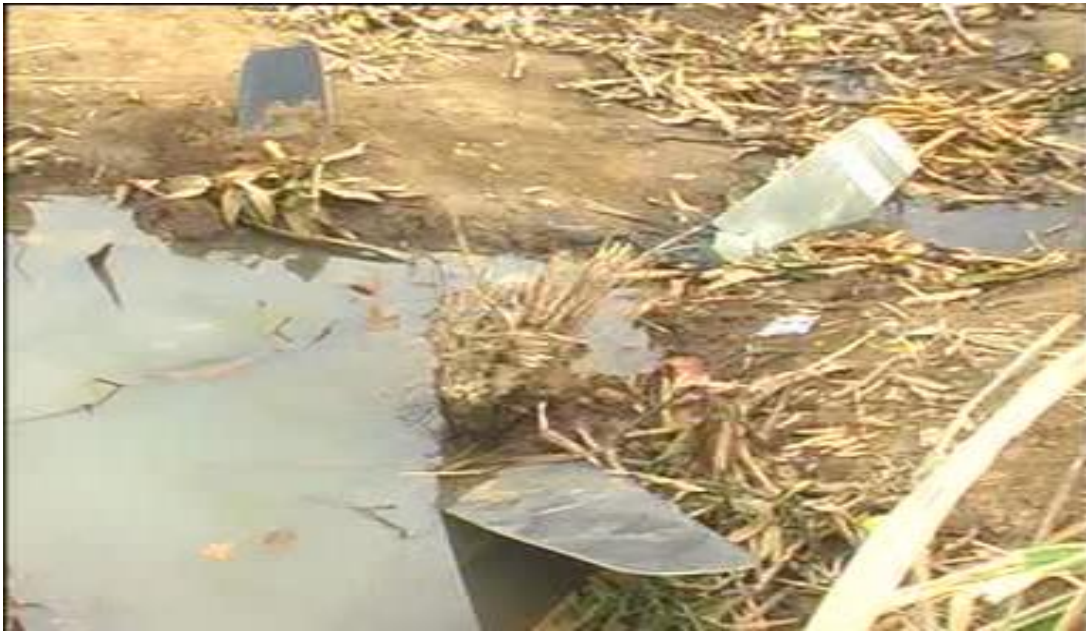
Figure 5: Detached right propeller blade assembly

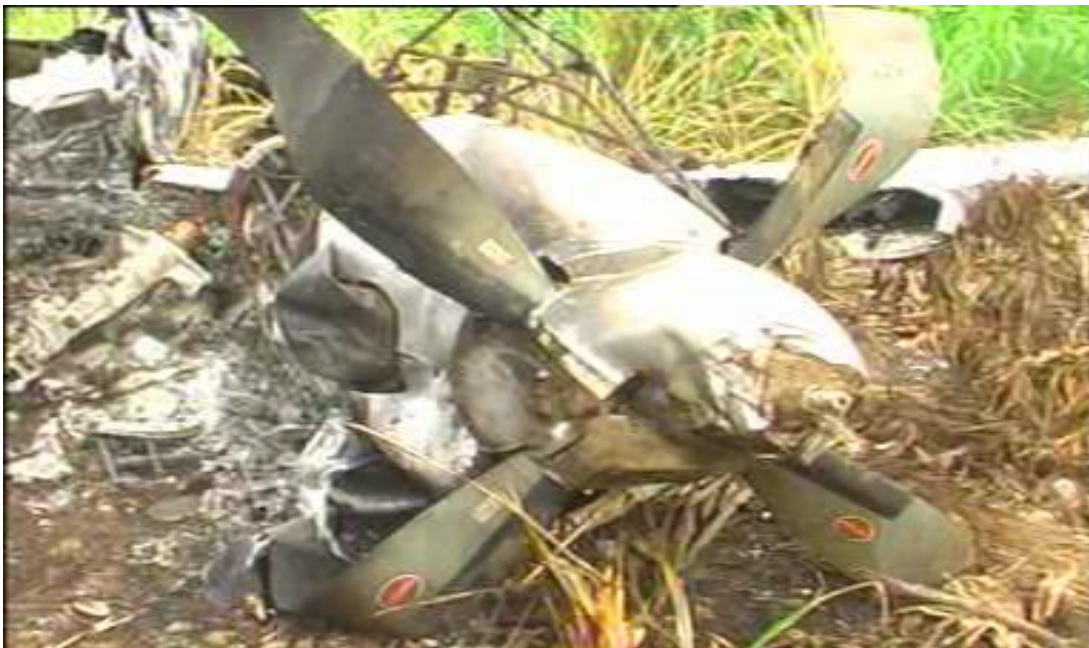
Figure 6: Left engine propeller blades bent backward

Examination of the left hand propeller blades revealed that the propeller blades were bent backwards at about one third from the tip and there was no significant twist on all the four blades. This type of damage is consistent with the propeller coming to a stop with significant low power upon impact with the ground, which suggested that the propeller was either wind milling¹ at the time of impact as per paragraph 12.3.1 of ICAO Doc 9756 Part III or that the propeller rpm was low compared to the forward velocity of the aircraft as per paragraph 12.3.4 of the ICAO Doc 9756 Part III. This was corroborated by the eye witness (a local farmer) who stated that he saw the aircraft moving up and down with increasing and decreasing engine sound. The pilot did not declare emergency in any phase of the flight.

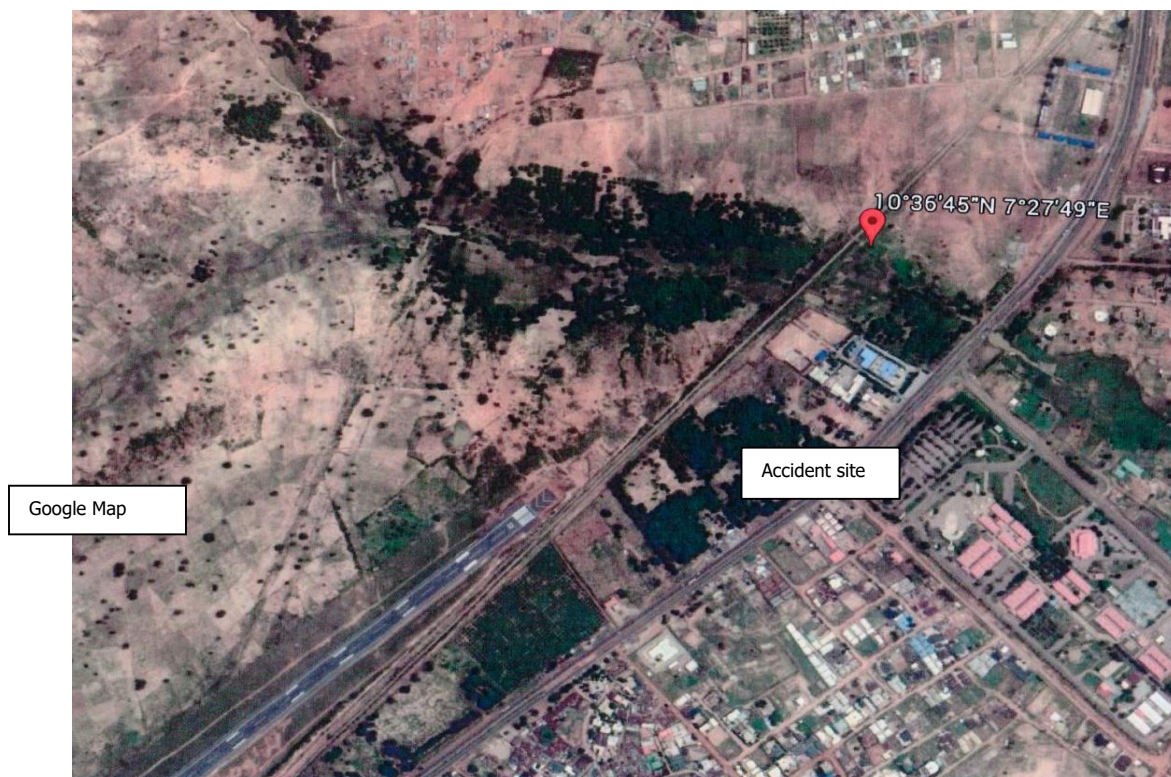
The aircraft was engulfed in flames after the crash which raged on for several minutes before the arrival of the rescue team thus consuming most of the aircraft as there was an existing rail track that obstruct the fire trucks from reaching the aircraft on time. However, Nig. CARs 12.6.15.2 stipulates that rescue and fire-fighting personnel should have access to areas that extend to 1000m beyond the ends of the runway and outside the aerodrome boundary.

Figure 7: Location of the accident site in relation to runway
