AIB BULLETIN

NCAT/2014/06-003

Report on the Incident involving a Tampico Club TB-9 Aircraft with nationality and registration marks 5N-CBB owned operated by Nigeria College of Aviation Technology (NCAT) Zaria which occurred at Zaria Aerodrome, Kaduna State, Nigeria On 18th June, 2014.

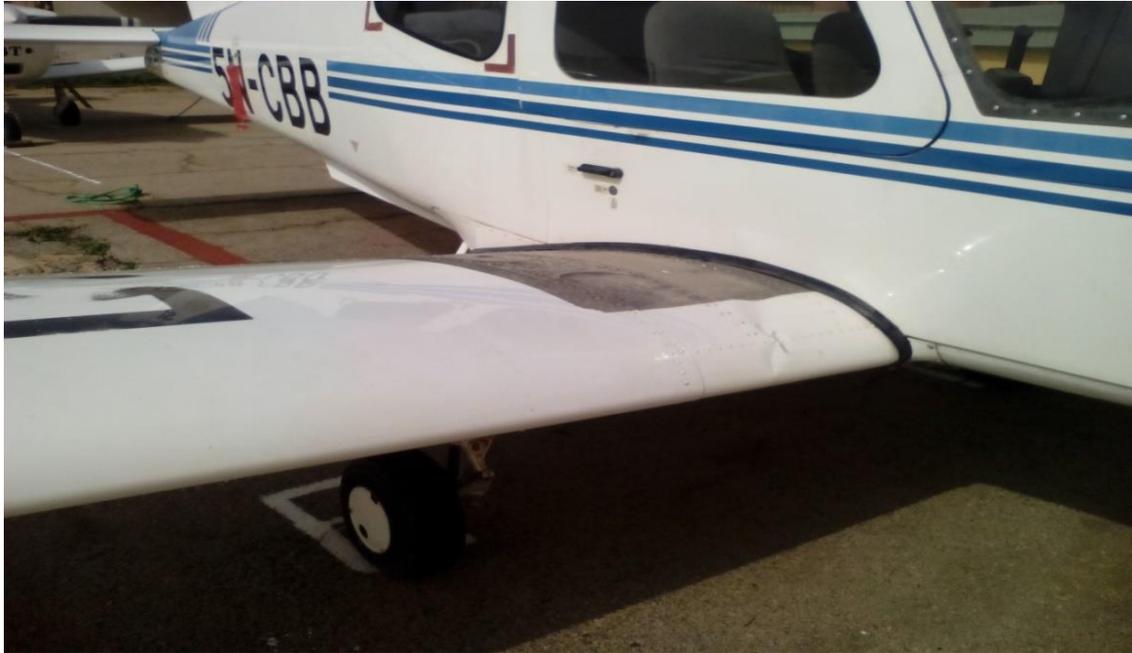
The damage to the aircraft was noticed by the maintenance engineer during pre-flight inspections the next day. The nature of the damage sustained by the aircraft were dent on the right wing skin at the root end, cuts on the right main landing gear, rivets on the affected right wing were shifted and dents on the right wing flap.

Figure 1: Dent on the right wing skin at the root end.

During the post incident interview, the SP was unable to explain the circumstances that led to the aircraft landing 50ft before the threshold of runway 24. This incident indicates poor judgment and lack of aircraft handling techniques.

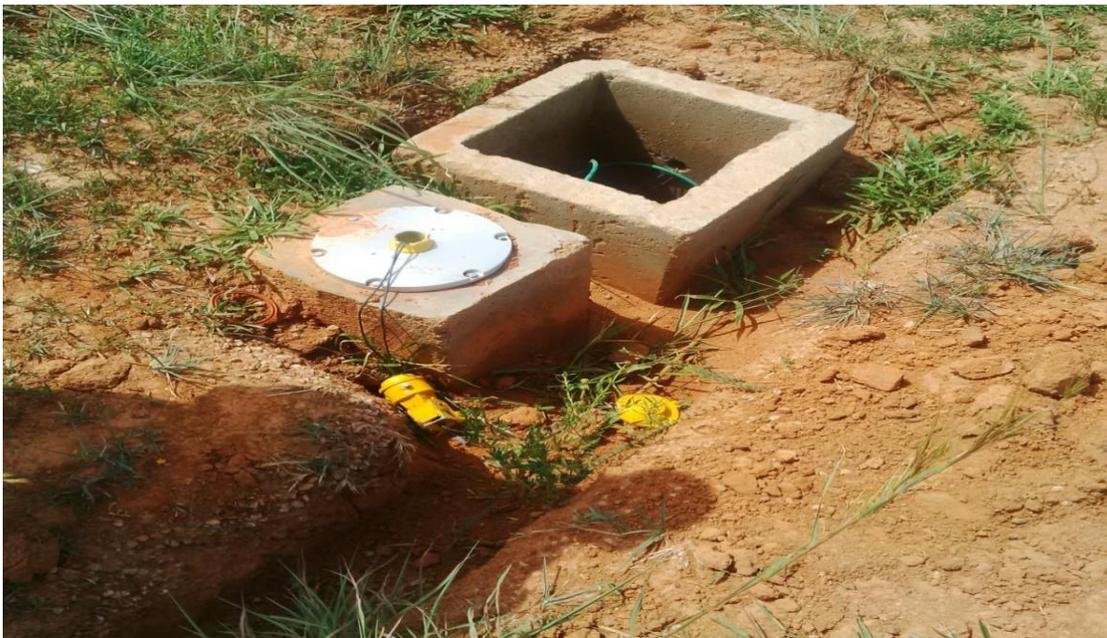
Two approach lights were damaged.

Figure 2: Damaged approach lights
