AIB BULLETIN

NCAT/2013/12/10-002

Report on the Incident involving a Tampico Club TB-9 Aircraft with nationality and registration marks 5N-CBG operated by Nigerian College of Aviation Technology (NCAT) Zaria which occurred at Zaria Aerodrome, Kaduna State, Nigeria On 10th December, 2013.

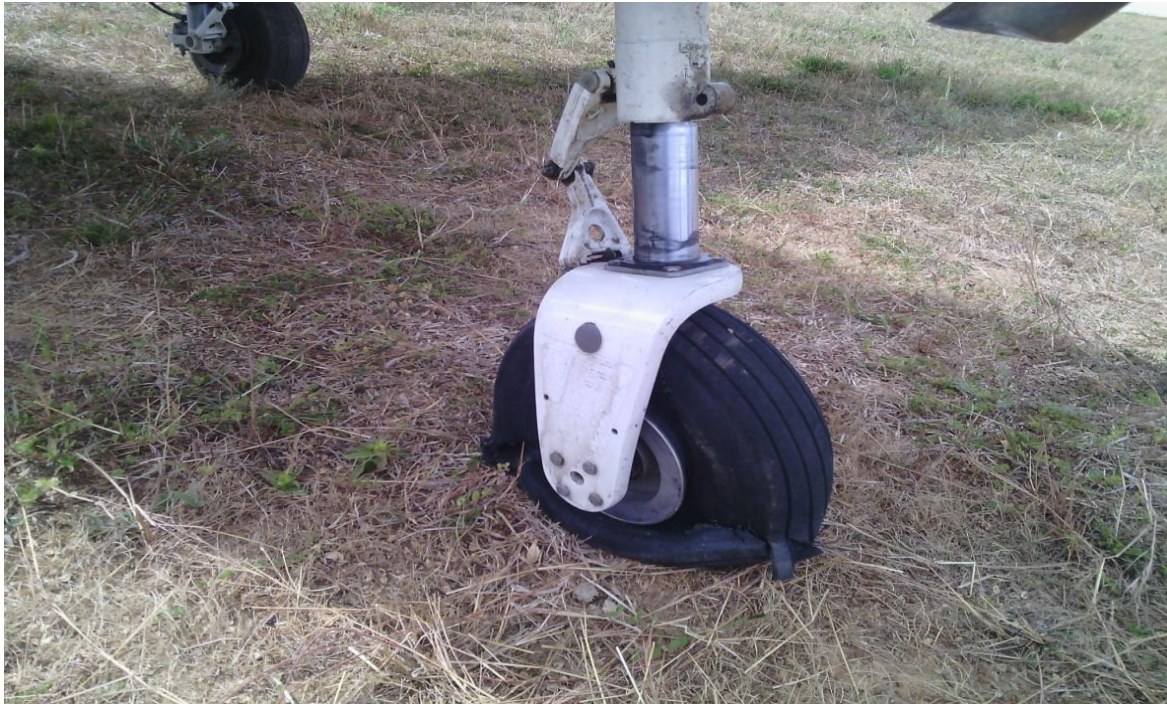
The aircraft was substantially damaged. The nose wheel tyre burst and the propeller blade tips struck the runway surface.

Figure 1: Burst nose wheel tyre

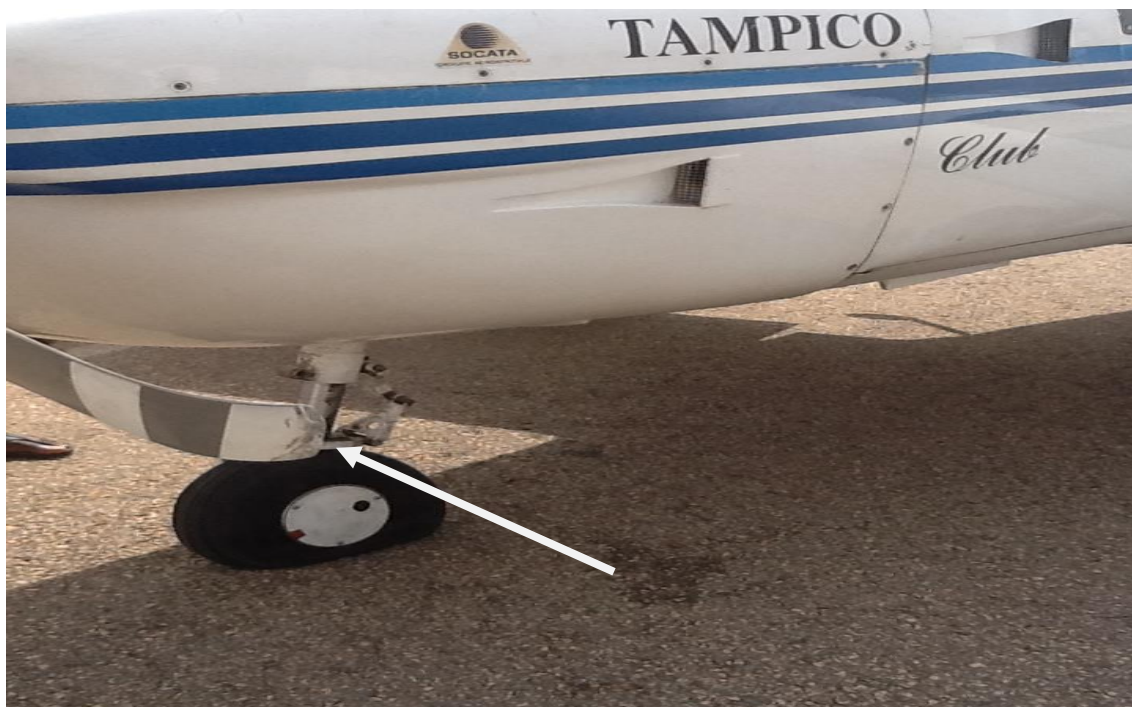
While on approach for the second touch and go exercise, the aircraft ballooned after the flare manoeuvre. The SP lowered the aircraft nose to overcome the ballooning effect; in the process the nose landing gear hit the runway and the nose wheel tyre burst. The propeller blade tips also struck the runway surface.

Figure 2: Bent propeller blade tip
