# AIRCRAFT ACCIDENT REPORT

NCAT/2018/09/26/F

**Report on the accident involving Tampico TB-9 with nationality and registration marks 5N-CBJ operated by Nigerian College of Aviation Technology (NCAT) Zaria which occurred at Zaria Aerodrome on 26th September, 2018.**

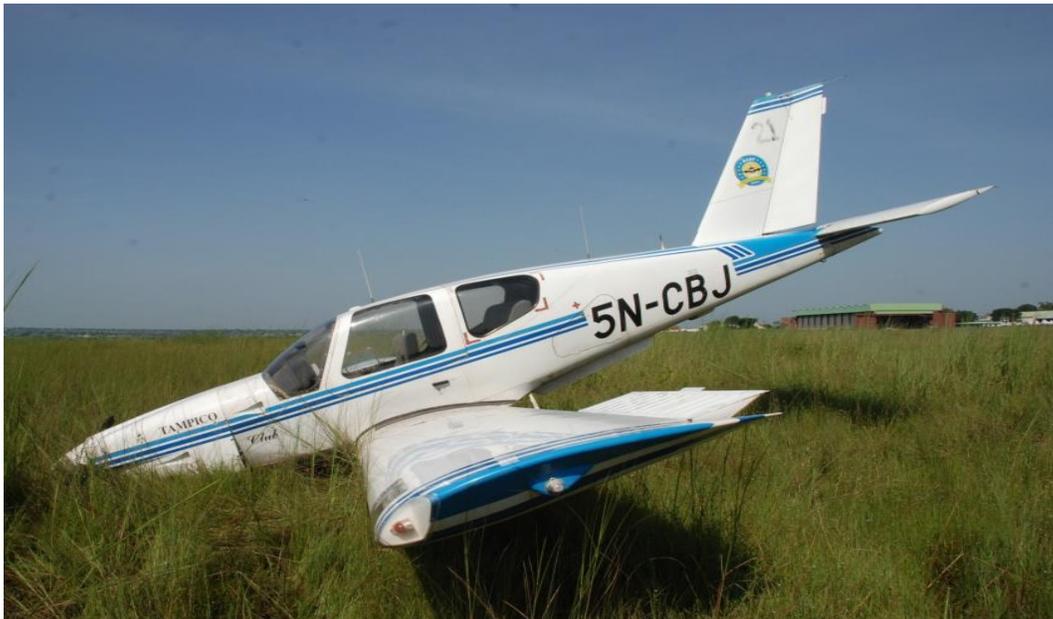
The aircraft travelled 133 m in the waterlogged grass area, came to rest on a heading of approximately 160° and at a perpendicular distance of about 73 m from the runway centreline. The seats, seat belts and shoulder harnesses were found intact.

**Figure 1:** Aircraft wreckage at its final position

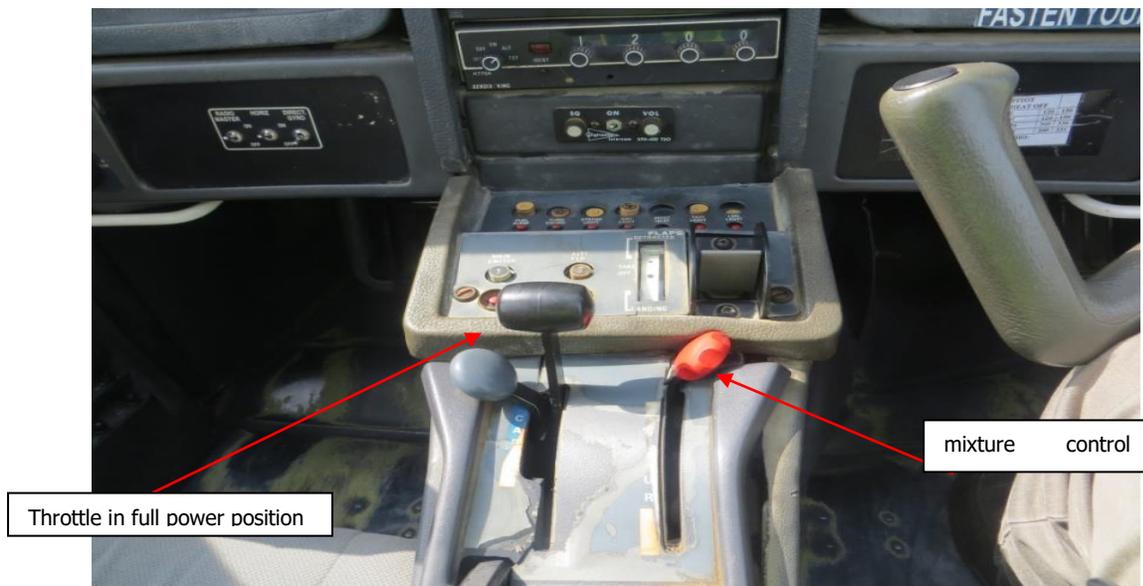
1. The throttle was found at FULL position
2. Mixture lever was at RICH position
3. Fuel selected to the left tank
4. The rudder pedals were found in the full left position
5. The rudder was deflected to full left
6. The ailerons were deflected to full left roll
7. Flaps fully down
8. All the three tires were found to be in good condition and remained inflated
9. Flight control surfaces were checked and found in good condition
10. The main landing gears were checked and found in good condition

**Figure 2:** Engine Control Levers with throttle at FULL power position and Fuel Mix Lever at RICH position after the incident.

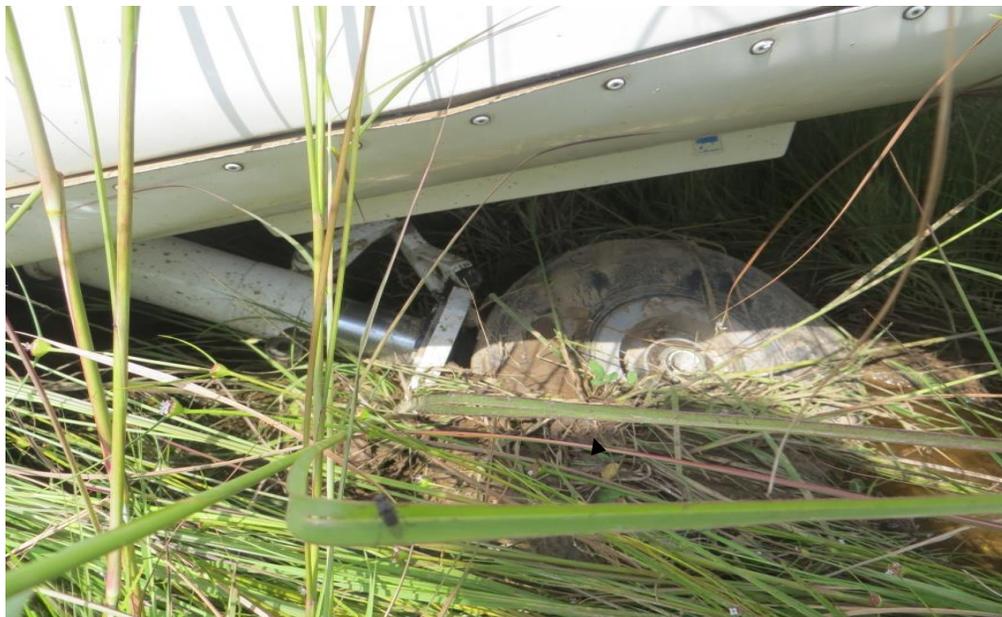
gear off the ground. The nose gear bounced twice and on the third bounce, sank into the soft ground, got bogged down and broke off at some of the firewall attachment points.

**Figure 3:** Collapsed Nose Landing Gear

13. The nose landing gear was damaged by impact forces in the grass area.
14. Rudder pedals were found full left position and rudder was at corresponding full left deflection.

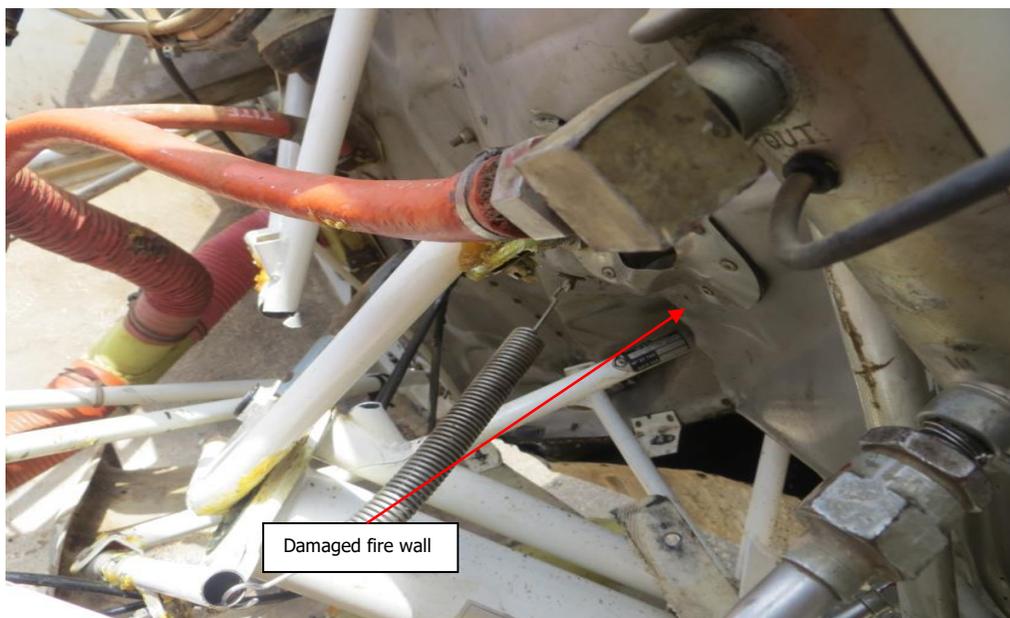
1. Nose landing gear attachment points.
2. The fire wall.

**Figure 4:** Damaged fire wall and detached nose gear mounts

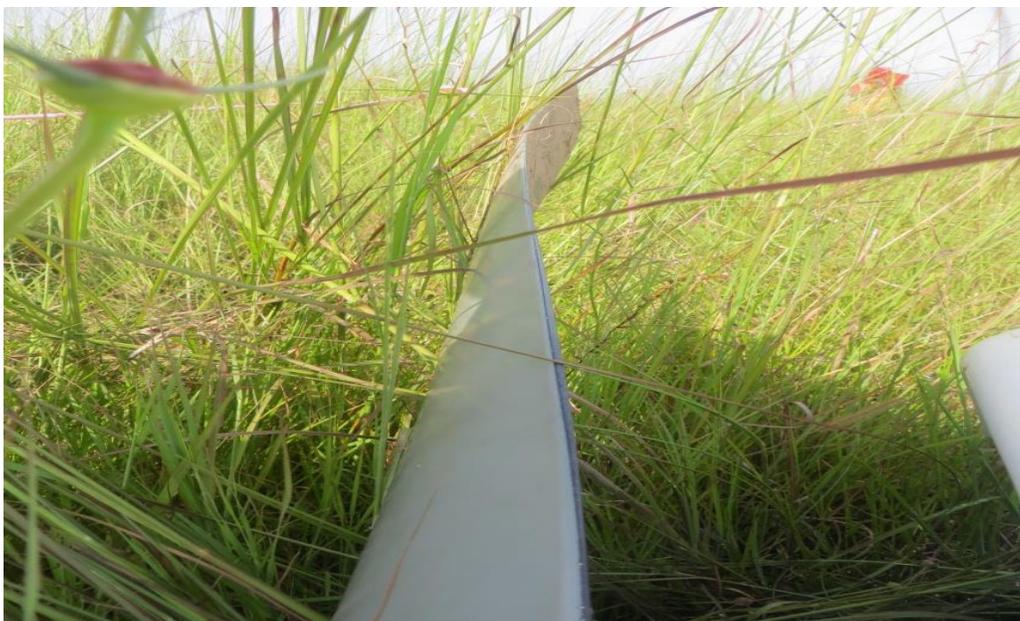
3. The right side of the cockpit floor.
4. Lower engine cowling.
5. One propeller blade bent rearward.

**Figure 5:** Damaged propeller blade.

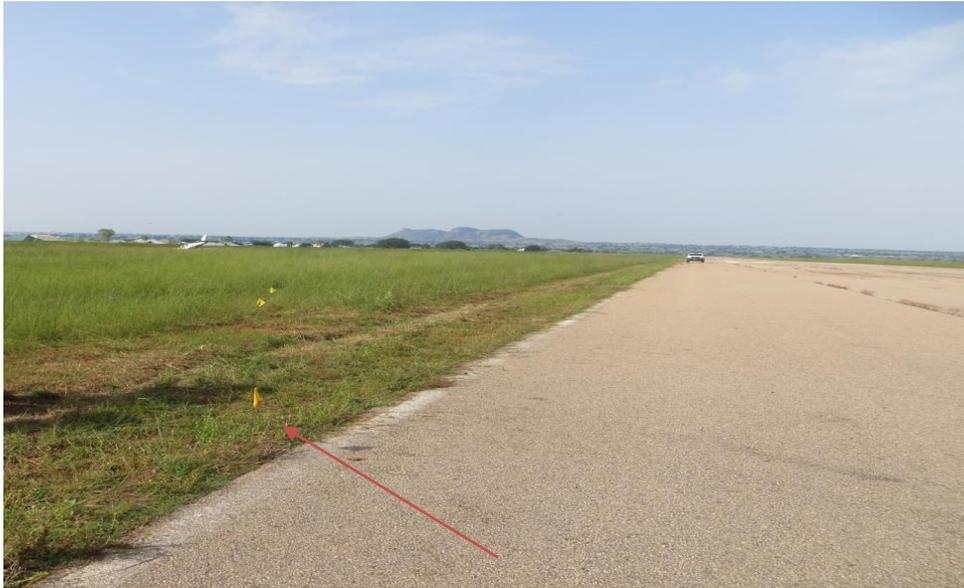
The left main wheel tyre marks seen on the runway depicted a curved track from the touchdown point to where the aircraft exited the runway to the left. The nose wheel tyre marks were seen at just three spots along the grass area until a few feet to where the aircraft stopped.

**Figure 6:** Aircraft exit point on RWY 23 showing left wheel tyre marks
