AIRCRAFT ACCIDENT REPORT

KAL/2013/10/04/F

Accident Investigation Bureau

Report on the serious incident involving a Boeing 747-200 Aircraft with nationality and registration marks 5N-JRM, operated by Kabo Air Limited which occurred at Sultan Abubakar Airport, Sokoto (DNSO); Nigeria on the 4th October, 2013.

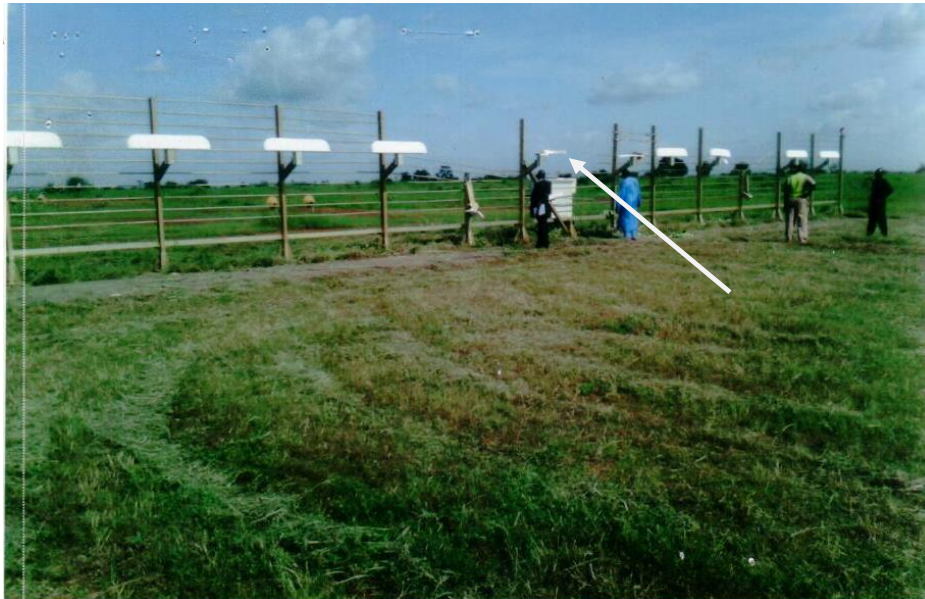
1. Six antenna elements with reflectors were damaged and the aluminium supports for the radiating elements were broken.
2. The Printed Circuit Board (PCB) cards and the protective synthetic fibre covering for the radiating elements were damaged.
3. 21 Low Intensity Approach Lighting fittings along runway 26 were crushed.

Figure 1: Damaged localizer antennae
