# AIRCRAFT ACCIDENT REPORT

VAL/2013/12/04/F

**Report on the accident involving a Boeing 747-200 Aircraft operated by Veteran Avia Airlines Limited with nationality and registration marks EK-74798 which occurred at Nnamdi Azikiwe International Airport Abuja on 4th December, 2013.**

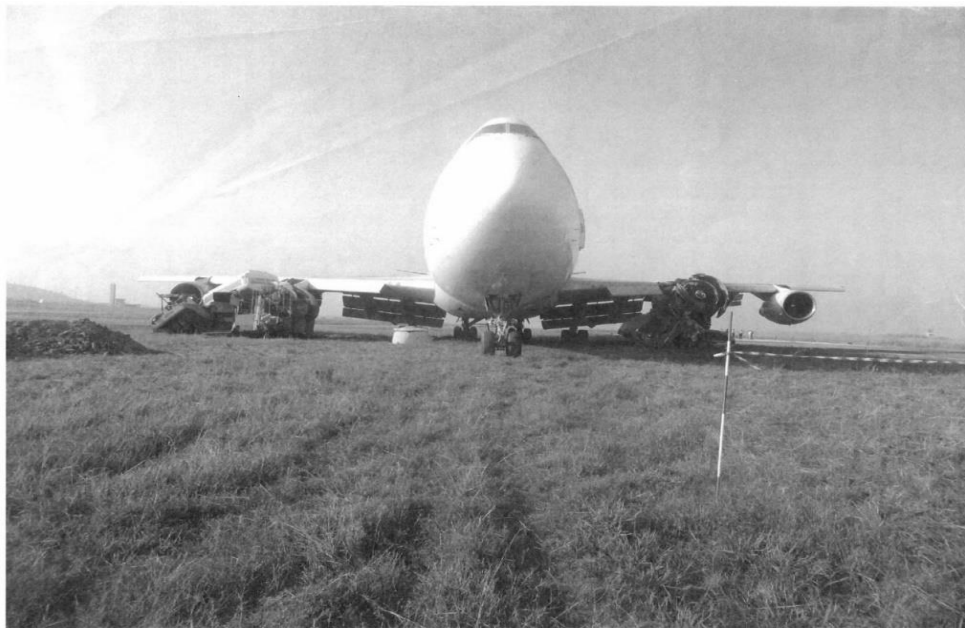
After the landing roll, the aircraft turned to the right to avoid the displaced threshold via exit A3, then veered off to the left of the exit and impacted some construction equipment parked on the side of the runway. There was heavy smoke and fire after the impact. Engines number 2 and 3 were severely damaged. The aircraft came to a final stop, parallel and to the right of RWY 04 on a grass verge with the fuselage and nose wheel between construction equipment.

**Figure 1:** The aircraft after the incident

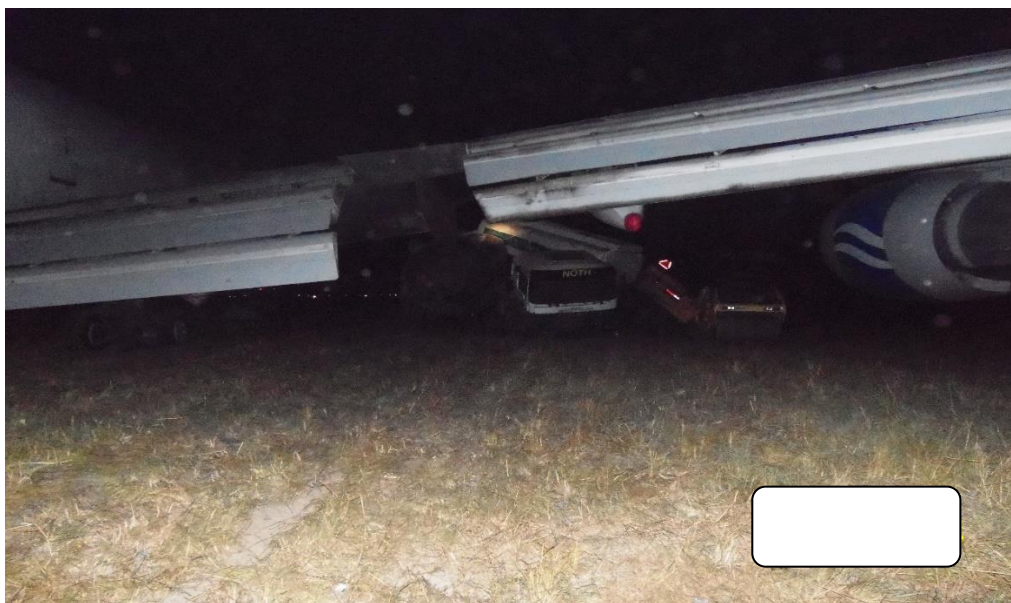
The aircraft impacted four (4) construction equipment parked by the side of the runway. The damaged equipment includes; 320 CL Excavator (Caterpillar), Pneumatic Roller (Dynapac), Asphalt Concrete Paver (Blow Knox) and 1500 litre water tanker (Man-Diesel). Some RWY edge lights were damaged.

**Figure 2:** Aircraft collided with parked construction equipment on the grass verge

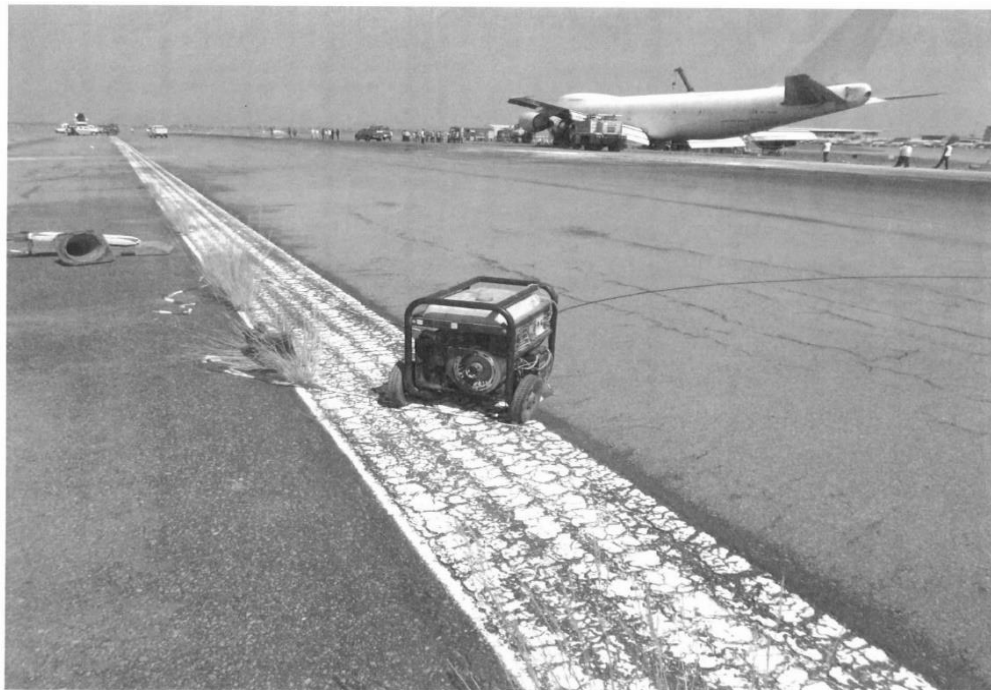
**Figure 3:** Standby generator at the wreckage site

*A generator was provided to power the warning red lights supported by battery back-up red warning lights at the displaced threshold at the commencement of the repair works to the end of the repair works. And also temporary markings were installed at the displaced threshold at the commencement of the repair works on the 2<sup>nd</sup> of December 2013 to the end. It was reported of working day and night to quickly complete the repair works. The workers were all the time guided and brought in and out of the runway by FAAN Operations Officers.*

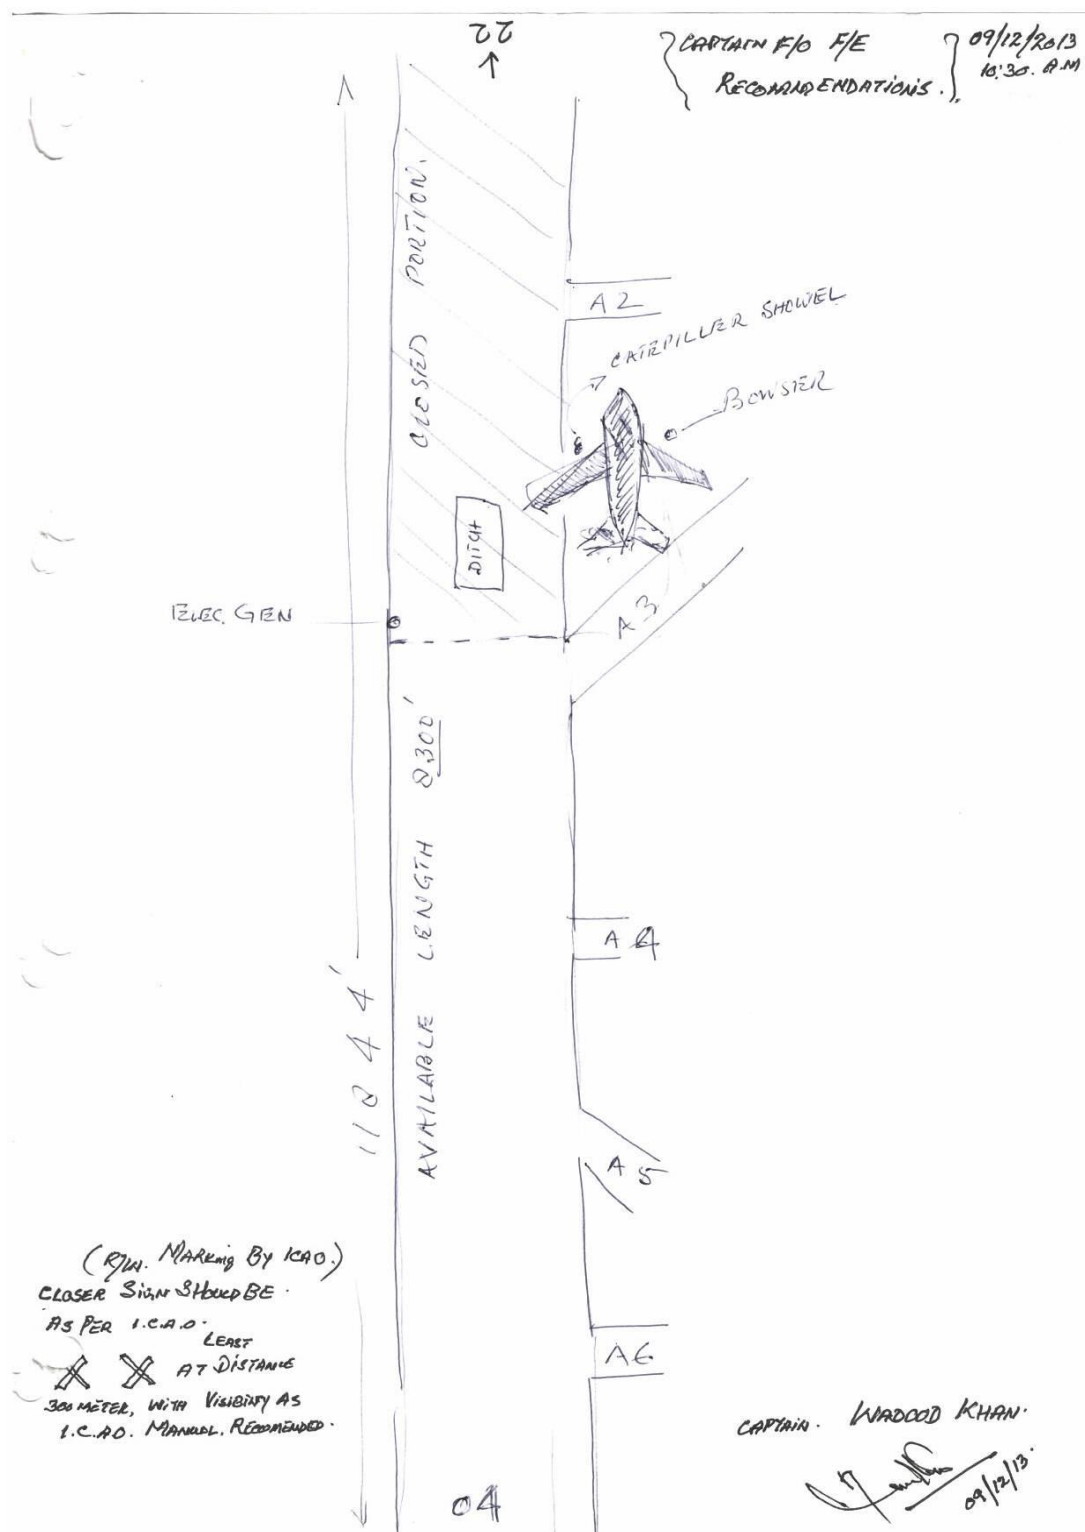
The aircraft came to a final stop, parallel and to the right of RWY 04 on a grass verge with the fuselage and nose wheel between the construction equipment.

**Figure 4:** A sketch of the wreckage site
