AIRCRAFT ACCIDENT REPORT

VAL/2013/12/04/F

Accident Investigation Bureau

Report on the accident involving a Boeing 747-200 Aircraft operated by Veteran Avia Airlines Limited with nationality and registration marks EK-74798 which occurred at Nnamdi Azikiwe International Airport Abuja on 4th December, 2013.

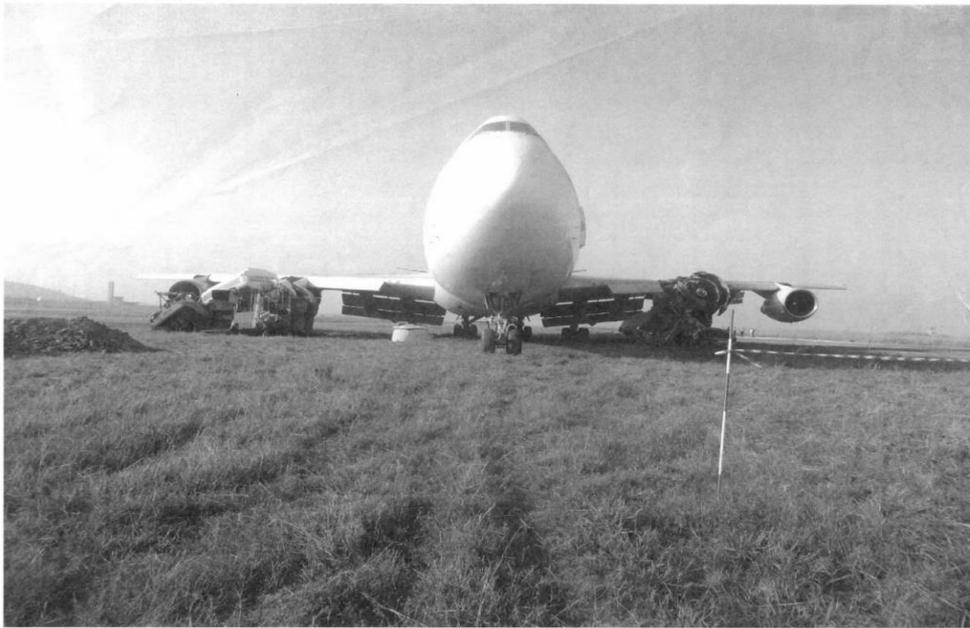
The aircraft was substantially damaged.

Figure 1: The aircraft after the incident

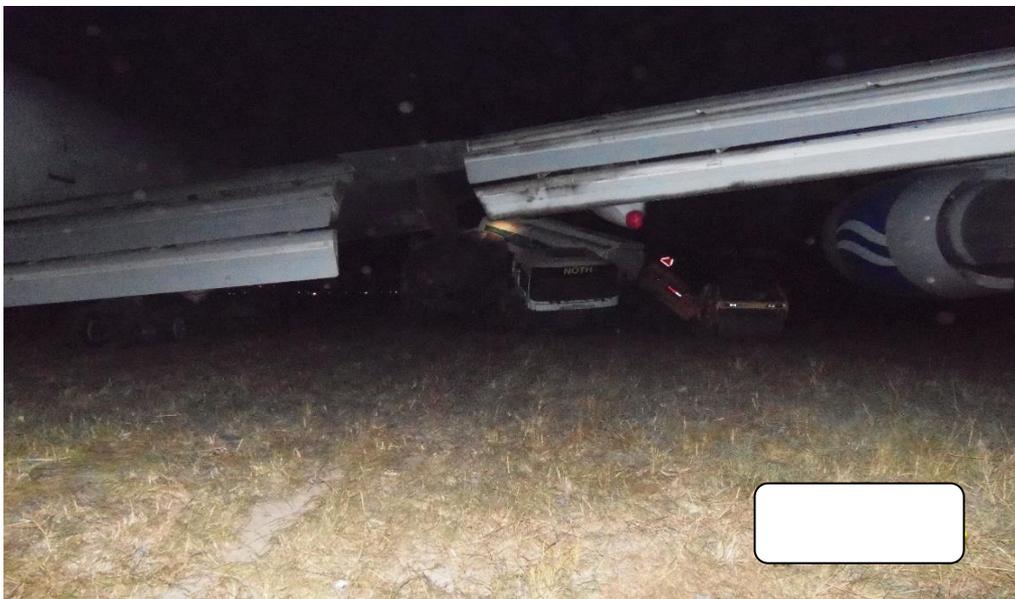
The aircraft impacted four (4) construction equipment parked by the side of the runway. The damaged equipment includes; 320 CL Excavator (Caterpillar), Pneumatic Roller (Dynapac), Asphalt Concrete Paver (Blow Knox) and 1500 litre water tanker (Man-Diesel). Some RWY edge lights were damaged.

After the landing roll, the aircraft turned to the right to avoid the displaced threshold via exit A3, then veered off to the left of the exit and impacted some construction equipment parked on the side of the runway. There was heavy smoke and fire after the impact. Engines number 2 and 3 were severely damaged. The aircraft came to a final stop, parallel and to the right of RWY 04 on a grass verge with the fuselage and nose wheel between construction equipment.

Figure 2: Aircraft collided with parked construction equipment on the grass verge

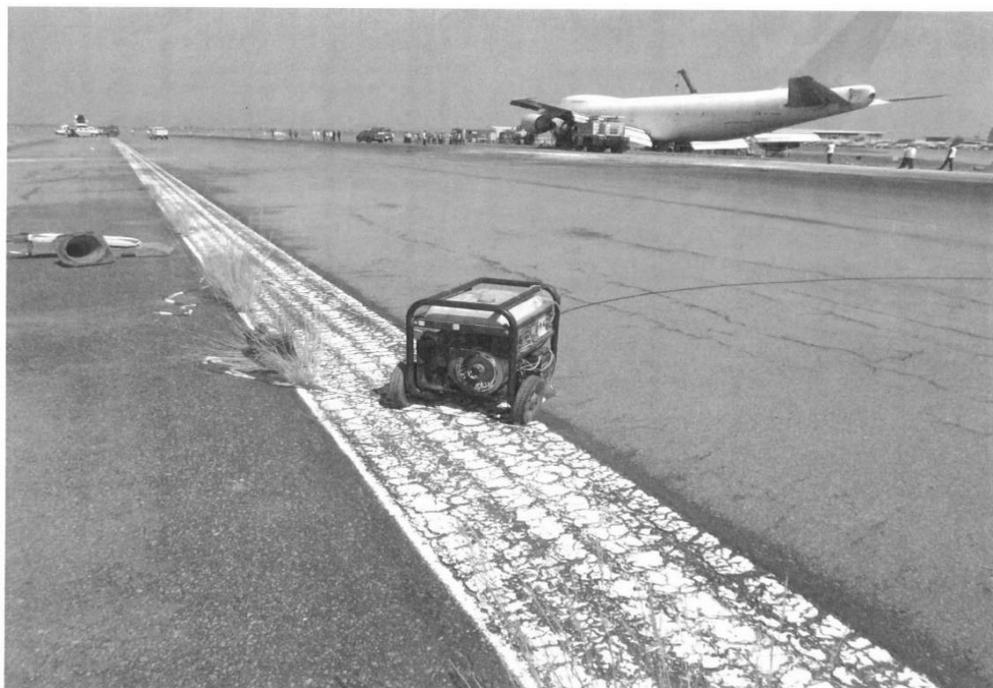
Figure 3: Standby generator at the wreckage site

A generator was provided to power the warning red lights supported by battery back-up red warning lights at the displaced threshold at the commencement of the repair works to the end of the repair works. And also temporary markings were installed at the displaced threshold at the commencement of the repair works on the 2nd of December 2013 to the end. It was reported of working day and night to quickly complete the repair works. The workers were all the time guided and brought in and out of the runway by FAAN Operations Officers.

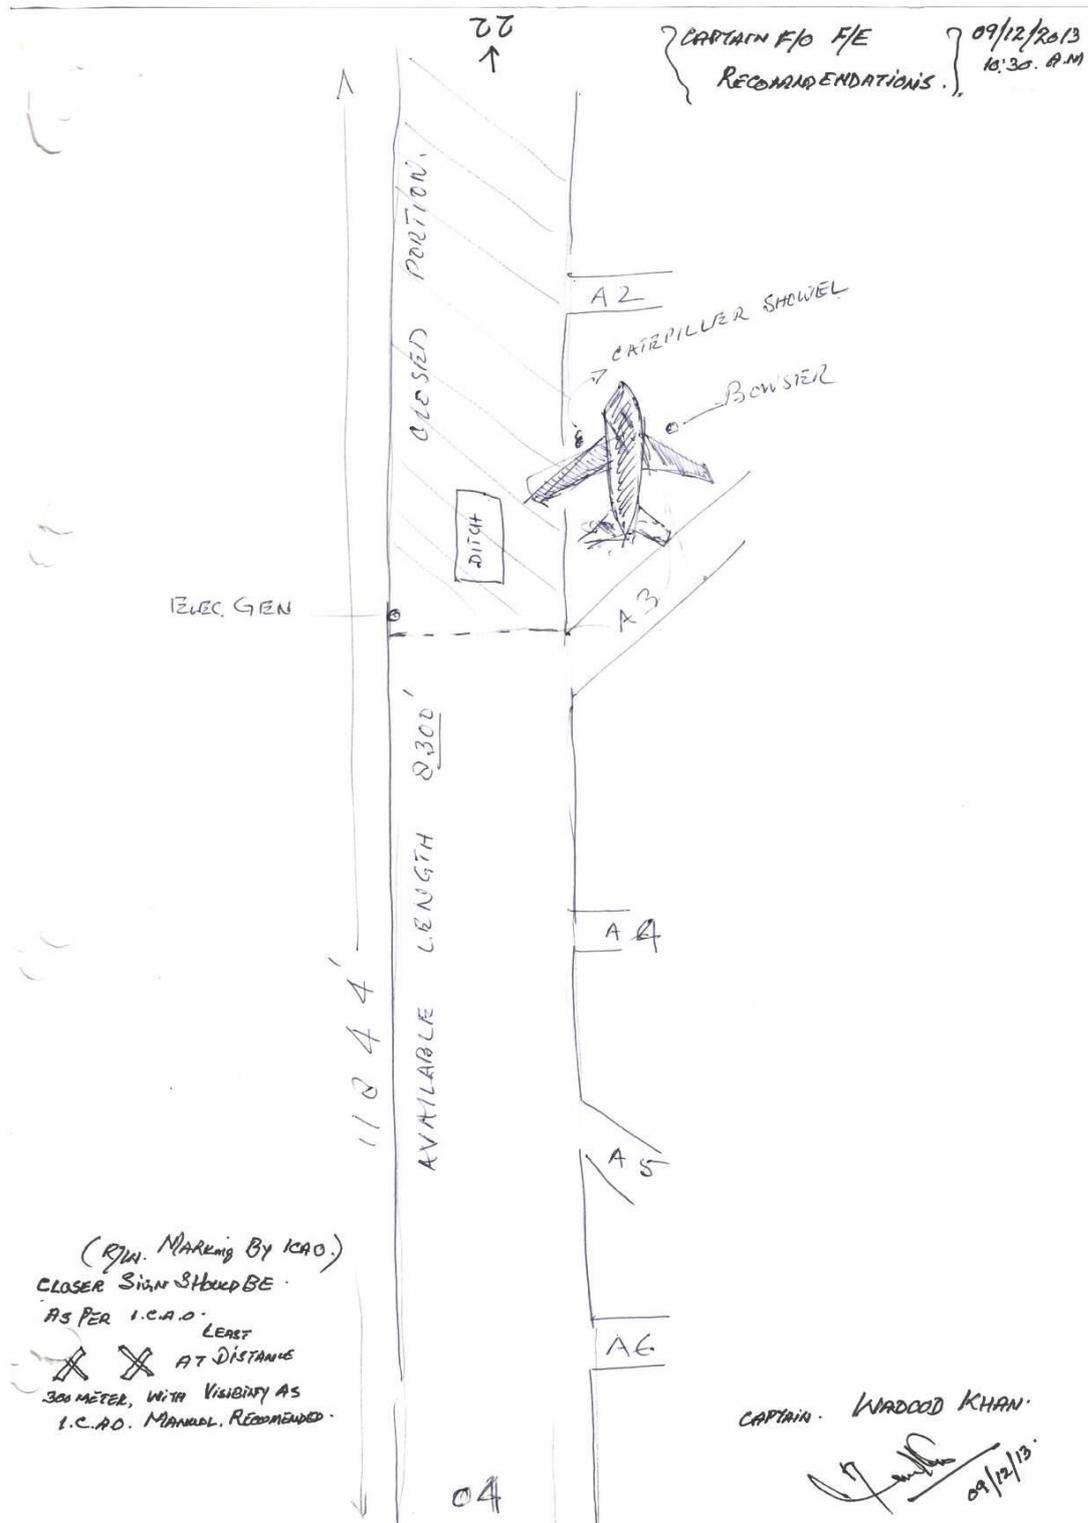
The aircraft came to a final stop, parallel and to the right of RWY 04 on a grass verge with the fuselage and nose wheel between the construction equipment.

Figure 4: A sketch of the wreckage site
